Pre-demolition audit as a tool for appropriate CDW management – a case study of a public building

3 Pre-demolition audit of a public building – a case study

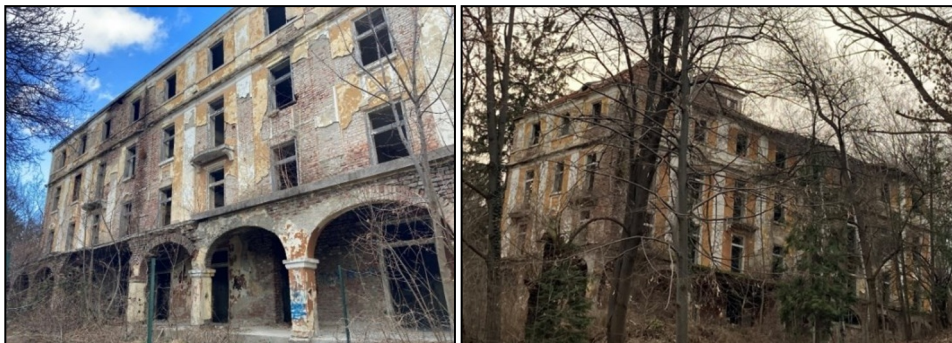
Fig. 1. General view of the building and its present condition.

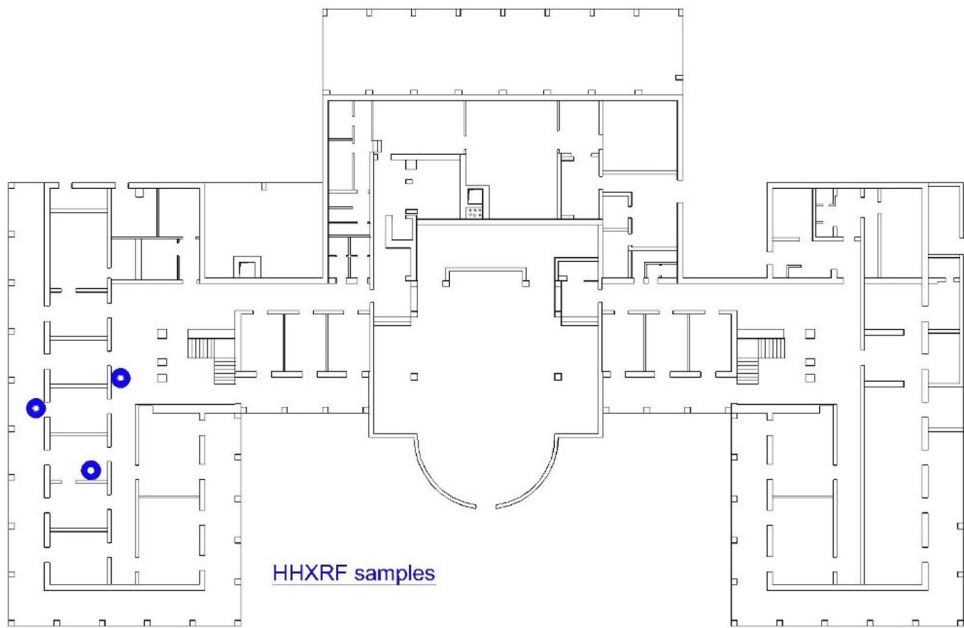
Fig. 2. Ground floor plan of the building.

Altogether 120 test points have been evaluated by the HHXRF. These paints have high levels of lead and represent 36% of the examined surfaces, which amounts to about 505 tons of hazardous construction waste (including woodwork and plaster on walls). High levels of Cr, Ni, As were registered in 27% of the tested paints. Some of the paints that were found to have high levels of pollutants by the HHXRF are indicated in Table 1. The locations where measurements were done are graphically presented on Figure 2 and Figure 3.

| Studied paints | | Unit | Pb | Cr | Ni | As | Hg | Cd |
|---|--|---|---|---|---|---|---|---|
| Ground floor | outside window frames outside | ppm | 14529 | 1238 | 193 | 0 | 0 | 0 |
| | interior plaster, room (white) | ppm | 5495 | 696 | 258 | 0 | 0 | 0 |
| | interior plaster, corridor (orange) | ppm | 0 | 602 | 107 | 102 | 0 | 0 |

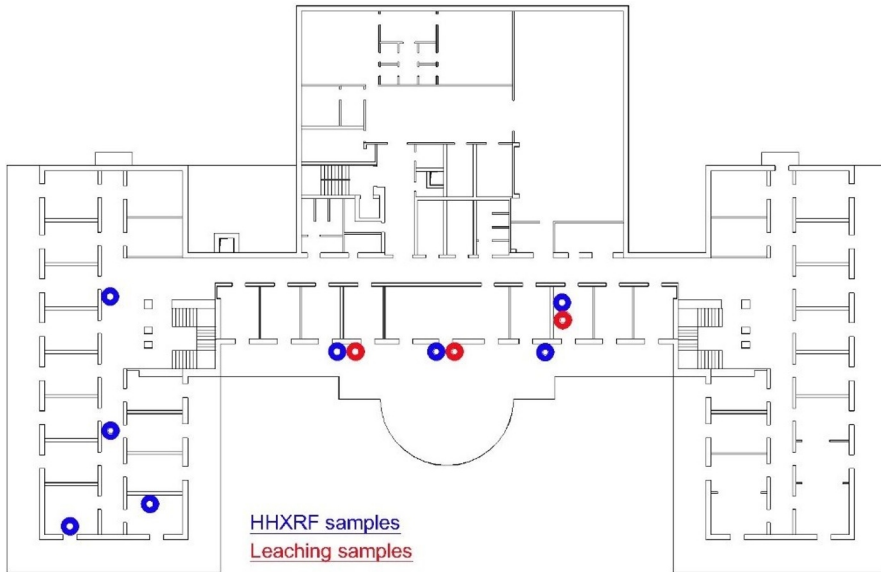
Fig. 3. A plan of level 2 of the building.

| Studied paints | | Unit | Pb | Cr | Ni | As | Hg | Cd |
|---|--|---|---|---|---|---|---|---|
| Level 2 - rooms | wall plaster (green, lean) | ppm | 1339 | 760 | 53 | 279 | 0 | 0 |
| | wall plaster (green) | ppm | 2337 | 981 | 116 | 275 | 0 | 0 |
| | internal window frames (white, yellow) | ppm | 0 | 582 | 140 | 133 | 0 | 0 |
| Level 2 - corridor | wall plaster (yellow) | ppm | 4865 | 472 | 0 | 0 | 0 | 0 |
| | wall plaster | ppm | 319 | 0 | 0 | 49 | 0 | 0 |
| Level 2 - terraces | facade plaster (white, blue) | ppm | 801 | 0 | 56 | 0 | 0 | 0 |
| | outside plaster (blue_ | ppm | 2372 | 0 | 68 | 0 | 0 | 0 |
| | outside window/door frame | ppm | 20906 | 949 | 249 | 0 | 0 | 72 |
