The Cause Analysis of Valve Stem Bolt Failures in Nuclear Power Plant

Abstract: The shaft of the electric isolation valve at the outlet of the seawater tank pump in a nuclear power plant fractured due to bolt failure, resulting in detachment and loss of electrical switching function. Upon disassembly, it was discovered that all connecting bolts on the frame were fractured. Macroscopic examination, chemical composition analysis, hardness testing, metallographic examination, scanning electron microscope (SEM) observation, and energy spectrum analysis were performed on the fractured bolts. Results revealed significant deviation from design specifications for stainless steel austenite in terms of their chemical composition; instead they consisted of low-alloy steel (40Cr). High-strength bolts exposed to marine environments are susceptible to corrosion-induced stress cracking or hydrogen embrittlement leading to fracture. Replacement is recommended as a preventive measure against corrosion-induced bolt failure.

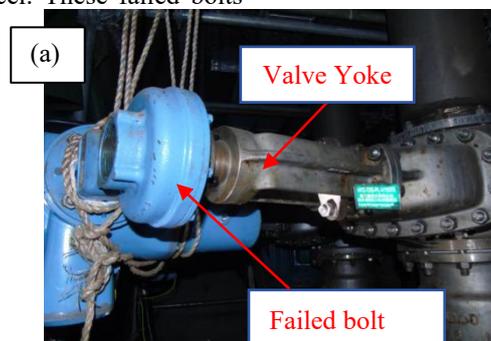
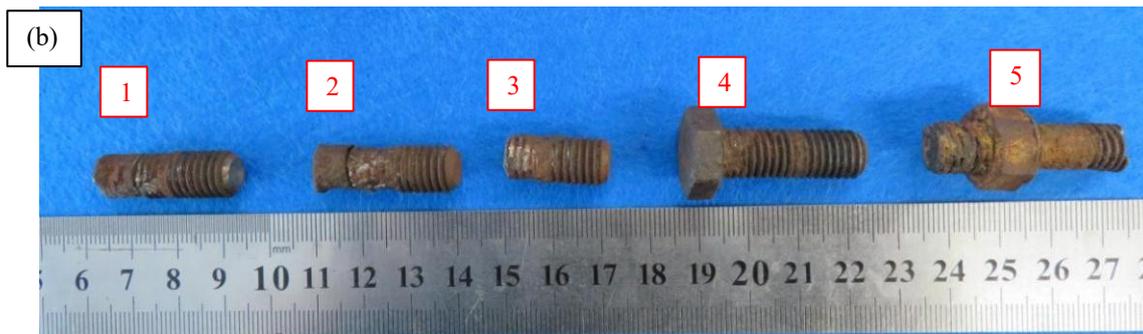
were located above the seawater pool in the underground level -14m of the conventional island of the nuclear power plant, operating in a humid marine environment. Since the pump upstream of the valve was started every 5-7 hours, the same valve had to be frequently switched on and off within the same time interval. The threaded connection was used to secure the yoke frame, with the threaded bolt passing through the hole from below and connecting to the threaded hole above to secure the yoke frame and electric actuator. Once these bolts failed, it would affect the safe operation of the valve and prevent the system from functioning normally. Figure 1 shows the location of the failed bolt and the macro morphology of the partial failure bolt sample.

Figure 1. Overall macroscopic photo of the fractured bolt (numbered 1-5 in sequence)
(a) The failed part of the bolts in the valve; (b) Sample of partially failed bolts.

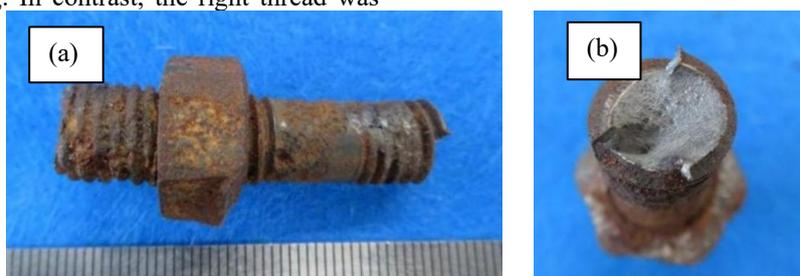
Among them, the base material of Bolt No. 5 had been seriously corroded, and the clear thread pattern was no longer obvious. The middle thread surface had also suffered mechanical damage, which was probably caused during cutting. In contrast, the right thread was

relatively intact and had less corrosion products attached to it, which might be because they were in the hole position. By analyzing the macroscopic fracture surface, it was found that a layer of gray-black corrosion products covered the fracture surface. The fracture surface was even or stepped, without obvious necking, showing typical brittle fracture characteristics. Figure 2 shows the macroscopic morphology of Bolt No. 5

Figure 2. Macroscopic morphology of No. 5 fractured bolt
(a)transversely fractured bolts; (b) axially cracked bolts

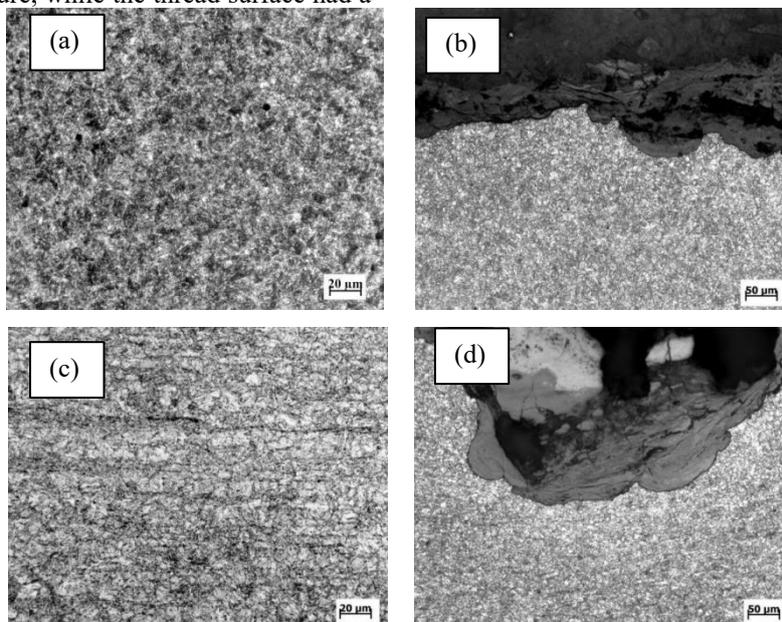
Microstructural analysis was conducted on the cross-section of the bolt bolt fracture, and the longitudinal section was examined for non-metallic inclusions using an OLYMPUS GX71 optical microscope. Through metallographic observation, it was found that the base material of the bolt had a tempered martensite microstructure, while the thread surface had a

large number of randomly distributed corrosion pits of various sizes, as shown in Figure 3. According to GB/T 10561-2005, "Standard Rating Chart for Determining the Amount of Non-metallic Inclusions in Steel by Microscopic Examination," we analyzed the non-metallic inclusions in the sample, and the results showed that all the non-metallic inclusions in the sample belonged to the fine system and were rated as A1.5 and D1.5, as shown in Figure 4.

Figure 3 Microstructural Analysis of Bolt Thread Root No. 5, showing (a) Area A at 500x magnification; (b) Area B at 200x magnification; (c) Area C at 500x magnification; and (d) Area D at 200x magnification.

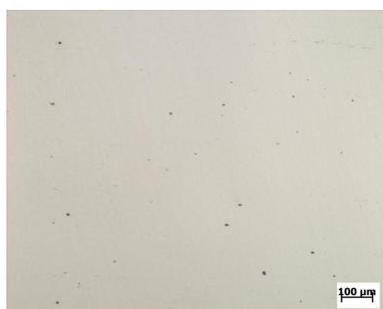
Figure 4 Non-metallic Inclusion Evaluation of Bolt No. 5

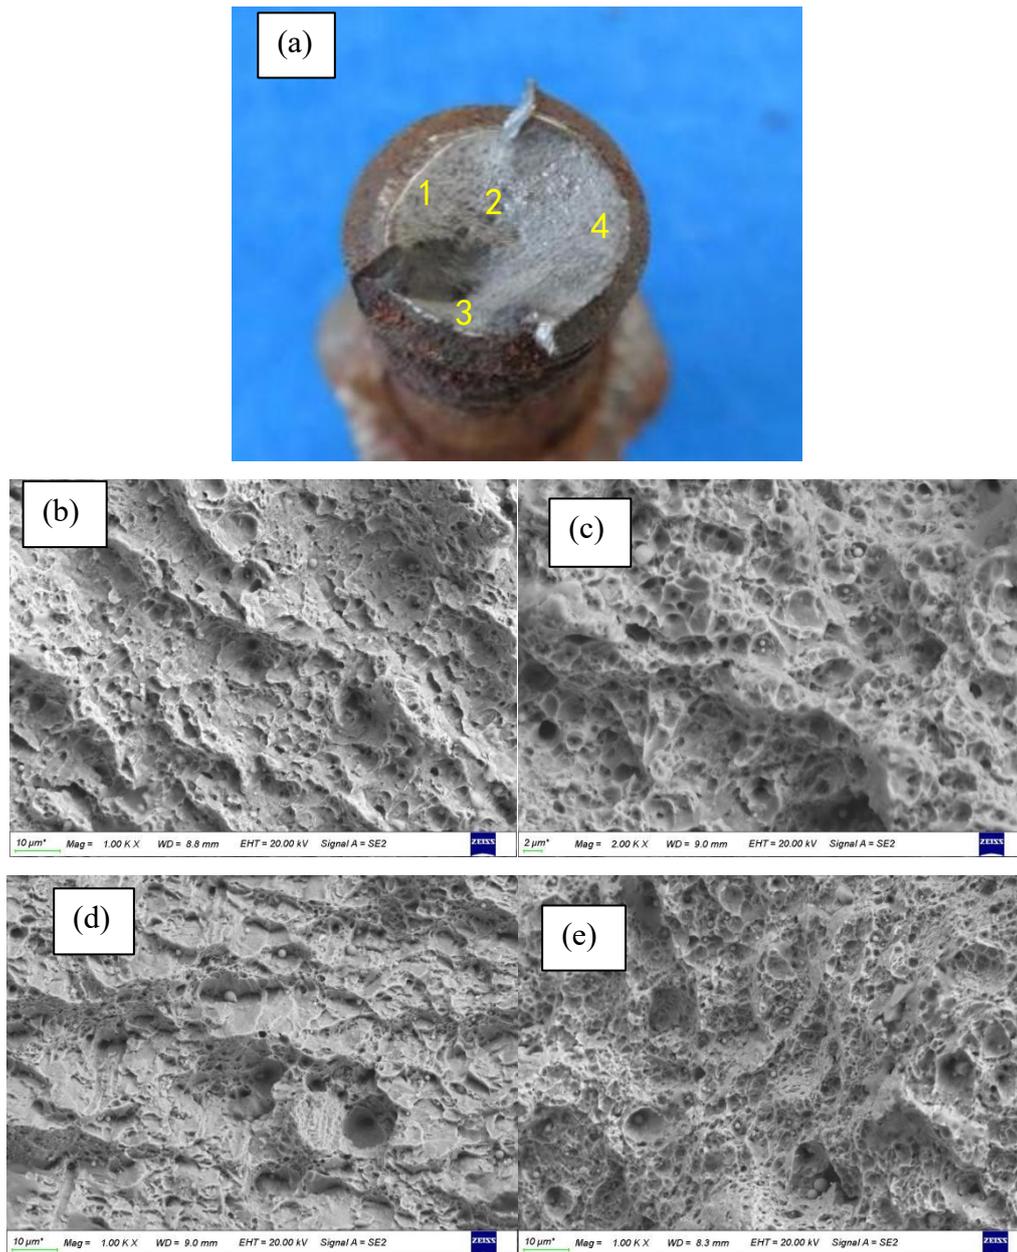
The fracture surface morphology of No. 5 sheared bolt was studied by using GeminiSEM 300 field emission scanning electron microscope., as shown in Figure 5. Combining the macroscopic analysis of the fracture surface, it can be known that a layer of gray-black corrosion products covers the fracture surface, and the fracture surface cannot be seen clearly before cleaning. The overall fracture surface presents a ductile dimple characteristic, indicating a ductile fracture.

Figure 5 Illustrates the microscopic morphology of the bolt fracture surface, showing (a) the overall morphology; (b) microscopic morphology at Position 1; (c) microscopic morphology at Position 2; (d) microscopic morphology at Position 3; and (e) microscopic morphology at Position 4.

The fracture surface of Bolt No. 5 shows a ductile dendrite feature, indicating a ductile fracture type, indicating that the bolt was subjected to a significant force before failure. The location of the failure is above the sea water pool on the intake side of the condenser, exposed to the marine environment. The material is a low-alloy steel (40Cr), with its main alloying element being Cr, with a content of about 1%. Due to its high strength (reaching 1300 MPa and 1000 MPa respectively), it belongs to high-strength steel materials, which are prone to corrosion and stress corrosion cracking or environmental hydrogen-induced fatigue in marine environments[6-10].

- The chemical composition of the bolt material does not conform to the specifications outlined in drawing A193M-B8M; instead, it is composed of low-alloy steel (40Cr). Based on the chemical composition and hardness analysis following GB/T 3098.1-2010 standard, bolts 1-4 can be classified as grade 12.9, while the fifth bolt can be classified as grade 9.8.
- The failed bolts are high-strength bolts and are in a marine atmosphere environment. In a marine atmosphere environment, high-strength bolts are prone to corrosion, which can lead to stress corrosion cracking or environmental hydrogen-induced failure.
- It is recommended to replace the existing bolts with A193M-B8M material that meets the requirements specified in the drawing to prevent failure due to corrosion.

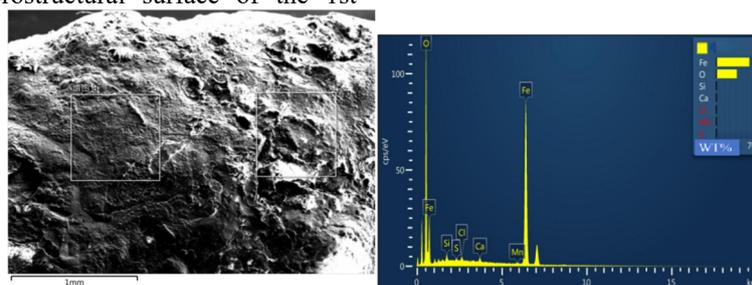
After conducting EDS analysis through GeminiSEM 300 field emission scanning electron microscope, we observed that the microstructural surface of the 1st

broken bolt joint was covered with a large amount of corrosion products, mainly composed of Fe oxides. According to the results of the spectrum shown in Figure 6, these corrosion products contain common elements in seawater such as Cl, Ca, and Na.

Figure 6 EDS analysis of the bolt fracture surface
(a) Microstructure of the fracture surface; (b) EDS analysis results of the local area.

Based on the results of comprehensive physical and chemical testing, the chemical composition of the bolt material does not conform to the specifications in A193M-B8M drawing, and there is a significant difference. The A193M-B8M material used in the original design was an austenitic stainless steel containing Mo for resistance to sea water corrosion, while the actual material used was a low-alloy steel (40Cr). The results of the energy spectrum analysis show that the corrosion products contain Cl, Ca, and Na, which are marine elements, indicating that the bolt has been corroded by the marine environment[3-5].
