# A risk-based approach to the quick clay landslide at Flatanger, Norway – comparison of national regulatory guidelines

Anders Gylland<sup>1,2\*</sup>, Jean-Sébastien L’Heureux<sup>1</sup>, Magne Wold<sup>2</sup>

**Abstract.** The quick clay landslide that struck Flatanger in Mid Norway on March 10, 2023, posed significant challenges for the safe reopening of County Road 6928. Key concerns included the risk of additional slide debris reaching the road, potential for new retrogressive failures from the shoreline, and the stability of the road itself. According to Norwegian Public Roads Administration regulations N200, the safety levels for repairing roads are in general the same as required for building new roads. For Flatanger, this would have implied extensive stabilization measures with substantial environmental, climatic, and economic impacts. Through an analysis of relevant legislation, regulations, and guidelines, this study explores how safety requirements can be interpreted and adapted while maintaining public safety. At Flatanger, a design strategy was chosen that prioritized addressing triggering factors rather than imposing large-scale interventions to achieve absolute

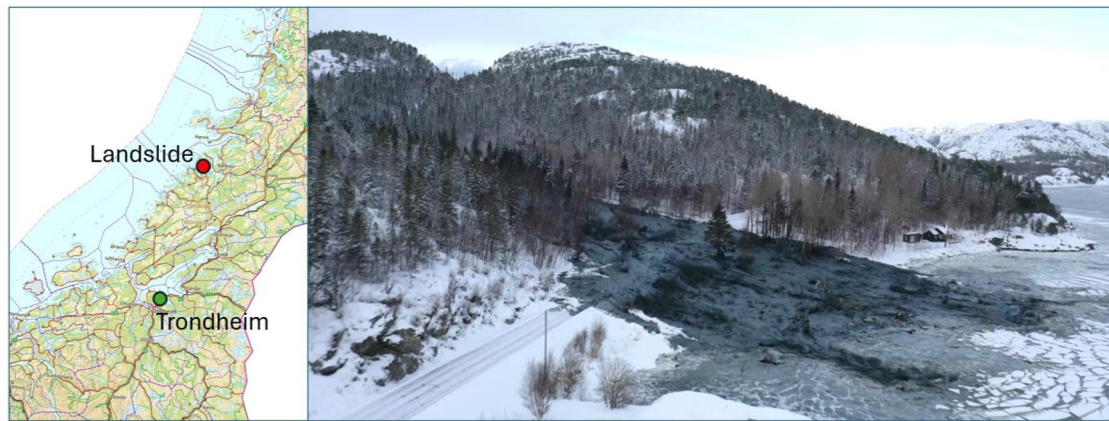
On Friday, 10 March 2023, a landslide occurred at Innervika, crossing County Road 6928 in the municipality of Flatanger. The location of the landslide is shown in Fig 1, together with a drone image of the event. Fig 2 shows an overview of the landslide area. The landslide was triggered approximately 100 m upslope from the county road, and the slide material flowed like a liquid river across the road and onwards into the sea. The landslide volume is estimated at approximately 43,000 m<sup>3</sup>, and the scarp is up to about 150 m wide and 12-15 m high. No people were caught or injured by the landslide, but approximately 100 people were isolated after the road was cut.

**Fig. 1.** Location of landslide in mid Norway. Capture from a drome-video of the landslide (Flatangernytt). Video is found here: <https://vimeo.com/806840967>.

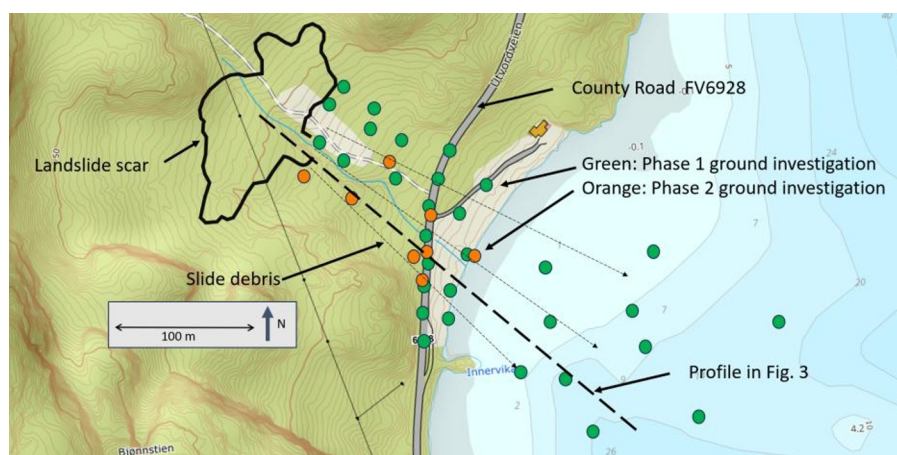
**Fig. 2.** Overview of the landslide area with location of borings and the cross section in Fig. 3.

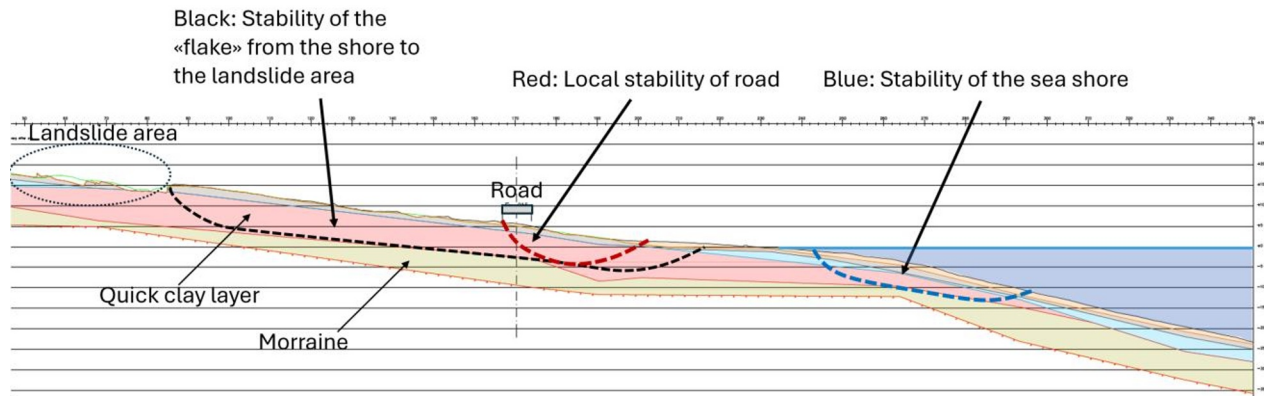
The site investigations identified a continuous layer of quick clay<sup>†</sup> extending from the seabed up to the landslide scarp (Fig 3). The quick clay normally consolidated and with low plasticity (plasticity index

around 5-6 %). The clay layer generally has a thickness of 5–15 m and is overlain by a coarser sandy material.

**Fig. 3.** Section through the bay, with the landslide area upslope to the left in the profile, and the sea to the right. The figure defines three stability situations.

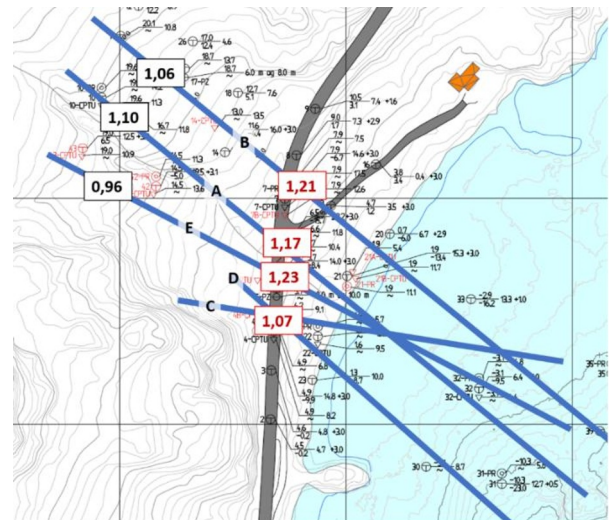
- The road's local stability ( $F_{cu} \approx 1.1-1.2$ ) falls below the thresholds specified for new road projects in quick clay areas according to current national guidelines (Section 6.1).
- Overall stability of the slope between the sea and the landslide area is also very low ( $F_{cu} \approx 1.0-1.1$ ).
- Mitigation measures intended to lower driving forces (such as unloading) or increase resisting forces (such as counterfill) at one location along the road leads to reduced stability at other locations on the slope. This behaviour is typical for long, uniform near-shore slopes where the infinite-slope conditions dominate.
- All drained analyses showed safety factors above absolute criteria

Consequently, the situation could not be considered satisfactory, and realistic improvement options were limited to extensive measures such as major ground reinforcement, bridge construction, or road realignment.

**Fig. 4.** Summary of  $F_{cu}$  for the remaining slopes after the landslide based on data from Phase 1 site investigation.

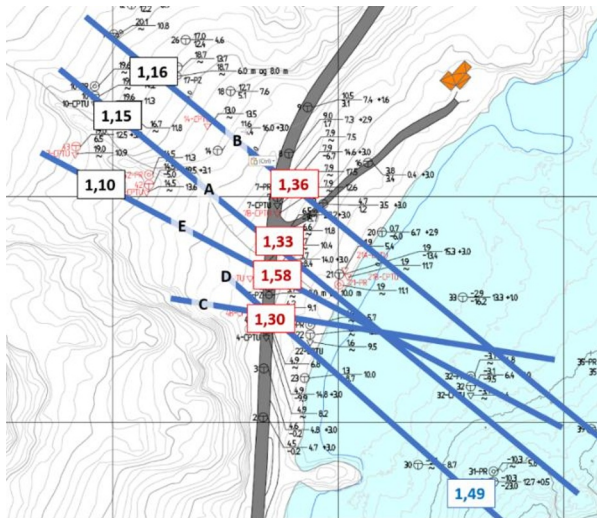
Calculated stability for the road and shoreline slope is summarised in Fig 5. In all cases, safety factors for drained analyses are well above 1.6. For total stress

analysis (i.e. undrained) the following results were obtained:

- Local stability of the road is  $F_{cu} \approx 1.3$ -1.4
- Analyses using a planar or translational slip surface (black) shows that the overall stability of the slope between the sea and the landslide area is  $F_{cu} \approx 1.0$ -1.16
- Stability of the shoreline slope is close to 1.5

**Fig. 5.** Summary of  $F_{cu}$  for the remaining slopes after the landslide based on data from Phase 2 site investigation.
