Assessment of Significant Causes to School Building Defects

Seven schools in Kedah were selected as case studies. All data were collected through visual inspections and interview sessions between the researcher and person-in-charge, technical staffs or maintenance officers from each school.

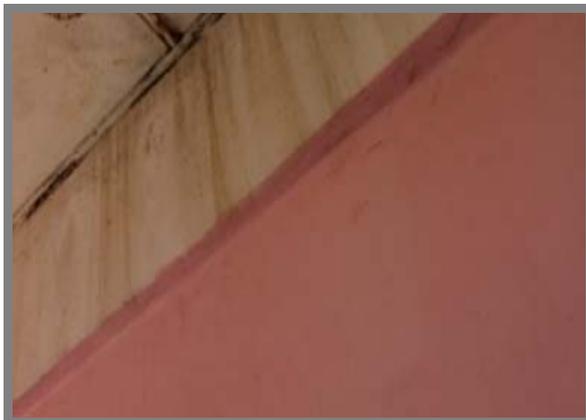
Dampness in schools resulted from water incursion either from internal sources (e.g. leaking pipes) or external sources (e.g. rainwater). This defect became a serious problem when various materials in the school buildings became soak for extended periods of time. Besides, excessive moisture in the air due to poor air ventilation system inside the buildings can also lead to dampness [10]. The common type of dampness found in school buildings is penetrating damp. Dampness was found on the ceiling and wall due to the ingress of water. The classrooms, especially on the top floor, were greatly affected by dampness of ceiling as the roof tiles were missing or blown away by wind. The rainwater penetrated directly into the building itself, resulting in dampness (Fig. 1).

Figure 1: Penetrating damp on the ceiling.

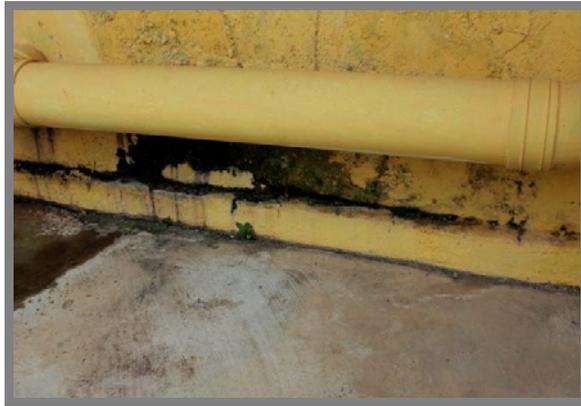
Dampness can arise from unintended water caused by leaking pipes, gutters and flashings [10]. The leaking water penetrated into the wall, resulting in horrible water stains. Under long term of dampness penetration and poor ventilation within the building, excessive moisture promoted the growth of mould on the surface of wall (Fig. 2).

Figure 2: Mould growth on wall caused by dampness due to leaking pipe.

The growth of mould and fungi are ordinary consequences caused by excessive dampness. Mould and fungi will grow when they gain enough moisture and nutrients [4]. However, the growth of mould causes a lot of problems to the school environment. It not only physically affected the appearance of the building structure, but also led to plenty of health illnesses to the students and staffs.

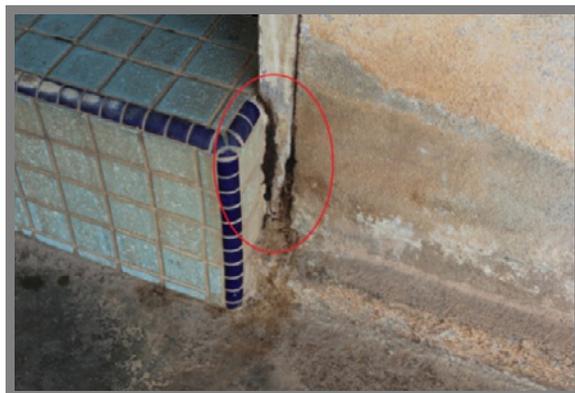
Figure 3. Timber decay on door frame in toilet.

The problem of timber decay was mainly found on door frames, window frames, timber roof struts and ceiling battens. Those components exposed to moisture which was the main critical element in the timber decay process. While, some timber materials decayed because of aging, e.g. ceiling battens. Fig. 3 illustrates the timber door frames in toilets that suffered from the worst situation because they were highly exposed to water and subsequently caused deterioration [6]. This type of timber decay was also known as wet rot. Wet rot was the most common type of timber decay in which the fungus feeds on timber; the timber must be damp or wet enough for the fungus to thrive and continue the rotting process. Timber decay occurred if the timber becomes sufficiently wet, with the present of oxygen and nutrients.

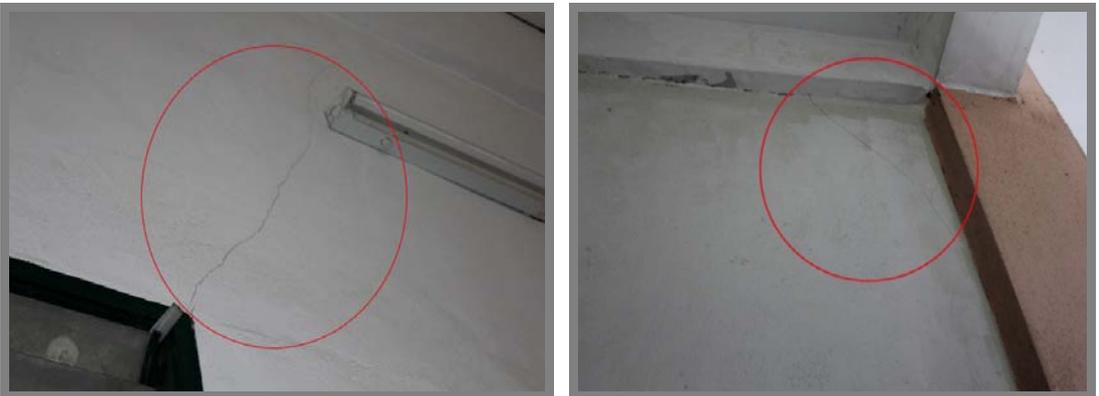
Cracks happened on the various elements in school buildings such as walls, ceilings, beams, columns and even floors (Fig. 4 and Fig. 5). There were many structural and non-structural cracks found. Structural cracks took place in walls, beams and columns. However, non-structural cracks usually happened in plaster or other finishes with cement rendering [7]. Different types of cracking such as vertical, horizontal, diagonal and hairline were found in the school buildings.

Figure 5: Diagonal crack on wall and at the corner of door

Some parts of the inspected schools showed serious cracks while some only showed minor cracks. From the inspection, cracks in wall were in various directions and varying in width from fine hair cracks to 5mm or more. The hairline cracks in plaster and other finishes affected the appearance of the structure but fortunately did not pose any safety concern [7]. There were long and continuous cracks across the walls, beams, columns, ceilings and floors. Moreover, a diagonal crack was found at the corner of door where the crack tip was very thin with increased thickness at the initial point.

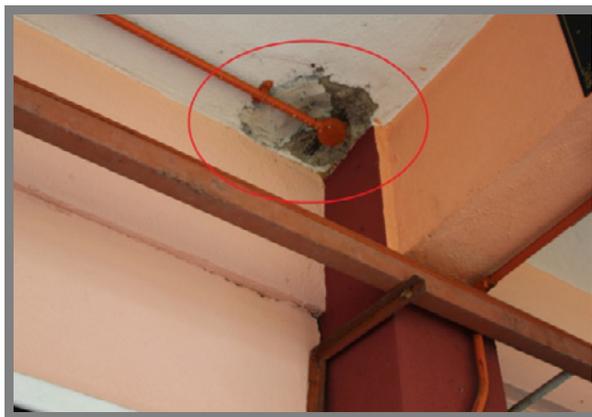
Figure 6: Broken plastered renderings.
