# Characteristics of landslides induced by an earthquake from a hidden strike-slip active fault in the Cianjur Area of West Java

**Abstract.** On November 21, 2022, the Cianjur area in West Java, Indonesia, experienced devastating landslides caused by a magnitude 5.6 earthquake, with the epicenter traced to a hidden active fault approximately 11 kilometers beneath the surface, known as the Cugenang Fault. This study investigates the post-disaster landslides and aims to discover the characteristics of the landslides triggered by this earthquake. The methodology involves literature review, lithology descriptions, landslide slip surface analysis, soil analysis, slope assessment, land cover and land use change examination, landslide orientation evaluation, and distance measurements to the earthquake's epicenter and the Cugenang fault. Drones aided spatial landslide analysis. The study highlights the strong link between intense shaking along the active fault and landslide occurrences. Due to lithological bedding control, these landslides all head southwest and are located 0.35 to 0.67 kilometres from the fault. The residual soil, highly weathered breccia, and possible tuff volcanic dep

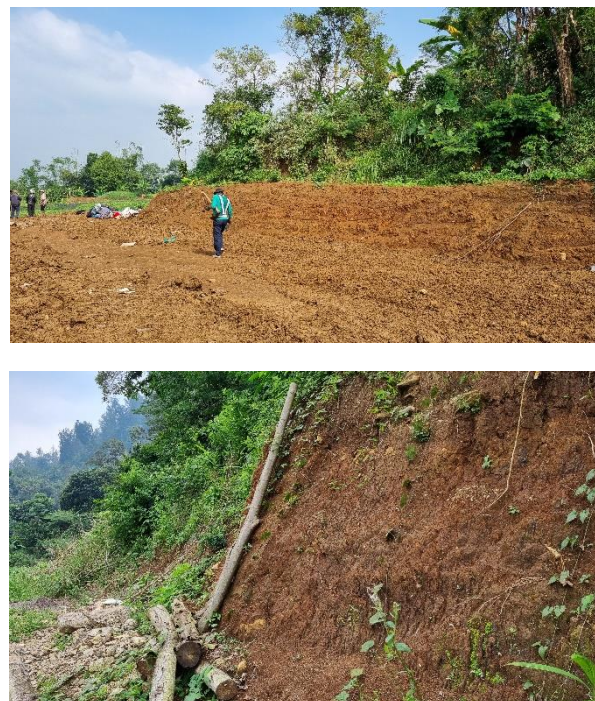
**Fig. 1.** Typical yellowish to dark brown residual soil and highly weathered breccia in the landslide area, exposed in the middle of the Cijedil Landslide (top) and in the crown area of Cugenang landslide (bottom).

In the areas of breccia and lahar deposits, small hills or basalt blocks are found locally. Based on field surveys, it was observed that the landslides in Cijedil, Cugenang, Sarampad, and Rawacina occur on the residual soil and weathered rock in the upper layer, with thickness of about 3 meters to 10 meters. The residual soil and the highly weathered breccia layer can be seen in figure 1.

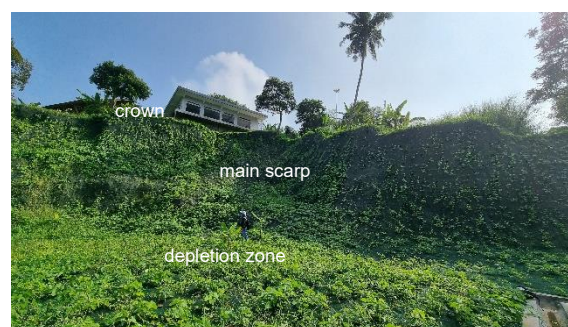
The Cijedil landslide occurred at coordinates 107.083194° E and 6.800222° S. At this landslide site, lithology resulting from volcanic breccia weathering is exposed, with the highly weathered breccia lies at the bottom part and dark brown residual soil at the uppermost layer. The exposure at this site shows variations in weathered soil, ranging in colors from dark brown (silty), light brown (sandy), to dark brownish-black (clayey) from upper to bottom, with a thickness of approximately 8 meters. At the base of the landslide, there is a spring, indicating the presence of an impermeable layer beneath the surface. The sliding plane of the landslide is believed to be the result of weathered, impermeable tuff layer. The slope is about 19° and the dip slope is predicted to be in the same direction as the ground surface slope, with the landslide movement direction approximately N165°E.

The landslide morphology exhibits the characteristic horseshoe shape at the crown, with the sliding material reaching the river at the base of the landslide. The

distance of the Cijedil landslide from the earthquake's epicenter is 3.96 km, while the estimated distance from the Cugenang Fault is 0.46 km. The landslide area covers 17.536 m<sup>2</sup>, with a length of 234.75 – 272.68 meters and a width of 65.98 to 70 meters. Before the landslide incident, the land use in the area was a mixed plantation, and at the base of the landslide, there were slope cuttings for a district road without reinforced on the cut slope.

The landslide occurred due to the earthquake's shaking on the saturated weathered breccia layer, which had an impermeable layer beneath it. During the survey, the post-landslide condition showed that the road construction had reinforced the cut slope area, and the landslide body and crown had been covered with plastic netting and planted with ground cover crops.

**Fig. 3.** Cijedil landslide showing the crown, main scarp and depletion zone.

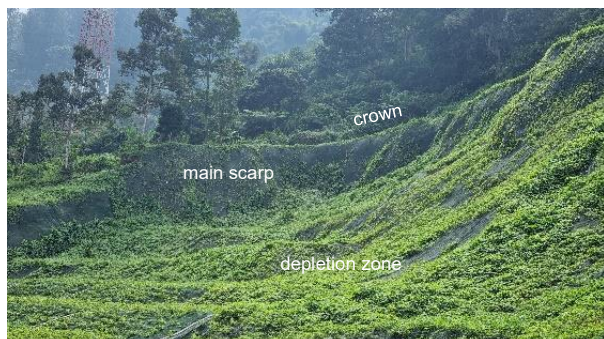
The Cugenang landslide occurred at coordinates 107.080219° E 6.79496° S. The exposed lithology on the surface consists of brown residual soil resulting from weathered volcanic rocks, with a thickness of approximately up to 12 meters. The landslide exhibits a distinctive morphology with a sizeable horseshoe-shaped crown, followed by a more miniature horseshoe indicating two primary and one more minor landslide at this location. The sequence of events suggests that the more significant landslide occurred first, followed by the smaller one. The slope is about 20°.

At the base of the sliding terrain, exposed at the bottom of the landslide, there is a moderately weathered volcanic breccia with component sizes ranging up to boulders. The sliding plane of the landslide is estimated to be composed of compact volcanic breccia, of slightly weathered or an impermeable layer derived from tuff rocks.

During the event, the landslide material covered the Puncak - Cianjur national road in Cugenang and reached the river at the base of the landslide. The main landslide direction is approximately N168°E, while the minor is N211°E. The distance from the landslide to the earthquake's epicenter is 4.62 km, and the estimated distance from the Cugenang Fault is 0.35 km. The landslide area covers 29.833 m<sup>2</sup>, with a length of 260.94 – 297.66 meters and a width of 94 to 117.57 meters.

Before the occurrence, the area of the landslide was a mixture of gardens and secondary forest vegetation, some of which had been cleared. At the base of the

landslide, there were slope cuttings for the national road that had yet to be reinforced before the landslide.

**Fig. 4.** Cugenang landslide showing the distinct horseshoe-shaped of the crown and main scarp and the depletion zone.

After the landslide, the area has been reinforced with rock gabions along the road edge, and the sliding area has been covered with plastic netting planted with ground cover crops.

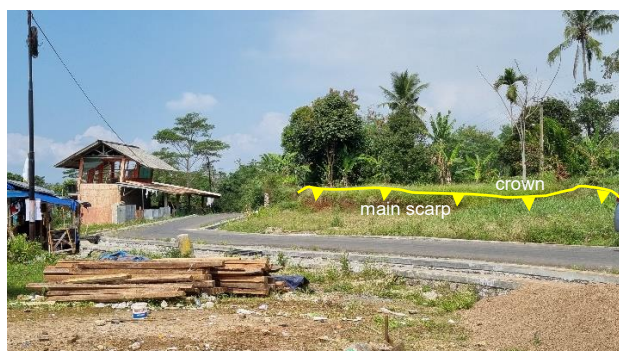
The Sarampad landslide occurred at coordinates 6.802749° S and 107.074958° E. The landslide area was relatively gentle, with a slope of about 9 degrees. The landslide crown was on the west side of the road and did not show a clear horseshoe morphology, but there was a 1.5-meter drop in the ground with a sliding direction of N120°E. The exposed surface of the landslide consisted of light brown to yellowish soil with a relatively porous sandy texture. Considering the sand fraction in this soil exposure, the landslide is likely to be a liquefaction event. However, other supporting evidence has yet to be more detailed and investigated.

**Fig. 5.** Sarampad landslide shows the main scarp, crown, and road rebuilt in the depletion zone.

The sliding plane of the landslide is estimated to be an impermeable layer composed of tuff. The landslide location is within a residential and rice field area, with a road cutting through the housing area, and about 60 meters to the north is a small river. The landslide affected part of the houses and rice fields in the eastern housing area. The distance of this landslide location from the earthquake's epicenter is 4.03 km, while the estimated distance from the Cugenang Fault is 0.43 km. The landslide area covers 6.331 m<sup>2</sup>, with a length of 65.75 – 96.25 meters and a width of 60.70 to 63.09

meters. The landslide occurred when water-saturated sandy lithology was above an impermeable layer, possibly composed of tuff, on a gentle slope.

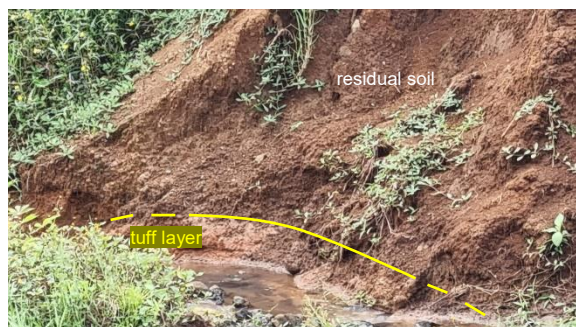
**Fig. 8.** Light brown tuff layer exposed at the toe side of Rawacina Landslide underneath the completely weathered breccia's light to dark residual soil.
