# Study on Environmental Control Methods of the Anterior Room During the Limited Opening to the Public of Burnt Wall Paintings in the Main Hall of the Treasure House at Horyu-ji Temple

Shuichi Kurose<sup>1\*</sup>, Daisuke Ogura<sup>2</sup>, and Hiroyuki Kitahara<sup>3</sup>

**Abstract.** The Main Hall of Horyuji Temple was damaged by fire in 1949, not only in the building but also in the preserved wall paintings. The wall paintings that survived the fire damage are national important cultural properties and, because of concerns about deterioration, are stored together with the burnt parts in a non-air-conditioned treasure house in the precincts of the temple, which is not open to the public at present as a general rule. In the previous report, a research study was initiated to open the treasure house to the public, and the effects of heat and humidity on the stored items have been studied through annual temperature and humidity measurements and numerical simulations. Based on these findings, an anterior room was constructed in the treasure house and a heat pump desiccant dehumidifier was installed as a dehumidifier to reduce the effects of the outside air and prevent the introdu

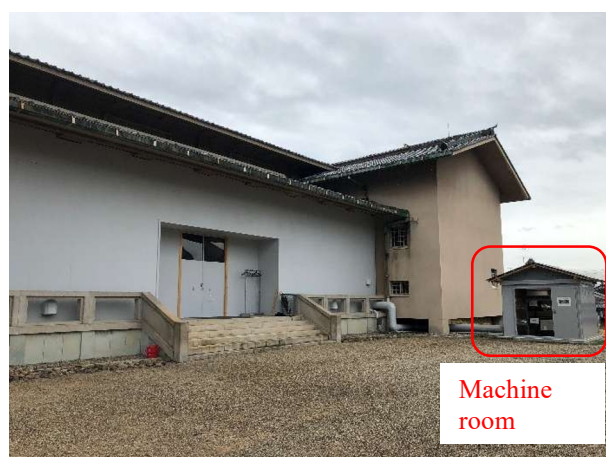
Figure 2. Exterior view of the Treasure House in the Main Hall at Horyu-ji Temple, where burnt wall paintings are stored.

A plan of the treasure house is shown in Figure 1 and a general view of the treasure house is shown in Figure 2. The treasure house for the main mural paintings and the machine room equipped with a desiccant dehumidifier supply dehumidified air to the anterior room through ducts. The anterior room is located at the anterior of the

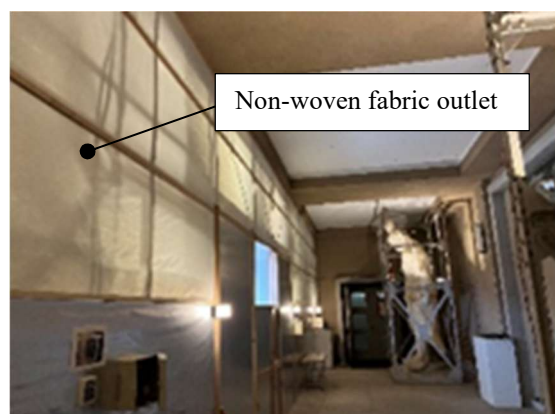
Figure 5. Interior view of the anterior room, including the non-woven fabric outlet for distributing dehumidified air.

Figures 4 and 5 show the floor plan of the anterior room and a photograph of the interior of the anterior room, respectively. The anterior room serves as a controlled humidity adjustment space and consists of a waiting space where visitors' moisture is removed, and the space where air from the desiccant dehumidifier is blown (hereafter referred to as the buffer). The air supplied from the desiccant dehumidifier is first received in the buffer and then gently supplied to the visitors' waiting space through non-woven fabric. Regarding the humidity adjustment method of the anterior room, outside air is introduced into the machine room, and the target relative humidity for the anterior room is set by the desiccant dehumidifier, using the temperature and humidity measurement data from the control sensors installed in the anterior room and the central room where the Wall Paintings are stored, to ensure there is no difference in absolute humidity between the rooms. The desiccant dehumidifier controls the absolute humidity and supplies dehumidified air through ducts to the anterior room. However, to avoid sudden fluctuations in temperature and humidity, dehumidified air is not directly supplied to the anterior room but is first supplied to the buffer shown in Figure 4. The air, with fluctuations mitigated in this buffer section, is then gently supplied to the anterior room through non-woven

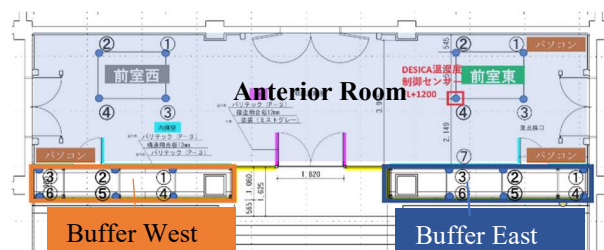
Figure 7. Locations of temperature and humidity sensors installed in the anterior room and buffer zones at multiple heights (FL+100 to FL+4,100)

Temperature and humidity measurements were carried out as follows to verify changes in the environment around the desiccant dehumidifier equipment in the machine room and in the anterior room. Temperature and humidity were measured using Sensirion SHT35 and SHT75 temperature and humidity sensors. Measurements were taken at one-minute intervals in the anterior room and at ten-second intervals in the buffer zone and around equipment. The measured temperature and humidity information is recorded on a PC. The temperature and humidity sensors were installed in the anterior room as shown in Figure 7, at locations where they could be installed in the anterior room east and west of the anterior room (1-4) buffer east (1-7) and buffer west (1-6). Each measuring point FL+100, FL+900, FL+1700, FL+2500, FL+3,300, FL+4,100.

A total of 126 points were measured, including the anterior room and buffer. A cross-sectional view of the buffer is shown in Figure 8. Desiccant dehumidifiers supply dehumidified air directly down through a Ø150 duct in a buffer from a height of FL+2,500 (two locations, east and west). The lower end of the non-woven fabric is at FL+1,850.
