Refurbishment and Installation of a Monitoring and Early Warning System on the Sierroz Embankments in Aix-les-Bains, France

Abstract. Sierroz embankments are located in an urban area, in the city of Aix-les-Bains (Savoie, France). Their linear is 400m on both rims. These embankments protect about 900 people against Sierroz river floods. Hydraulic studies performed in the frame of the Aix-les-Bains Inundation Risk Prevention Plan (PPRI in French) have shown that these embankments have a high risk of failure by overtopping during a 100 year return period flood of the Sierroz River. These studies have defined inundation maps with High Danger areas. From these results, the city of Aix-les-Bains asked EDF to perform a safety assessment study, in order to assess the safety margins of these embankments for each of their potential failure modes: overtopping erosion, internal erosion, slope sliding and liquefaction. This study confirmed that the main risk is breaching by overtopping erosion during flood. This diagnosis led the city of Aix-les-Bains to launch two parades: (i) the embankment refurbishment in order to provide them satisfactory safety margins during a 100 year return period fl

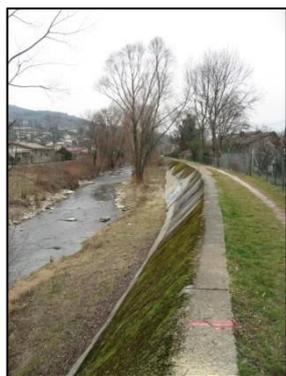
Figure 1. The Sierroz River and its embankments

The Sierroz River is a tributary of the Bourget Lake, which crosses the city of Aix-les-Bains before its mouth in lake. Sierroz embankments are located between the Red bridge, upstream, and the railway bridge, downstream. Their linear is 400 m on both rims. These embankments protect about 900 inhabitants against Sierroz River floods. A view of the Sierroz River and its embankments is shown on the Figure 1.

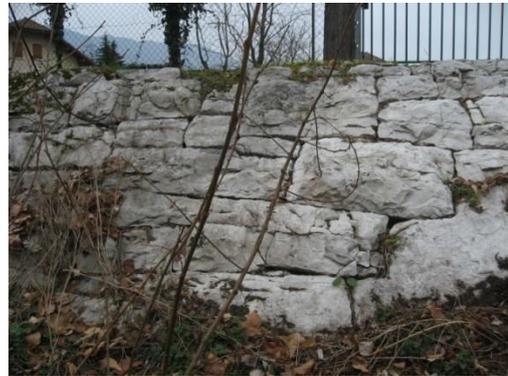
Figure 2. Masonry wall protecting the upstream face of the embankments

France. No document related to the construction of these embankments could be found in the regional archives. However, it was found that embankments located downstream on the Sierroz River were built by the French administration in the years 1879-1881 with a similar design. It is reported that these embankments were constituted on gravels. Their upstream face was protected by a masonry wall inclined at 45° with a rockfill toe. Their downstream slope was 3H/2V. The masonry wall of the upstream face is still visible on the Sierroz embankments (Figure 2).

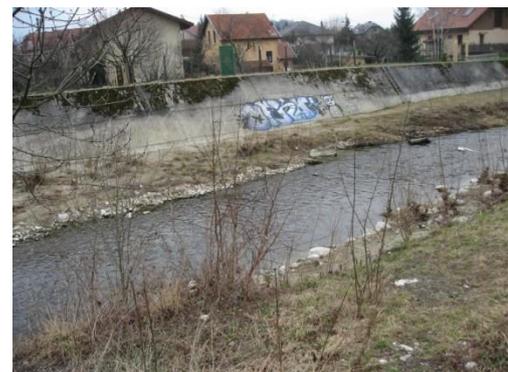
Figure 3. Concrete wall constructed in the years 1960 to reinforce the upstream face of the left rim embankment

The left rim embankment was reinforced along 157m after the important damages due to the flood that occurred on 30 September 1960, which peak flow remains unknown. The upstream face of this embankment was reinforced by a 25cm thick concrete wall with a 1H/1V slope (Figure 3).

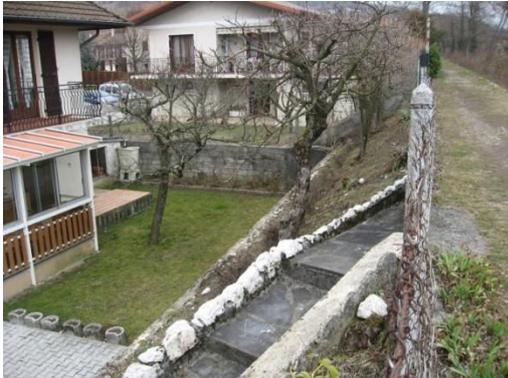
Figure 4. Retaining wall constructed without respecting the state of the art rules for that kind of structures

been transformed as slopes of private gardens. Some owners transformed the downstream fill of the embankment by constructing a retaining wall without respecting the state of the art rules for that kind of structure (Figure 4). In some cases, the house itself was partly built inside the downstream fill of the embankment.

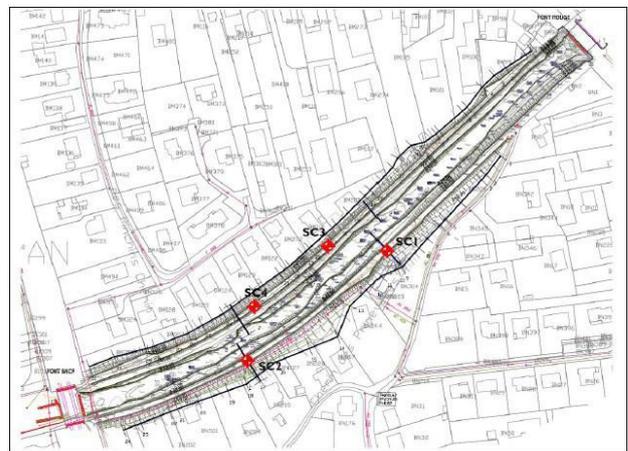
Figure 5. Location of the four core drillings. Red bridge located at the right end and railway bridge located at the left end.

In order to meet the different constraints of these embankments (difficult access to the crests, narrow crests), geotechnical surveys consisted in four 12m deep core drillings (Figure 5) performed from the crest (named left rim upstream, left rim downstream, right rim upstream and right rim downstream). Laboratory tests were then performed on the core samples (identifications tests, sieve curves, CD triaxial tests on undisturbed fines samples and Jet Erosion Tests on clayey silts and sandy silts).

These surveys highlighted homogeneous sandy gravels materials on the left rim upstream core samples. For both right rim upstream and downstream core samples, these surveys showed an embankment body made of sandy gravels, an upper layer in the foundation made of clayey silts and a lower layer in the foundation made of sandy gravels. In the right rim downstream core samples, these surveys showed a fine sands layer between the embankment body and the clayey-silty upper layer of the foundation.

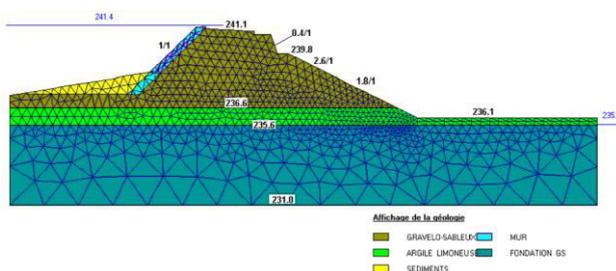
Figure 6. Geometric, geological and hydraulic models at the cross-section located downstream on the left rim.

The hydraulic boundary conditions are stationary. The hydraulic loading on the upstream face of the embankments is the maximum water level of the 100 year return period flood in the Sierroz River. The hydraulic loading on the downstream boundary of the hydraulic model is the estimated maximum level of the water table. Permeability of materials constituting the embankments and their foundation was carefully estimated from sieve curves and the EDF experience in that kind of modelling.

The geometric, geological and hydraulic models at the cross-section located downstream on the left rim are presented on the Figure 6.

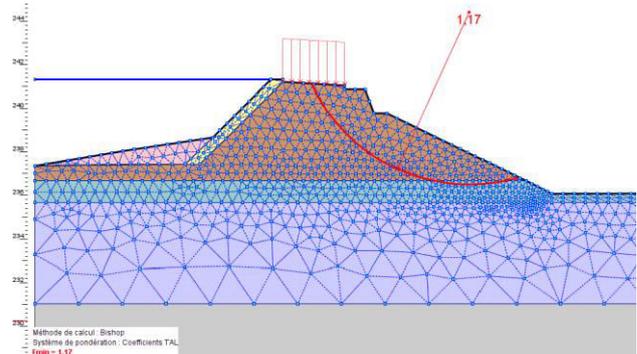
Figure 7. Slope stability analysis at the cross-section located downstream on the left rim.

Minimum safety factors range for the four cross-sections, from 1.11 to 1.18 for a required safety factor of 1.4 (Figure 7). Safety margins of these embankments for the risk of slope sliding under static loading are thus not satisfactory.

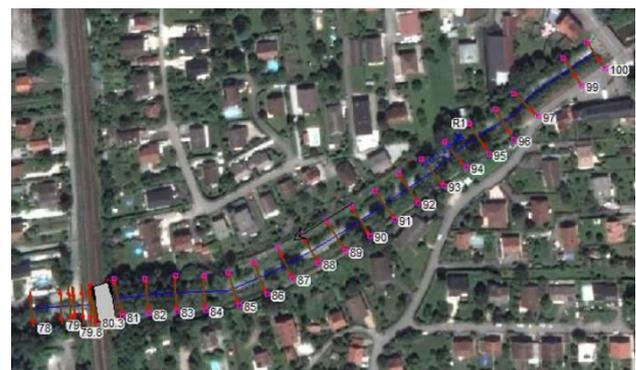
Figure 8. HEC Ras model of the Sierroz River between the Red bridge (right end) and the railway bridge (left end).

Several hydraulic modelling of a 100 year return period flood of the Sierroz River between the Red and railway bridges were performed with HEC Ras model (Figure 8) considering several hypothesis of partial obstruction of the flow path below the railway bridge (downstream boundary condition). This modelling allowed to define precisely linear of left rim and right rim embankment which would be overtopped and linear which need to be reinforced.

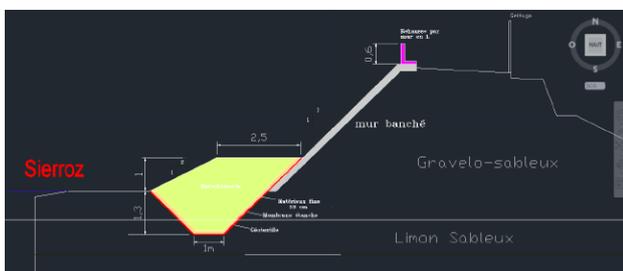
Figure 9. Reinforcement design of the embankments by rock-fills on the upstream toe

- Reinforcement type 1: embankment section with a masonry wall on the upstream face, enhance of the embankment crest elevation, no sealing of the masonry wall, no upstream toe berm.

- Reinforcement type 2: embankment section with a masonry wall on the upstream face, no enhance of the embankment crest elevation, sealing of the masonry wall, construction of an upstream toe berm with rock fills.
- Reinforcement type 3: embankment section with a masonry wall on the upstream face, enhance of the embankment crest elevation, sealing of the masonry wall, construction of an upstream toe berm with rock fills.
- Reinforcement type 4: embankment section with a concrete wall on the upstream face, enhance of the embankment crest elevation and refurbishment of the concrete wall where necessary.

Figure 9 below shows the design principles of a reinforcement type 3.

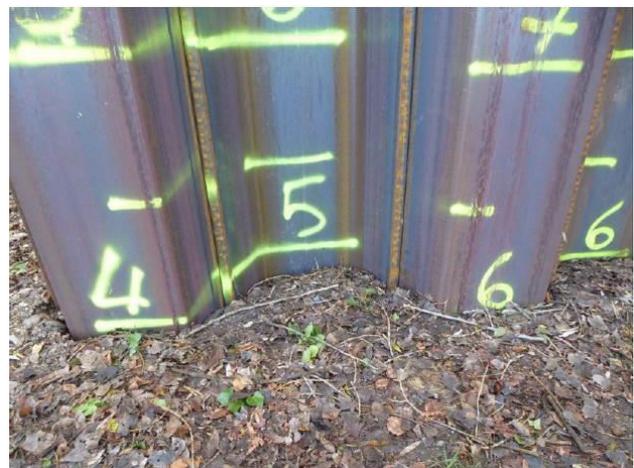
Figure 10. Test of sheet piles driven

The potential risks of this solution are due to vibrations during driving the sheet piles. Potential impacted structures are the railways on the railway bridge and houses located near the embankments. In order to assess this impact, tests of driving sheet piles on a small linear of the right rim embankment crest near the railway have been performed (Figure 10).

These tests have shown acceptable vibrations for the neighbouring houses as well as for the railway bridge, excepted in the first 15m from the bridge. In this section, a solution of reinforcement of the upstream face of the embankment should be chosen.

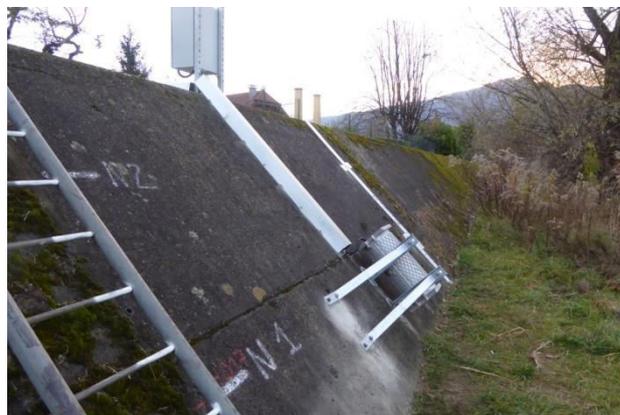
Figure 11. Automatic system of river level N1 detection

The criterion used to launch surveillance during flood is a water level (called "N1") on the upstream face of the embankments. Once the Sierroz River's level reaches the level "N1", a gauge located on the upstream concrete wall of the left rim embankment (Figures 11 and 12) sends automatically a SMS to the *gephyConsult* and EDF engineers in charge of this surveillance.

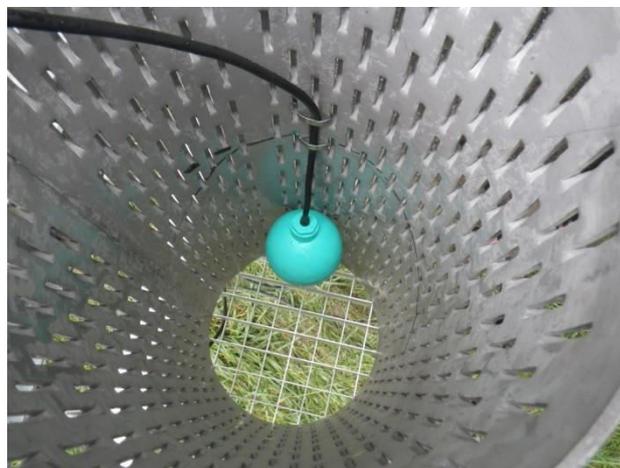
Figure 12. Zoom on the gauge for river level N1 detection

The "N1" level corresponds approximately to the maximum level reached during a 2 year return period flood.

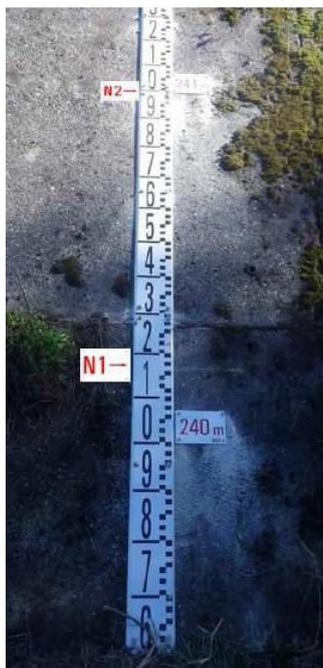
Figure 13. Scale for water level measurements located on the upstream concrete wall

Real time surveillance of the Sierroz embankments consists in visual inspections, water level measurements on a scale installed near the automatic device (Figure 13) and piezometric measurements in the four piezometers installed were core drillings had been performed.

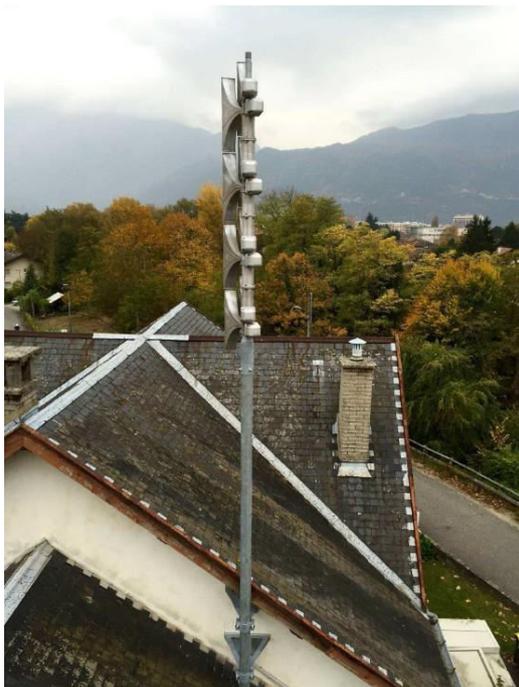
Figure 14. Sound alarm installed above the church's roof

The sound alarm was designed to be audible in the High Risk Area. Height broadcasters are fixed at the top of a mast above the church's roof (Figure 14).
