# Unconfined strength of an unsaturated residual soil struck by replicated lightning

**Abstract** It is well known that different triggering factors are related to landslides occurrence. However, in many cases, it is not possible to identify main factors that may contribute to start a landslide. Following that, lightning phenomena is herein considered as a possible factor that may promote changes in the structure, and eventually, in the strength of soils. The current study aims to analyse the influence of laboratory simulated lightning in the structure of undisturbed granite-gneiss residual soil samples. The main focus is to compare the peak strength of unsaturated samples that were not struck by replicated lightning with the peak strength of soil samples struck by replicated lightning. The methods used are: Soil sampling and physical characterization; unconfined compression strength tests on unsaturated undisturbed samples; submission of soil samples to replicated lightning; unconfined compression strength tests on samples struck by replicated lightning and micro tomography of samples submitted to lightning. As results, it is seen that lightning may cause a hole with irregular ge

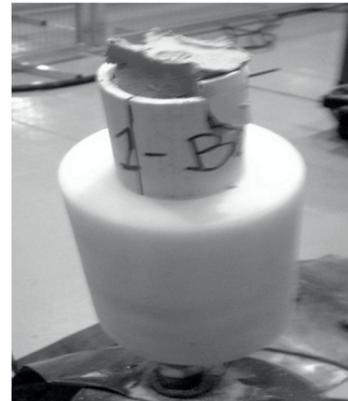
It is interesting to notice here that saturated samples were initially tested. However, they presented

catastrophic failure under the incidence of replicated lightning (Figure 6). So it was chosen to work just with unsaturated samples, under their natural water contents.

**Figure 6.** Catastrophic failure of saturated samples
