As- built inventory of the office building with the use of terrestrial laser scanning

Marek Przyborski¹, Paweł Tysiąc^{1,*}

¹Gdansk University of Technology, Faculty of Civil and Environmental Engineering, Department of Geodesy, Narutowicza St. 11/12, 80-233 Gdansk, Poland

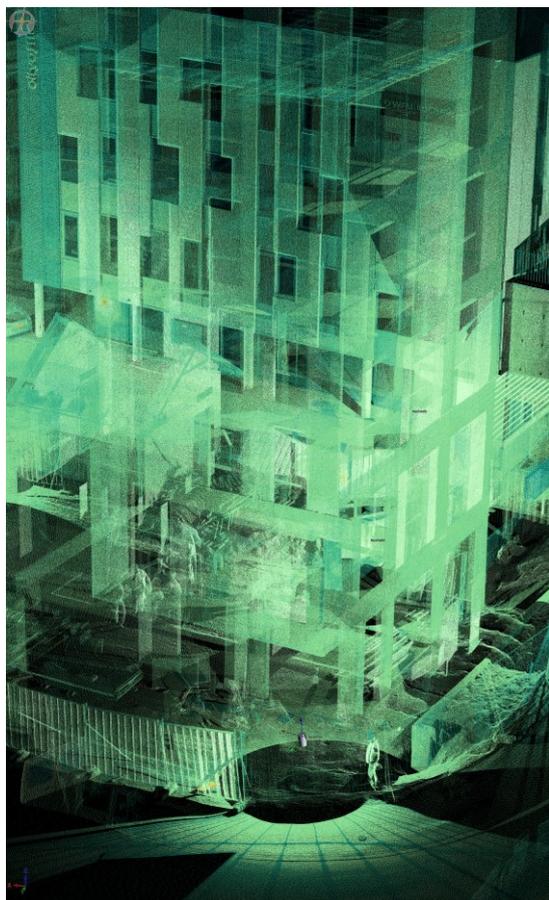
Fig. 2. The view of a scanned object.

Unfortunately, the situation was different from presumed. The whole object was enclosed by metal plates, preventing from enter into the construction site. Also, a close neighbourhood of road and other buildings was a problem for data acquisition. It was not possible to cover assumptions. It was a need to create a lot more scan stations. Authors placed 15 scan positions. The alignment of that positions and estimate the perfect, according to the project place of walls for deviations calculations was crucial. The Fig. 2 is presenting the scanned object.
