Industrial chimney monitoring - contemporary methods

Olga Kaszowska¹, Piotr Gruchlik¹ and Wiesław Mika¹

¹Główny Instytut Górnictwa (Central Mining Institute), Katowice, Poland

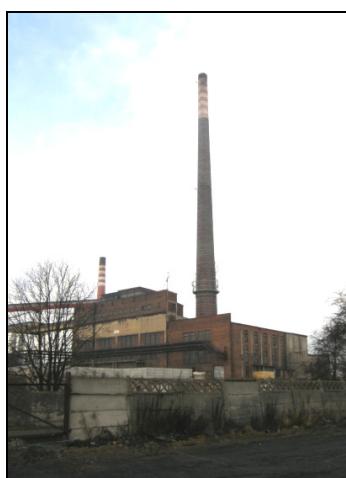
Fig. 1. View of the chimney

The chimney was erected in the first half of the 1940s and it serves to discharge hot (122 - 170°C) flue gas from coke-fired and hard-coal-fired boilers. Its current height is 113 meters. Originally it was 115 meters high but in 1997 it was shortened by 2.05 meters. It is a ceramic chimney with a circular cross-section (Fig. 1, 2). The chimney diameter is 7.64 m at ground level, and 3.5 m at flue-gas outlet level. The shaft is made of stack brick, and the inner lining, of up to 40 meters, of clay bricks. The chimney’s foundation is a reinforced-concrete circular plate with a diameter of 17.0 m, positioned 5 m below ground level. It is adjacent to a boiler house (Fig. 10) but they are separated by an expansion joint.

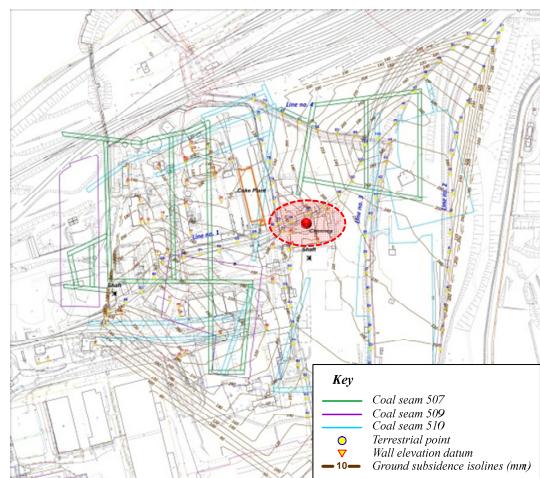
Fig. 2. The chimney location in respect of the mining plots and iso-lines of surface subsidence measured in the period of 2012 – 2016

The boiler house chimney was subjected to the impacts of hard coal mining activity conducted during the period of 2013-2016 in three coal seams. Due to the specific conditions of building and structure protection, an experimental system of drift mining was used. Fig. 2 shows the location of the chimney and the mining operations.

Geodetic measurements of surface deformation started in September 2012. They included the levelling of dispersed points and levelling and length measurements along the lines shown in Fig. 2. The last levelling was made at the end of 2016.

The stabilised points of line 1 and line 4 are closest to the stack. Subsidence of approximately 0.16 m occurred within the chimney area. Interpolation of the measurement results led to the delineation of surface deflection iso-lines (Fig. 2) and calculation of land inclination increase. At the chimney site, the increase is 0.5 mm/m SE. At the height of 113 m, i.e. the flue-gas outlet, the deflection changes by 5.6 cm. However, one must remember that the deflection of buildings and structures does not always correspond to land inclination changes.

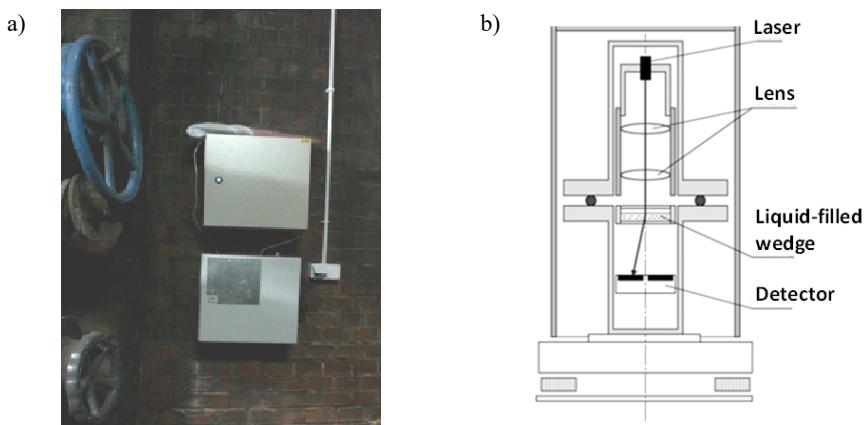
Fig. 3. Laser sensor for continuous measurement of deflections a) a view of the sensor and the recorder, b) the sensor diagram

In the period from March to December 2016, the chimney underwent continuous measurements of deflections, using a laser sensor constructed at GIG [1]. The sensor and the recording device were installed on the chimney base wall approximately 2m above the ground level (Fig. 3a).

The sensor is based on a module of a vibration and deflection sensor with the following measuring parameters:

- range of measurement: 5 mm/m (possible adjustment to 2 to 50 mm/m),
- resolution: 0.02 mm/m,
- vibration frequency < 10 Hz.

With the sensor, the building deflection can be measured accurately, continuously and automatically. The measurement is made by registering the vertical deflection of the laser beam after it passes a liquid-filled wedge (Fig. 3b). The outcome of the measurement, in the form of a graphic printout on a recorder tape, offers a full picture of deflections, both in terms of their value, direction, and duration.

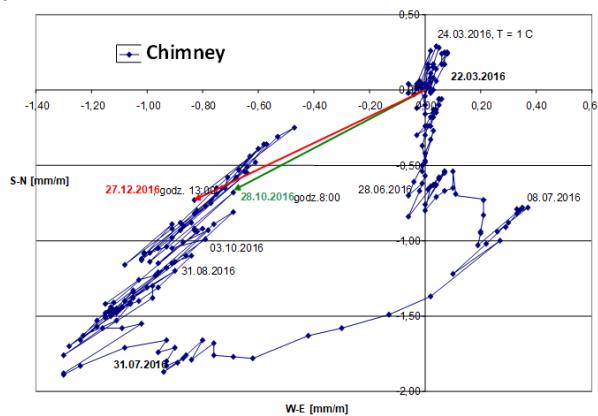
Fig. 4. Chimney base deflection vectors from the date of laser sensor installation

The results of the continuous monitoring of the chimney base deflection are presented in a diagram of changes in the values and direction of the resultant deflection vector (Fig. 4). The monitoring demonstrated that noticeable deflection of the chimney base started on 28 June and lasted until August 2016, i.e. over the period of the strongest impact of the mining activity on the surface of the chimney site. On 8 July, a change was observed in the deflection in the south-eastern direction, and from 14 July - a significant increase in the south-western direction. On 4 and 5 August, the resultant deflection in this direction was 2.3 mm/m and subsequently it gradually diminished and the resultant deflection changed its direction to north-eastern. This tendency was observed until mid-November, when the deflection decreased to 0.72 mm/m. In December 2016, the deflection became stable.

Compared to the initial position on the date of the commencement of the measurement, the chimney base showed a displacement in the south-western direction, oscillating around a mean value of 1.0 mm/m.

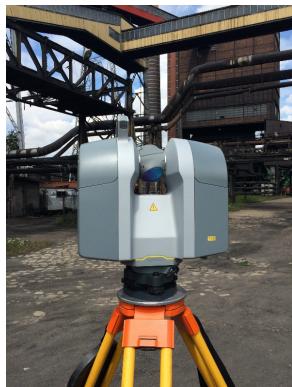
Fig. 5. 3D Trimble TX8

The 3D Trimble TX8 is an ultra-high speed, phase-shift, long-distance scanner (Fig. 5). It can capture up to one million points per second while maintaining high accuracy over the entire scan range, within the scan range of up to 340 m and broad field of view ($317^\circ \times 360^\circ$).

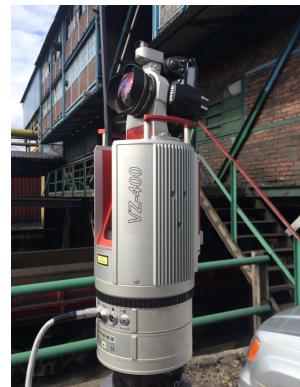
Fig. 6. 3D Riegl VZ-4000

Riegl VZ-4000 is an impulse terrestrial long-range scanner (Fig. 6). Its operating range is 5 – 4000 m in favourable air conditions (medium air transparency) and low reflectiveness. It works with maximum efficiency within the range of 1 km. Riegl VZ-4000 is among the fastest of its type: it works with a frequency of 50 – 300 kHz (37 – 222 thousand points/s).

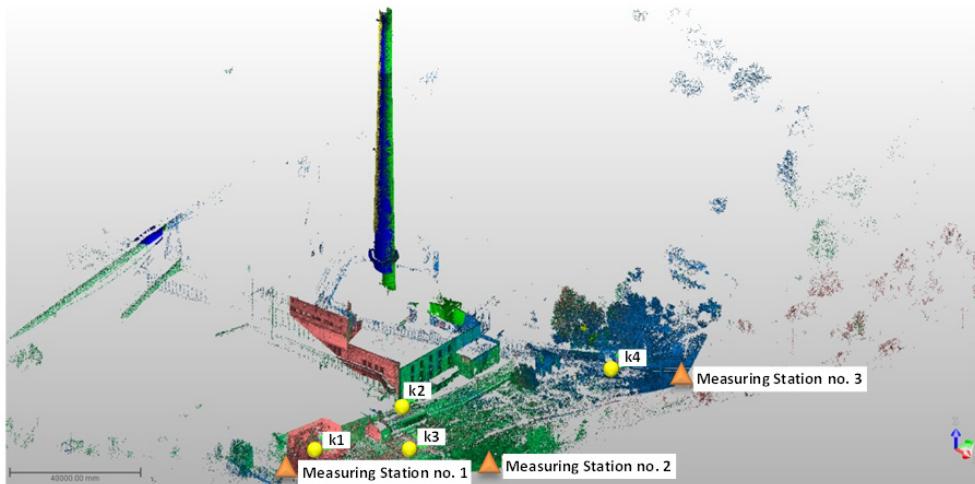
Fig. 7. Layout of measuring stations and spheres (k1-k4) for chimney measurement

The chimney measurements were made from four scanner workstations. Their positioning is shown in Fig. 7 [2]. The data obtained from measurements, in the form of point clouds, was registered. The absolute orientation of the points was determined. The transformation is based on clearly identifiable overlapping points in point clouds. The points can be natural or artificial. Natural targets are the selected chimney points. Artificial targets are spheres inserted in the measured space.

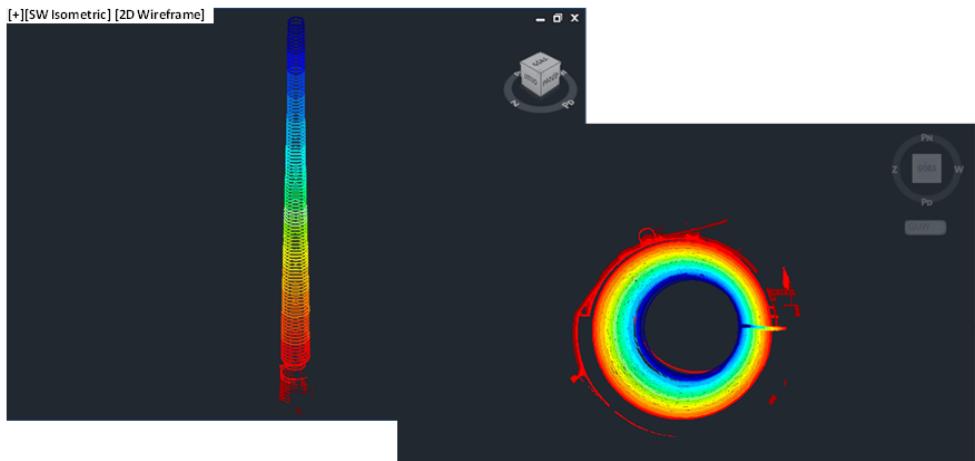
Fig. 8. Chimney model and its cross sections on successive horizontal lines

The 3D chimney model made from point clouds (Fig. 8) was scrutinised. The chimney cross-sections were prepared, spaced at a distance of 1 m. The location of the circular section centre on successive horizontal lines was analysed, and the direction and value of chimney deflection was determined at each level (Fig. 9).

In December 2017, the chimney deflection was 546 mm in the north-eastern direction (azimuth 62°). With respect to the measurement of June 2017, the deflection decreased by 29 mm, and the azimuth changed by 5° to the southern direction.

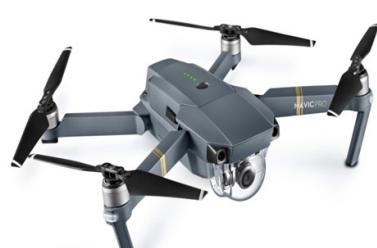
Fig. 9. The drone

In June 2017, a chimney technical check was made using an unmanned aerial vehicle commonly called a drone [3]. The checks were made using a DJI MAVIC Pro drone (Fig. 9).

With the drone, the technical conditions of the external brick wall of the chimney could be assessed,

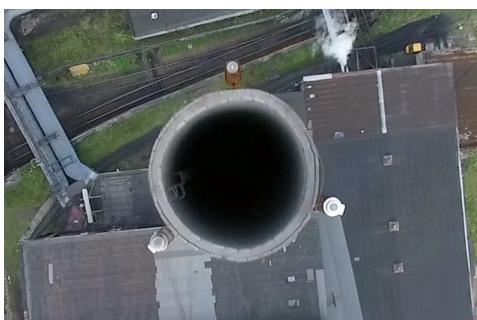
Fig. 10. Ovalisation of the chimney shaft cross-section at the flue gas outlet level

along its entire height, with accuracy comparable to direct visual inspection. The check showed ovalisation of the chimney shaft cross-section at the outlet (Fig. 10) which could not be detected using traditional inspection methods.

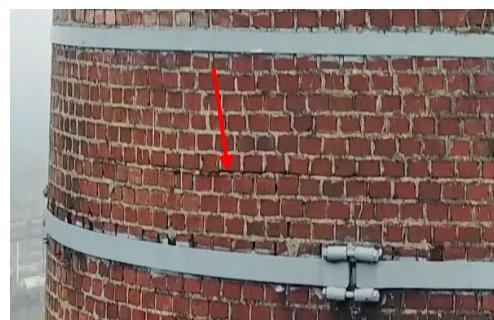
Fig. 11. Crack at the chimney wall - a photo taken by a drone in November 2017

In October 2017, during a ground-based inspection of the chimney condition, a crack along a joint was observed at the height of approximately 35 m, from the south-western side. The inspecting personnel indicated that the crack was not clearly visible on previous checks. The analysis of photographs taken earlier indicates that the damage was already there in May 2015. Another inspection of the chimney's technical conditions, made with the drone in November 2017, demonstrated that the technical condition of the chimney shaft wall did not significantly change at this point (Fig. 11).
