Experiments with sediment replenishment in a residual flow reach: Comparison of field data with laboratory experiments

Severin Stähly^{1,*}, Anthony Maître¹, Mário J. Franca^{1,2}, Christopher T. Robinson³,
and Anton J. Schleiss¹

¹Laboratory of Hydraulic Constructions (LCH), Swiss Federal Institute of Technology Lausanne (EPFL), Switzerland

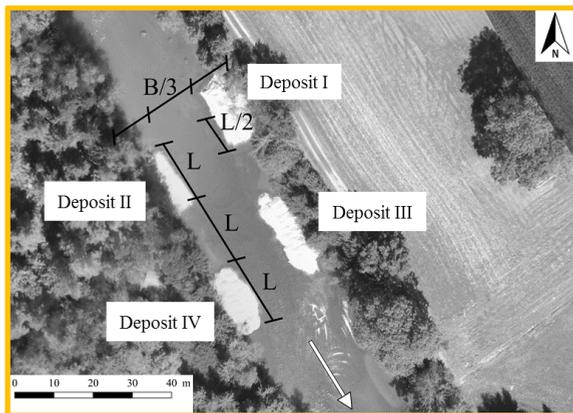
Fig. 2. The four deposits of sediment replenishment in the Sarine river. The distance between deposit I and deposit III as well as between deposit II and deposit IV was one deposit length L . Deposit I and deposit II are shifted by half a deposit length $L/2$. The deposits should occupy two thirds of the river width B . A larger overview of this reach can be seen in Figure 1.

Laboratory experiments pointed out that for steep rivers with a longitudinal slope of 1.5%, a combination of four deposits assembled as alternate bars result in a favorable deposition process [6, 7]. Such a cluster formation in the river creates habitats that are valuable for fishes. Especially in bedrock-alluvial rivers such as the Sarine with exposed molasse rock, a deposition in clusters is more valuable for in-stream organisms than a homogenous uniform distribution in the river. As can be seen in Figure 2, deposit I and III are located touching the left bank, at a distance corresponding to one deposit length L . Attached to the right bank, deposit II and IV have been arranged longitudinally shifted by half a deposit length (Fig. 2). The extent of Figure 2 corresponds to the yellow square in Figure 1. Unlike in the laboratory

experiments, which were performed in a straight trapezoidal channel with a fixed bed, the deposits were installed downstream of a bend in the river. This location was the only relatively straight reach in the strongly meandering Sarine with possible access for the digging machines.
