# Quality of outdoor and indoor environment during the cruise of the tall ship STS Fryderyk Chopin

**Abstract.** The aim of this paper is to present the results of measurements, on the quality of internal and external environment, carried out during the cruise of the tall ship STS Fryderyk Chopin. The cruise took place between 16th and 30th September 2017 as part of the scientific seminar of the Warsaw University of Technology (WUT) on the Wave, addressed to students of the WTU. After leaving the port of Edinburgh, crossing the North Sea, the Danish straits, stops in Copenhagen and Kołobrzeg, the tall ship reached Szczecin after two weeks. The measurements carried out on the deck included the temperature and relative humidity of the indoor air in three cabins and the men's bathroom. In two cabins, the CO<sub>2</sub> concentration was measured additionally. The outdoor temperature, relative humidity and concentration of PM1.0, PM2.5 and PM10 were also measured. The obtained results allowed to assess the quality of the internal environment in accordance with the standards and to analyze the effectiveness of the mechanical ventilation system. Measurements of particulate matter have s

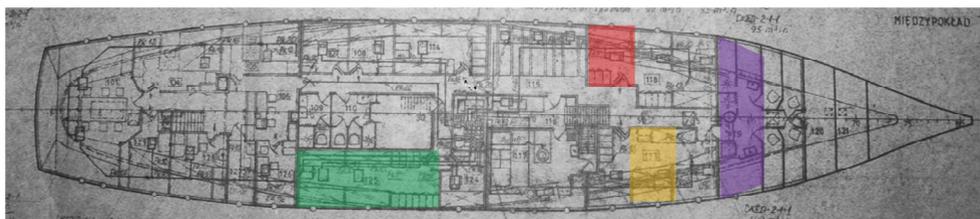
**Fig. 1.** Measuring device placement at the tweendecker: green – cabin 27, red – cabin 36, yellow – cabin 35 and purple - men’s bathroom.

The measurements carried out during a cruise on the tall ship concentrated on indoor and outdoor air quality. The used approach was similar as for buildings [2, 3]. The indoor air temperature and humidity measurements were performed using NTC sensors, range -20 ... + 70°C and 0 ... 100% RH, accuracy  $\pm 0.5^\circ\text{C}$ , and  $\pm 3\%$  RH integrated with data loggers 175-H2 produced by Testo company. The CO<sub>2</sub> concentration was measured using NDIR sensors model aSENSE-D produced by SenseAir, range 0–6,000 ppm, accuracy  $\pm 100$  ppm with data loggers 175-S2 produced by Testo. The quality of indoor air was monitored in three cabins and the men's bathroom – because of the small number of sensors the scope of measurements was different. The largest cabin nr 27 was design for nine people but during the cruise occupied only by six. Three students stayed in the cabin 36 and two in 35 (Fig. 1). The measurements included:

- cabin 27 – CO<sub>2</sub> concentration, air temperature and relative humidity,
- cabin 35 – air temperature and relative humidity,
- cabin 36 – CO<sub>2</sub> concentration,
- men's bathroom – air temperature and relative humidity.

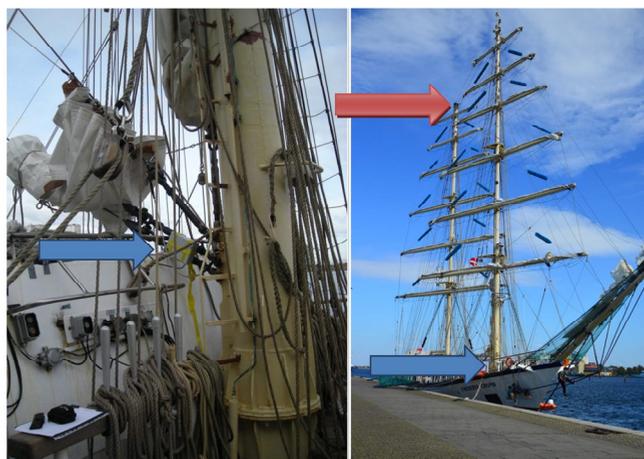
**Fig. 2.** Measuring device placement (blue arrow) at the base of the foremast at the beak of the tall ship, engine chimney (arrow red).

The measuring device was set up at the beak of the tall ship, and the base of the foremast (Fig. 2) at the height of around 1.7 m over the deck. The chosen placement minimized the influence of the ship’s own emissions on the measurement. All the exhausts, i.e. from the engine, and the kitchen were behind the device. The ship mostly sailed into the wind or with a side wind, thus leaving the device freely perfused by air coming straight from the sea. Most of the cruise was sailed, and the engine was used periodically. The engine and power generator exhaust were emitted through a chimney placed on the mainmast at the waist. The chimneys height is 32 m from the deck.

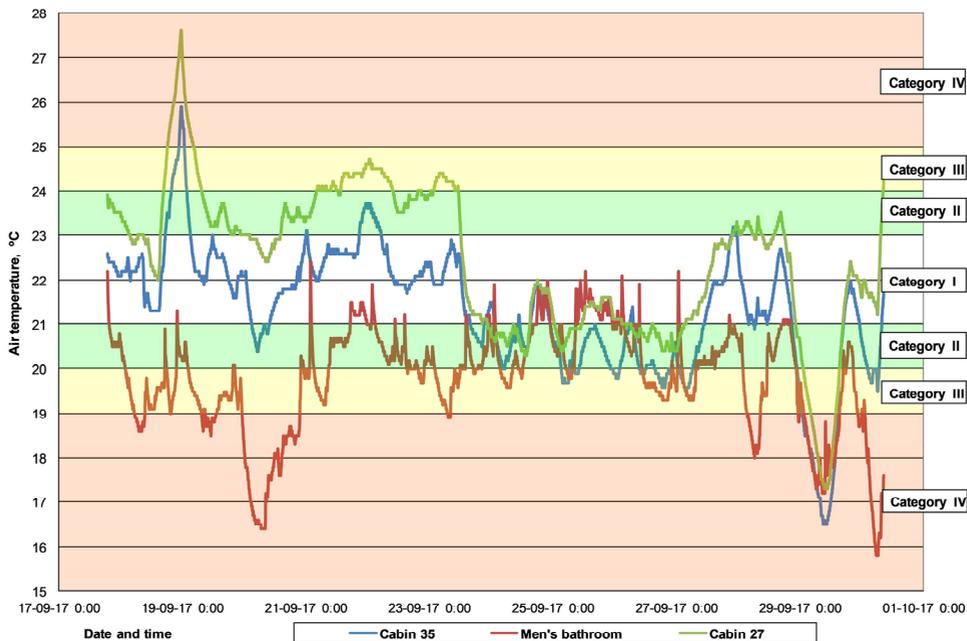
**Fig. 3.** Change of indoor air temperature in cabins and men’s bathroom of the tall ship.

The Fig. 3. shows the indoor air temperature changed a lot during the cruise. It was over 27°C in cabin 27 on the 18th of September and below 16°C in the men’s bathroom on the 30th. The wide range of changes shows that there is no temperature control. It depends on outdoor conditions, internal heat gains and the operation of the ventilation system. The ship has an air heating system that was off during the cruise.

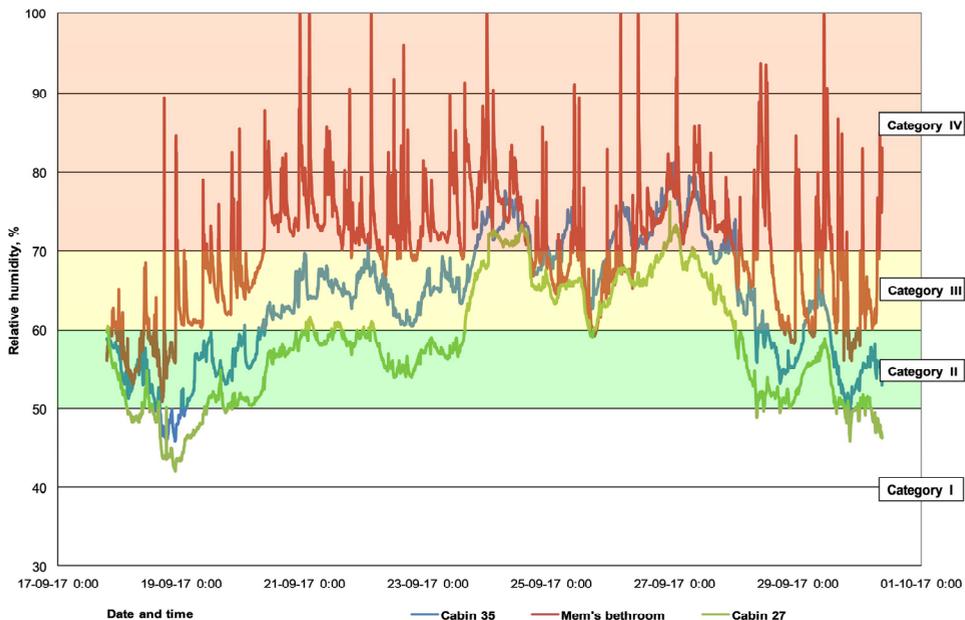
**Fig. 4.** Change of indoor relative humidity in cabins and men’s bathroom of the tall ship.

The Fig. 4. clearly shows that as a result of moisture gains (during the showers or cleaning), the level of RH increases quickly in the bathroom reaching sometimes 100%. The level of humidity drops quickly also, which shows that the ventilation is quite effective. The main reason of high RH is the low temperature in the bathroom. During the majority of the cruise it is below the temperature in the cabins. Only between the 24th and 27th of September the temperatures are similar, and as result the RH in the cabins increases

to the level as in the bathroom. A high level of humidity in the bathroom can cause mold growth [6] and corrosion of the ship's structure. The difference between cabin 27 and 35 is caused probably by a difference in occupation density– more people per m<sup>2</sup> were staying in cabin 35 and the air exchange rate was greater.

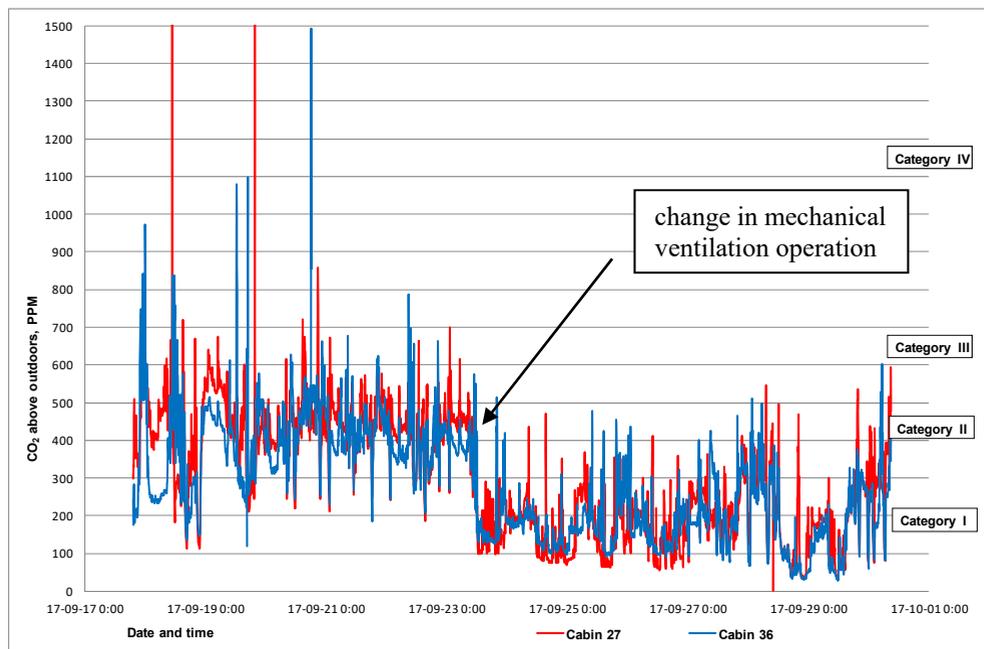
**Fig. 5.** Change of CO<sub>2</sub> concentration above outdoors in cabins of the tall ship.

The results in Table 5. and Fig. 5. show that the air quality was very good. In cabin 27 almost 85% and in cabin 36 almost 90% of time the concentration was in category I and II. The scale of value variation is rather small. Some higher concentrations can be seen for a short time but this is probably the results of the student’s tests (checking if the device is

working). It can be also observed that from the 23rd of September the concentrations are clearly smaller. This is a result of change in mechanical ventilation operation. The system was equipped in two air intakes – one outside and one inside. At the beginning of the cruise the inside air intake was open – the system was working in recalculation mode. From the 23rd it was closed. As a result the CO<sub>2</sub> concentration in the cabins decreases. The effect of change can be also seen on the Fig. 3. – temperatures in the cabins are dropping down as more outdoor, cold air is supplied. The extreme value-peaks (> 1,500 ppm) probably represent the sensor checking by the students – it was possible to see the result on the display.

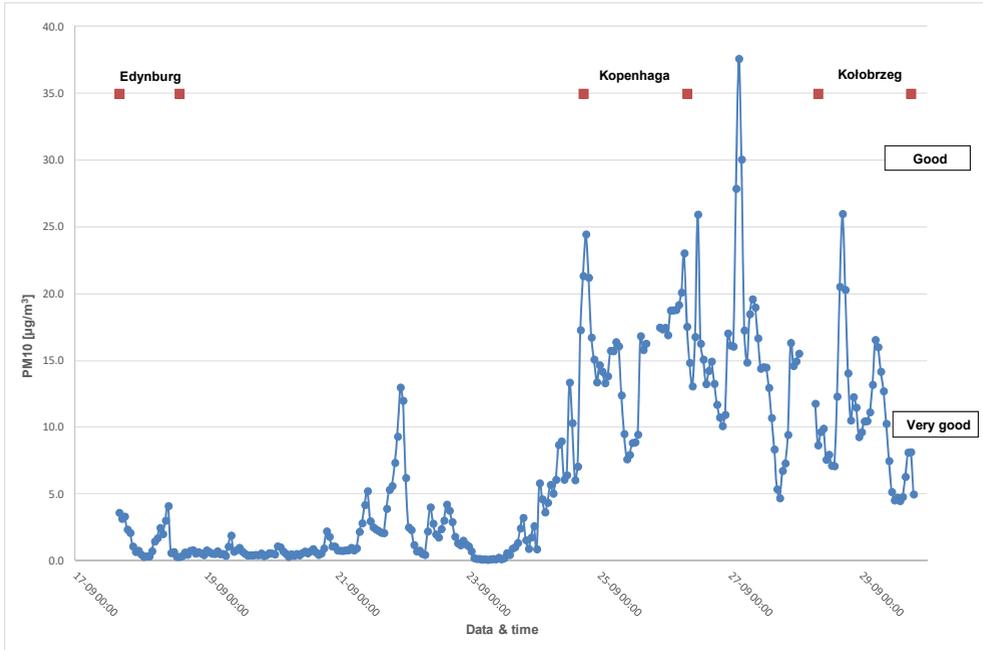
**Fig. 6.** Average hourly concentration of PM 10 particles [ $\mu\text{g}/\text{m}^3$ ] throughout the whole cruise with marked stops in ports.

Recommended PM 10 concentrations from Chief Inspectorate for Environmental Protection [7] were used to evaluate the outdoor air quality (Fig. 6). If the average hourly concentration of PM 10 particles is below  $20 \mu\text{g}/\text{m}^3$  the air quality is very good, and between  $20\text{--}60 \mu\text{g}/\text{m}^3$  is good. The maximum measured concentration was  $37.6 \mu\text{g}/\text{m}^3$  and the minimum  $0,1 \mu\text{g}/\text{m}^3$ . During 95% of the cruise the quality of the outdoor air was very good. The WHO limit for PM 10 concentrations is  $50 \mu\text{g}/\text{m}^3$ .

The results have shown better than expected quality of air in the region of Edinburgh, compared to many different cities and ports in Europe. There were many areas on the North Sea with good air quality – starting from the Scottish coast to Danish or Swedish coasts, sometimes the measuring device did not register any suspended dust presence. The outdoor air was very clean in an area around the entrance to the Skagerrak Strait. The major influence on the good air quality was caused by high wind speeds. The particle concentration was relatively low up until the Copenhagen port.

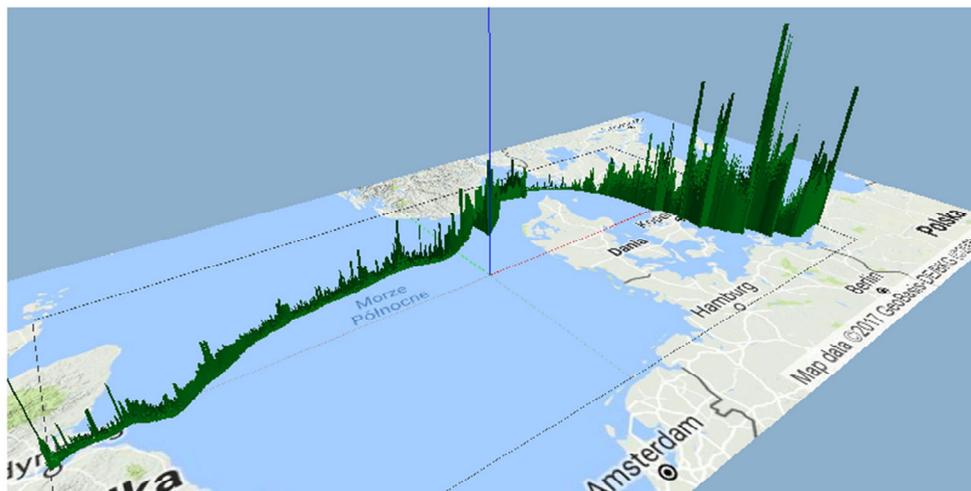
**Fig. 7.** Average hourly concentration of PM10 particles [ $\mu\text{g}/\text{m}^3$ ] throughout the whole cruise with marked stops in ports.

The values of changes in PM10 concentration in Copenhagen are characterized by typical, city fluctuations (this means min. around noon, max. afternoon). The Baltic Sea (Fig. 7) region was characterized by much a higher level of pollution than the North Sea, or even the Copenhagen port. It is hard to point at land sources of emission as the main element of air pollution on the sea - the highest temporary pollution was registered at a location further from the land, with values increasing as the ship approached.

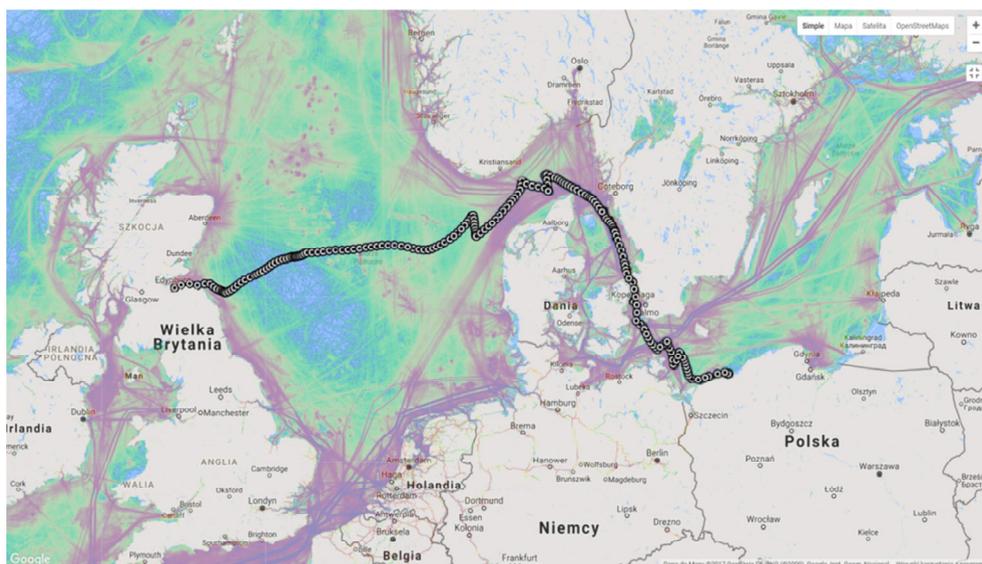
**Fig. 8.** Tall ship path on a background showing sail intensity of ships and main shipping lanes (source: marine traffic).

Shipping lane analysis, performed via the marine traffic service, shows that the tall ship was near the main lane attended by multiple ships (Fig. 8). Based on the comparison performed above we could risk the following hypothesis. The vast majority of the cruise

route, in the events when the ship was nearby land, happened in the Danish straits and the Baltic Sea, wherein principle it's much "narrower" than in the full North Sea. The high level of pollution could have been influenced by land sources, however, as it is shown in the above Figure and, in such places the route of the tall ship was close to, crossing or even following, the highly attended shipping routes. One gets the impression that the sources of pollution coming from ships "covered" emissions coming from land (except port entrances, which were present in bigger or smaller cities), and they were the main source of pollution on the sea. A confirmation of such a claim can come from the fact that places were recorded at a considerable distance from land - about 200 km and 400 km, where there were higher concentrations, and they could not have come from land-based emissions. The source of emission was in this case probably the ships using diesel or marine oil.
