Properties of meandrical geotextiles designed for the protection of soil against erosion

Joanna Grzybowska-Pietras^{1,*}, Giang Nguyen^{1,2}, Stanisława Przybyło¹, Monika Rom¹, and Jan Broda¹

¹University of Bielsko-Biala, Faculty of Materials, Civil and Environmental Engineering, Willowa 2, 43-394 Bielsko-Biala, Poland

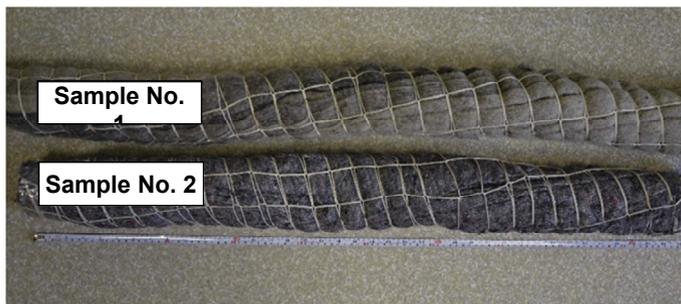
Fig. 1. The Kemafil ropes covered by knitted sheath [9].

In frame of implementation of the international project (CORNET), the University of Bielsko-Biala in cooperation with a German partner, undertook activities aimed at developing and creating meandrically arranged Kemafil ropes (Fig. 1), acting as protection of slope surface against erosion. Kemafil ropes were made of wool nonwoven fabric (sample No. 1) and non-woven fabric obtained from a mix of waste natural and synthetic fibers with grass seeds - RKL (sample No. 2). The ropes were meandrically arranged in segments of a width of 1.8 m. The subsequent turns of meandrically arranged ropes were connected with regularly spaced five chains formed from five subsequent loops produced with knitting technique. Spread Kemafil meander on the slope surface can be seen in Fig. 2.

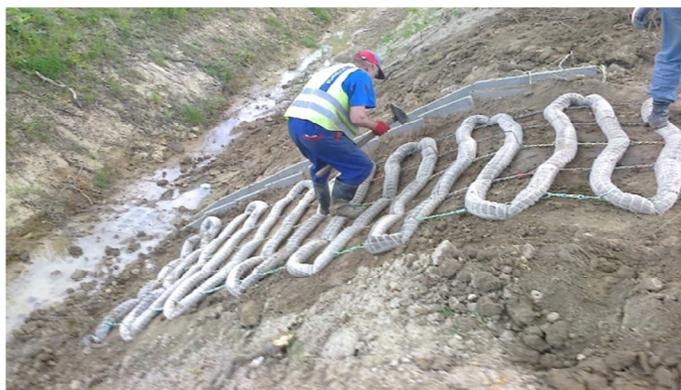
Fig. 2. Spread Kemafil meander on the slope surface.

Before geotextiles were installed, the ditch slope was profiled and the deep channels were filled and covered with soil. In addition, concrete open conduits were installed. Kemafil rope segments have been spread on the slope surface beside the conduit (Fig. 2). The segments were anchored to the upper edge and then attached to the slope surface using steel U-shaped pins. After installing ropes, the slope surface was covered with a soil layer (soil CL and CI; more information on soils will be introduced in the Chapters 3 and 4).

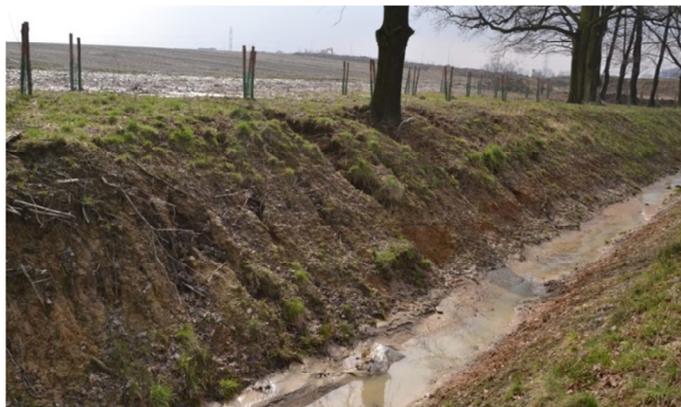
Fig. 3. The bank of the ditch with erosive channels before installation of the geotextiles [12].

Geotextiles have been used to protect the steep slope of the drainage ditch. The steep slope of the ditch with an inclination of 1 : 1.5 and length of 4–6 m were exposed to surface erosion caused by flowing down water during heavy rains, which grooved deep erosive channels with a depth of up to 0.5 m (Fig. 3).

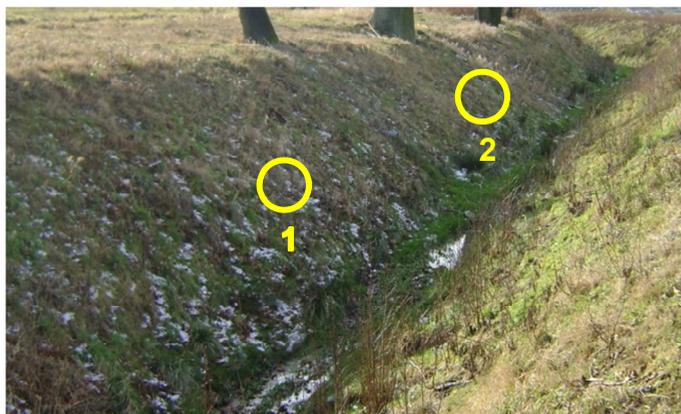
Fig. 4. Specimens locations.

During the research, soil samples were taken from the ditch slope (Fig. 4). Particle size distribution of the soils and their basic parameters were determined. Determination of soil particles size distribution was carried out in accordance with the BS 1377: 1990. Part 2 (wet sieving method and sedimentation by the hydrometer method) [13]. Soil parameters: water content (w), liquid limits (w_L) and plastic limits (w_P) were also determined in accordance with mentioned standard. For determination of the liquid limit the Casagrande apparatus method (four-point method) was applied. Based on obtained values, soils classifications were carried out in accordance with the British Standard BS 5930:2015 [14].

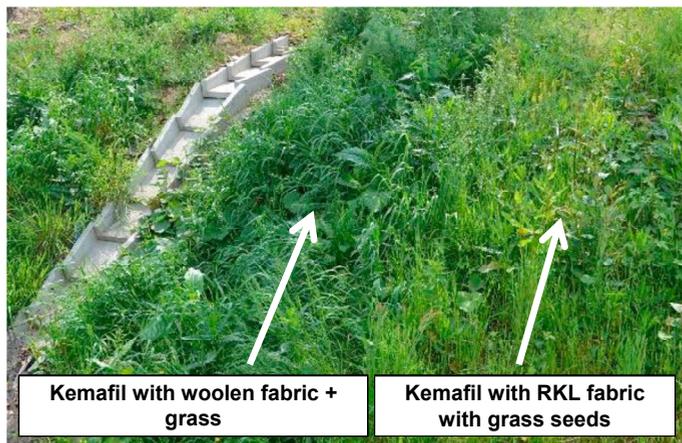
Fig. 5. The state of protected ditch bank one year after installation of the geotextiles [21].

After the installation of the ropes the condition of the ditch was regularly monitored. Immediately after installation on the banks of the ditch a network of micro-dams created from the meandricly arranged ropes was observed. The ropes slowed down the flow of water and reduced the transport of the soil along the slope. During six and twelve months of exploitation no erosive channels on the surface of the banks of the ditch were formed and no sliding of the slope was observed (Fig. 5) [21].

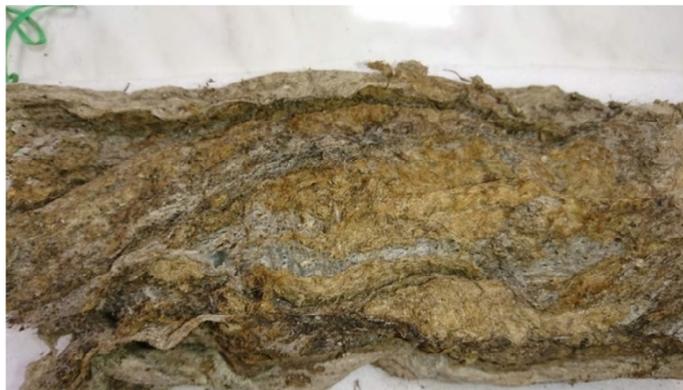
Fig. 6. View on woolen Kemafil rope after 12 months from installation.

Based on results of the tests, it was found that the materials used for the production of ropes undergo gradual biodegradation. In the case of wool nonwoven (Fig. 6) a very significant reduction in the value of all analyzed parameters was observed. In the case of nonwoven fabrics made of recycled fibers, it was found that the influence of operating time had a small effect on the change of its selected mechanical features (Fig. 7).

After the first 6 months after installation, the strength of Kemafil ropes made of wool fibers was reduced by 30% compared to the initial strength 0.67 kN/m. After one year, the strength of the wool nonwoven being the structural skeleton of the rope was small and barely reaches a value of 0.05 kN/m. Such a low tenacity compared to the initial sample is the result of intensive biodegradation of wool fibers in the nonwoven fabric. In the case of assessment of operating time impact on the static and dynamic puncture resistance of wool fabric, the largest decrease in the analyzed parameters occurs after the sixth month from the installation on the site (Tab. 2).

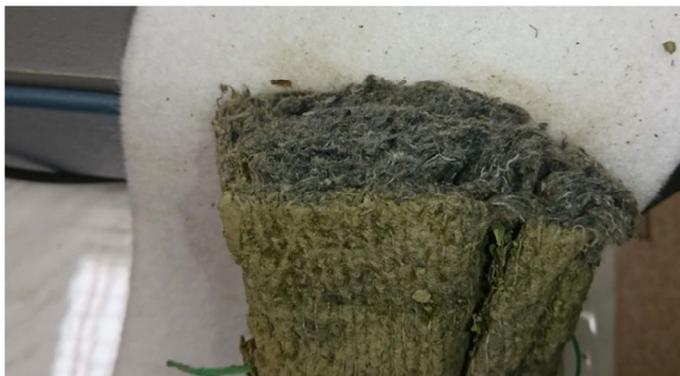
Fig. 7. View on RKL rope after 12 months from installation.

Geotextile used for the production of Kemafil ropes from recycled synthetic fibers with a small admixture of natural fibers (RKL) had a strength of 3.3 kN/m before being installed on the slope. After 6 months, the strength decreased by only 0.1 kN/m. After 1 year, the strength was reduced by only 7% compared to the initial strength. At the same time, no profound changes were observed in the structure of the Kemafil rope (Fig. 7). It is noted that the outer layer is very colmated, and the deeper geotextile layers are not affected.

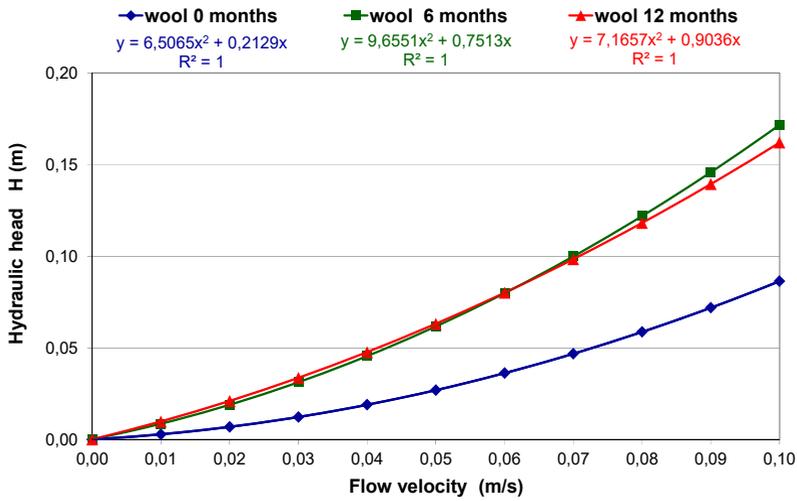
Fig. 8. Influence of the time of exploitation nonwovens wools on water permeability normal to the plane.

Tests were carried out in accordance with harmonized standards [20]. Obtained results are introduced in Tab. 3 and also in Fig. 8, 9.

Analyzing the obtained tests results of influence of exploitation time on filtration properties of the outer layer of rope, one can observe that the greatest decrease in water permeability occurs in the first 6 months after installation, regardless of the type of material used.

The initial speed of water flow through geotextile from wool was approx. 71 mm/s. After six months, this value decreased by 37.2% (44.36 mm/s). After another 6 months (1 year) the permeability of the water normal to the plane decreased by only 2.22 mm/s.

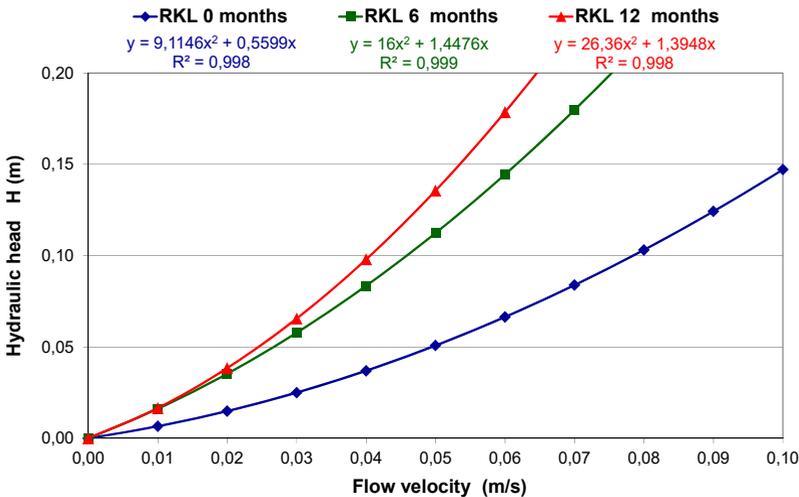
Fig. 9. Influence of the time of exploitation geonwovens RKL on water permeability normal to the plane.

A similar situation was observed in the case of outer layer from recycled synthetic fibers RKL. The initial water flow rate was 40.42 mm/s. After 6 months from installation, the discussed parameter was 28.03 mm/s - a decrease by approximately 31%. In the following 6 months, the water flow rate was recorded at 26.04 mm/s. In addition, mechanical and biological colmatation was visible on outer layer of the RKL. Clogging of the material by soil particles significantly affected water permeability in the outer layer of the product (Fig. 7). This was due to the fact that RKL fabric was subjected to atmospheric factors such as water (rain, snow) and soil, which caused smear of examined material and this is also associated with intensive development of vegetation root system.
