Assessment of a steel bridge corrosion degree

Abstract. The subject of this analysis is connected with the verification of the load capacity of the span structure taking into account the degree of corrosion of the railway viaduct components located at 41.446 km, on the railway line no. 301 of "Kotlarnia" SA Sand Mine built over the national road DK88 and railway tracks PKP-PLK near T. Kościuszki street in Zabrze. The general condition of the structure with regard to the corrosion assessment of structural steel is presented in the paper. Static and strength calculations were carried out to determine the load capacity class, and as a result of the analysis it was found that the technical condition of the facility steel girders is suitable for repair.

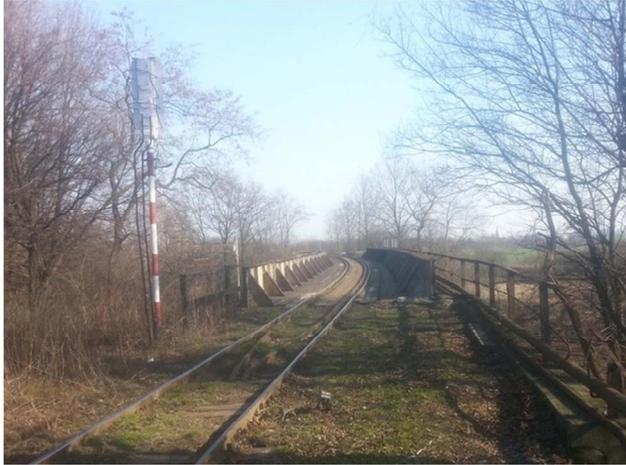
Fig. 1. Railway viaduct view.

The railway viaduct runs a single-track railway line over the national road No. 88 and railway tracks of PKP-PLK. The tracks on the object are placed in a horizontal curve. The building consists of two spans in a mixed-wall full-blown steel structure - riveted and welded with the bridge open on bridge sleepers. In the cross-section, two main girders with intermediate steel plates were used. The railway line crosses the road diagonally. Supports parallel to the obstacle were used - the object is diagonal. In order to complete the object and level the bevel, additional short spans were used perpendicularly to the axis of the abutment track. The girders were built in kinked curve shape adapt to the pillar track arc. The northern span of the riveted structure has a theoretical span of 28.40 m, plus a support with a projection of 3.90 m, on which the welded structure of the southern span is based. The theoretical span of the eastern span is 19.50 m, and the western span is 19.90 m. On the bridgehead, on the western beam, a short span is used to level the structure bevel. The bridge supports [13, 19] consist of two bridgeheads and a pillar with a circular, massive concrete structure. At the western girders, the sidewalk is made on the outside on brackets attached to the girder. Figures 1 ÷ 3 describe the analyzed object.
