# The feasibility and economic efficiency of selective modernization solutions in a single-family house located in Siemianice near Słupsk

Agata Stolarska<sup>1,\*</sup>, Jarosław Strzałkowski<sup>1</sup>, Michał Szczęciński<sup>1</sup>

<sup>1</sup>Department of Building Physics and Building Materials, Faculty of Civil Engineering and Architecture, West Pomeranian University of Technology Szczecin, al. Piastów 50, 70-311 Szczecin, Poland

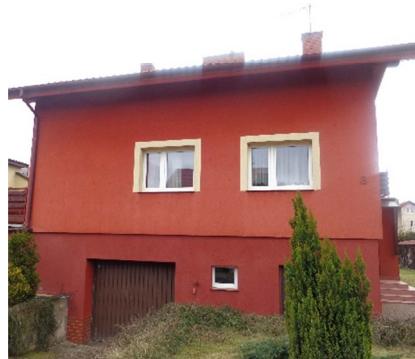
The building is located in Siemianice near the city of Słupsk. The location is in Polish climate zone I. The meteorological station located closest to the considered building is in Ustka. The building entrance and the garage entrance are on the south side of the facade. Fig. 1 presents a current photo of the building.

**Fig. 1.** South building facade [11].

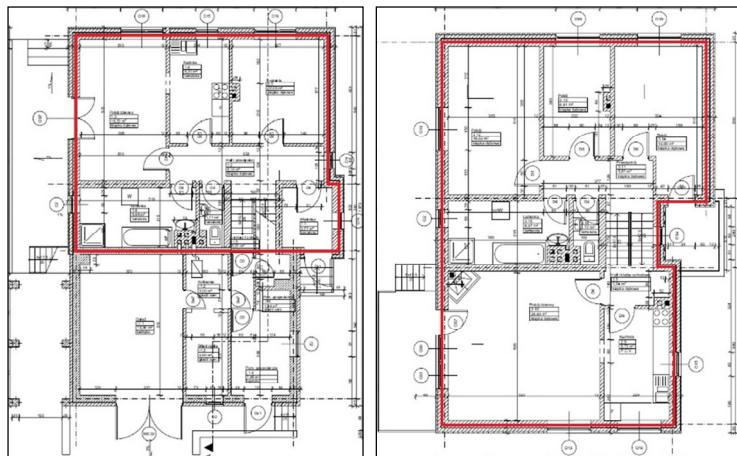
performing the necessary measurements and interviewing the inhabitants. On the basis of the inventory and other information received, technical drawings of the building were made. Layouts and cross-section of the building (Fig. 2–3) present the border of energy balancing.

**Fig. 2.** The ground floor and second floor layout with the delineated energy balancing border [11].

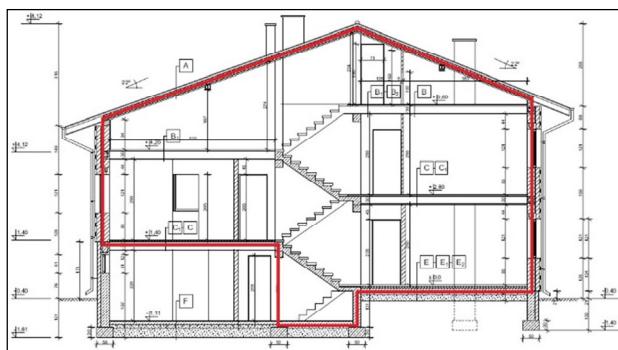
**Fig. 3.** Cross-section [11].

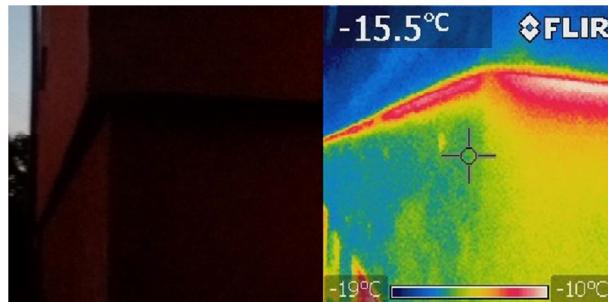
The current technical condition of the building is good; no excessive humidity is observed. The partitions and other structural elements do not have cracks or excessive deflections. In critical areas, thermal measurements using thermographic cameras were carried out [11]. The examination was performed at a temperature difference of  $\Delta\Theta \approx 20^\circ\text{C}$ , after sunset, with high clouds and no precipitation. In the thermal imaging photos from the outside of the building (Fig. 4–6), a clear heat escape is observed through the uninsulated

building envelope below the ground floor level. The presented photographs of the outside are for illustrative purposes. Temperatures represented in the thermograms were distorted by the impact of sky radiation. Nevertheless, it is still possible to observe the temperature gradient between the individual surfaces of partitions. Apart from the massive losses of heat occurring in the uninsulated basement walls, point thermal bridges are also clearly visible in the area of mechanical connectors of wall insulation.

**Fig. 4.** Thermogram of a basement wall corner [11].

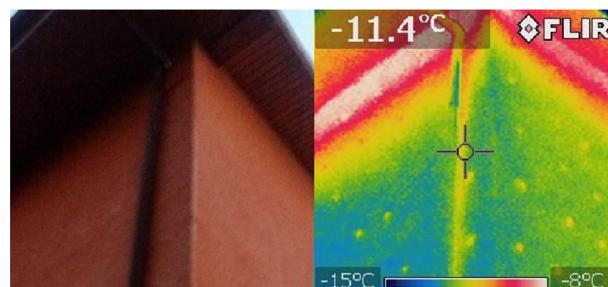
**Fig. 5.** Thermogram of the outer wall corner and the wall-roof connection [11].

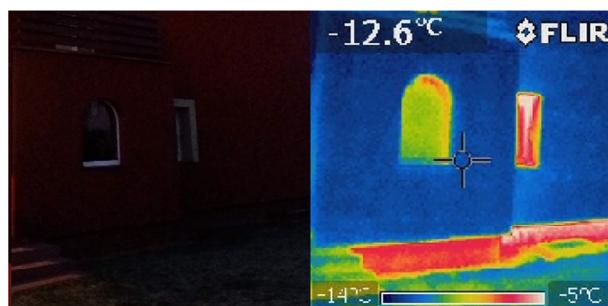
**Fig. 6.** Thermogram pointing to the lack of insulation of the building base [11].

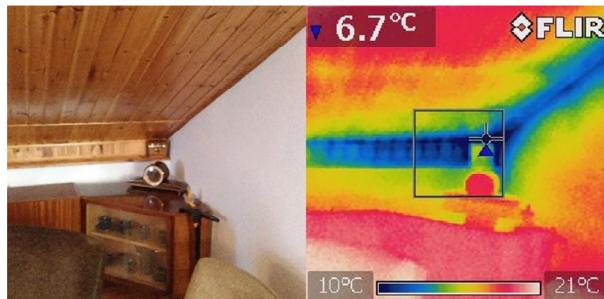
Thermograms shown in Fig. 7–9 were carried out inside the building. Clearly visible is the linear thermal bridge of the wall-roof connection. The minimum temperature of the wall surface in the corner was 6.7°C at an inside temperature of ~20°C. A similar large heat loss was observed in the basement on the uninsulated ceiling and walls.

**Fig. 7.** The thermal bridge resulting from the lack of insulation of the roof-wall connection (from the inside) [11].

In the case of thermal insulation of the roof, mineral wool was chosen with a thickness of 0.12 m and  $\lambda = 0.039 \text{ W/mK}$ . The *SPBT* received was 21.4 years. The under-rafter insulation significantly improves the thermal insulation properties of the roof and eliminates the thermal bridge in the wall-roof connection area (Fig. 7).

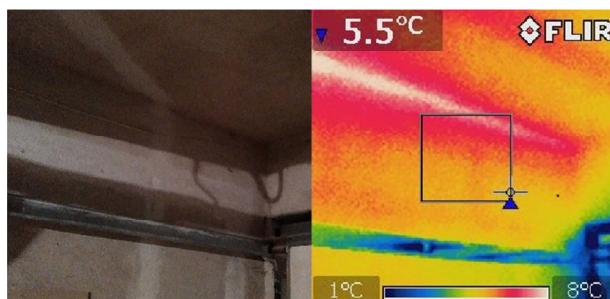
**Fig. 8.** Thermal bridge resulting from the lack of insulation of the ceiling above the basement (from the inside) [11].

Another improvement concerns the thermal insulation of the ceiling above the non-heated basement and the walls separating the heated space from the unheated space. The most sensitive places are shown in the thermal camera images (Fig. 8–9). It was decided to install foam polystyrene plates with a thickness of 0.15 m and  $\lambda = 0.04 \text{ W/mK}$  on the wall and the ceiling. The evidence for its cost-effectiveness is the very short payback period which is 1.9 years.

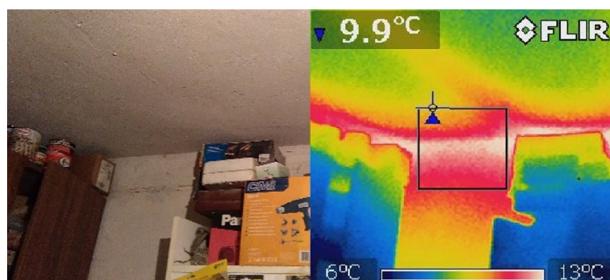
**Fig. 9.** Thermal bridge resulting from the lack of insulation of the basement walls and ceiling (from the inside) [11].

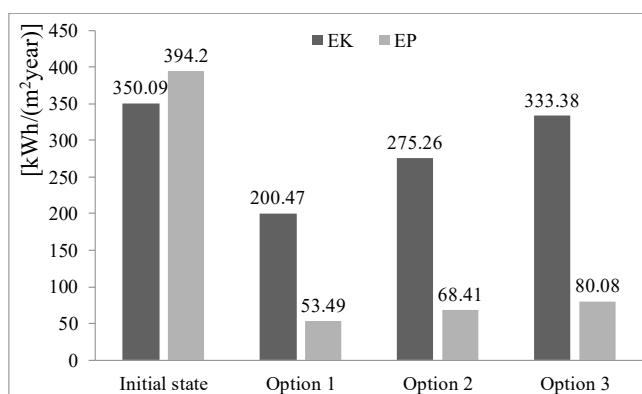
All the thermal modernization variants involve the use of a biomass boiler. This had the expected significant impact on the primary energy demand factor  $EP$  (Fig. 10). Thanks to this solution, even the minimum upgrade variant (option 3) could meet the limit values of the  $EP$  factor.

**Fig. 10.** The  $EK$  and  $EP$  factors before and after energy upgrade implementation.

As a result of full modernization (option 1), up to a 43% reduction of final energy consumption can be expected. After the full thermal modernization, the building meets the requirements set out in the regulation [12]. The middle upgrade option does not involve exterior walls and roof insulation and therefore does not meet these requirements. Despite this, a relatively small investment helps to reduce the final energy consumption by 21%. Similarly, the minimum option does not include insulation of external partitions and as such does not meet the requirements contained in the resolution [12]. The final energy demand in the case of the minimum option was reduced by only 5%. Still, this variant has an economic justification – it is low-cost, pays back quickly and does not involve renovation works inside the residential part of the building.
