# Application of new measurement technology for deformation study of structures in mining areas

**Abstract.** Despite of classic geodetic measurements, which are used in mine surveying at the beginning, more new technology are applied to measure deformation of structures and surface in mining areas. In the article new technologies are described for utilitarian aims based on strain sensors, laser, scanners and drones. The application of new technologies are especially useful when direct access to measured object is impossible using classic methods and in situation where continuous or quasi-continuous measurement is necessary. In Central Mining Institute the research has been conducted to understand the phenomenon of surface deformation induced by underground mining comparing predicted and measured values before and after extraction. In the last 20 years the mining technology has changed and dynamics of structure and surface deformation induced by mining. The second reason of technology development is necessity to instantly inform users of land and structures about changes using for instance the Internet.

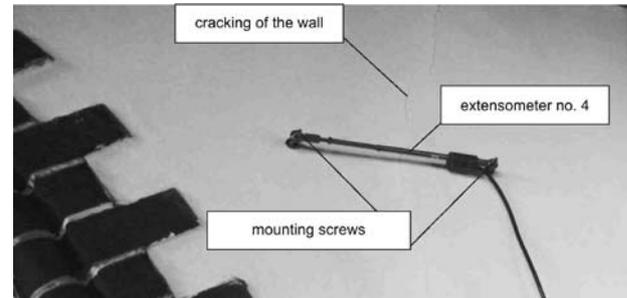
**Fig. 2.** Installation of extensometer number 4 over the crack of the wall nearby main entrance of the church [4].

First instruments were constructed in The Strata Mechanics Research Institute of the Polish Academy of Sciences [2]. The system has been applied for remote monitoring of building construction of Lutheran Church in Bytom-Miechowice (compare section 2.2) induced by longwall 18a in lower layer of 510 seam extracted during 2011-2012, Fig. 1 [3]. In this church cracks on walls and roofs have emerged. The construction of the building has been induced by uneven subsidence.

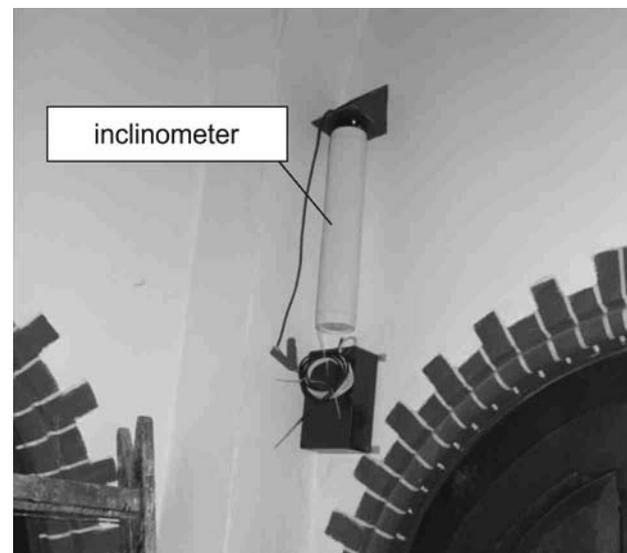
**Fig. 3.** Installation of inclinometer in quoin of the church tower [4].

Surveys proved that system was working well to monitor deformation of construction of the church building during deformation of ground induced by mining in terms of time. Three dimensional surveys of

the church tower enabled to indicate main directions of inclination.

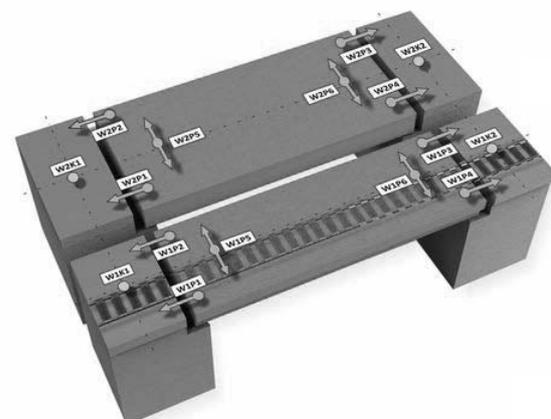
**Fig. 4.** Arrangement of sensors on tram and road viaduct designed to measure displacement increments (WP) and arrangement of inclinometers (WK).

Another but similar system has been applied in two viaducts (road and tram viaduct) in Ruda Śląska (Fig. 4). The monitor system includes twelve sensors as follows:

- eight crackmeters (Geokon 4420) to measure displacement increments of deck in term of abutments along y axis,
- four vibrating wire tiltmeters (Geokon 6350) to measure inclination of abutments along two perpendicular planes and 16-channel recorder to store data.

Received displacement increments of road viaduct abutments in real time were similar to predicted value. Whereas, displacement increments of tram viaduct were completely different than the predicted values. It may be interpreted as viaduct work.

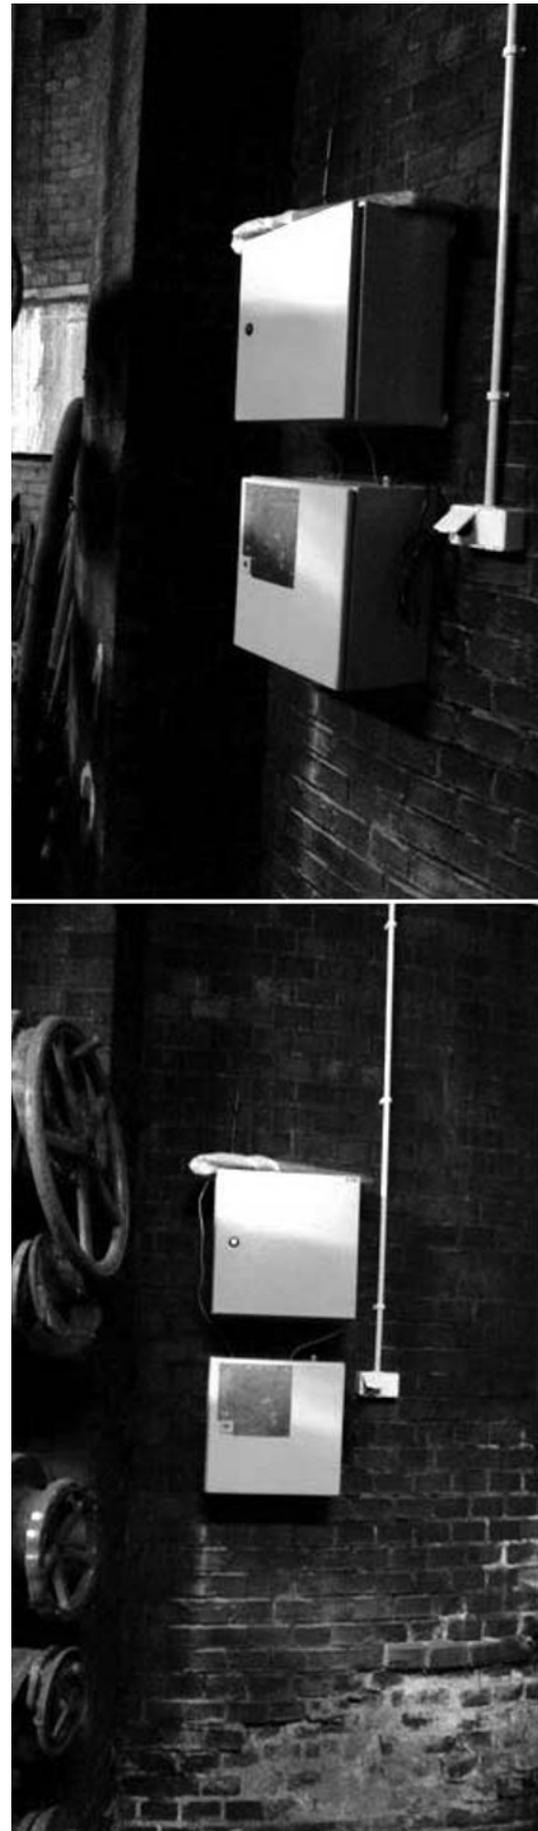
Fig. 5. The place of sensor installation.

Inclination sensor and digital recorder were installed in steal covers on south-east side of “Terma-Dom” chimney base about 2 m above the floor in Zabrze (Fig. 5). The chimney was described in details in section 2.3. The monitoring system has been started on the 22.03.2016. The inclination directions of sensor were calibrated according to cardinal directions. Before field use it had been tested in the laboratory on swing table with micrometer screw.

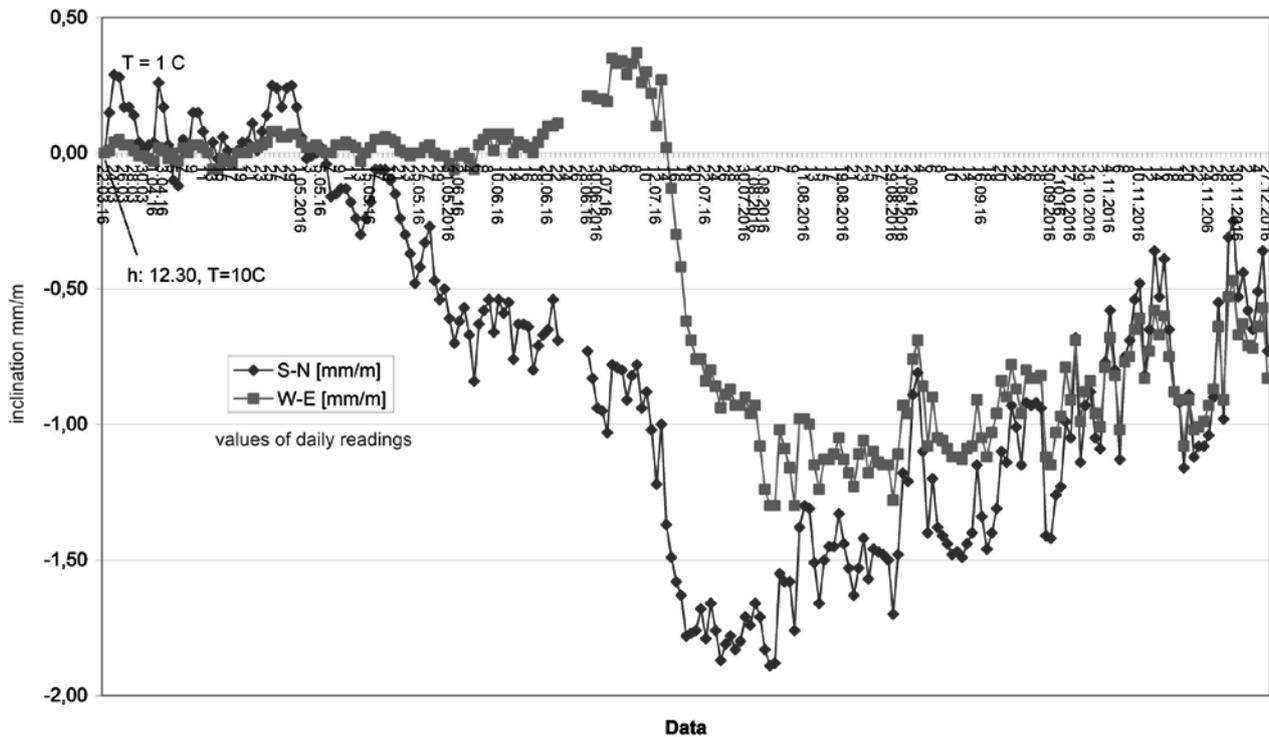
**Fig. 6.** Inclination distribution of chimney base along W-E and N-S axes.

Next, daily increments of chimney inclination are shown in Fig. 6. Fig. 7 shows values of resultant vector in plane X – Y (S-N – W-E). Based on the mentioned charts, temperature (and sun exposure) above  $10^\circ\text{C}$  triggers chimney inclination in south-west direction ( $-0.3 \text{ mm/m}$  south for temperature  $25^\circ\text{C}$ ). Temperature below  $10^\circ\text{C}$  induces inclination in opposite direction ( $0.4 \text{ mm/m}$  north for temperature  $1^\circ\text{C}$ ). Between 28 of June to 8 of July direction of chimney inclination was south-east, whereas from 14 to 31 of July rapidly had been change to south-west. The highest values of vector components ( $1.3 \text{ mm/m}$  west and  $1.89 \text{ mm/m}$  south) has been recorded between 4 and 5 of August.

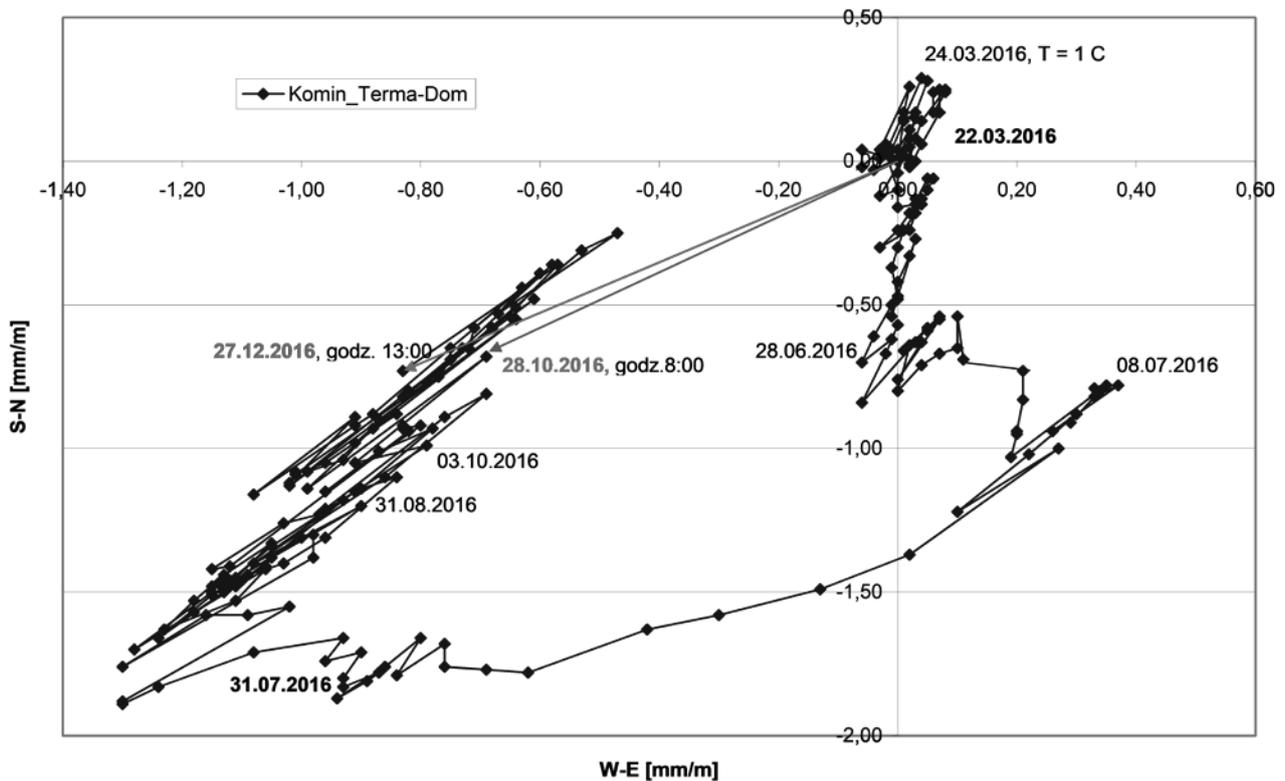
**Fig. 7.** Inclination vectors of chimney base since the day of sensor installation.

The calculated length of resultant vector is 2.3 mm/m in south-west direction according to the first day of storing data. In September 2016 there were periodic sinusoidal changes of direction of chimney inclination (+0.3 mm/m). The resultant vector has been decreased by 0.2 mm/m in north-east direction. This tendency has

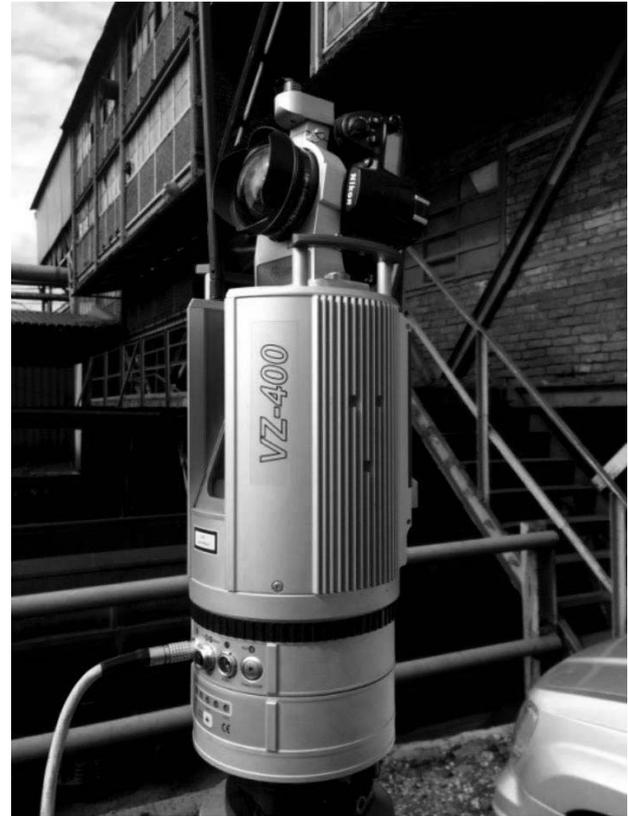
Fig. 8. 3D laser scanner Riegl VZ-400.

Department of Surface and Structures Protection in Central Mining Institute has 3D laser scanner Trimble TX5, which enables to store data with speed 976 000 points per second at a range of up to 120 m [5, 6]. For high objects such as chimneys it is possible to use 3D laser scanner Riegl VZ-4000 too (Fig. 8).

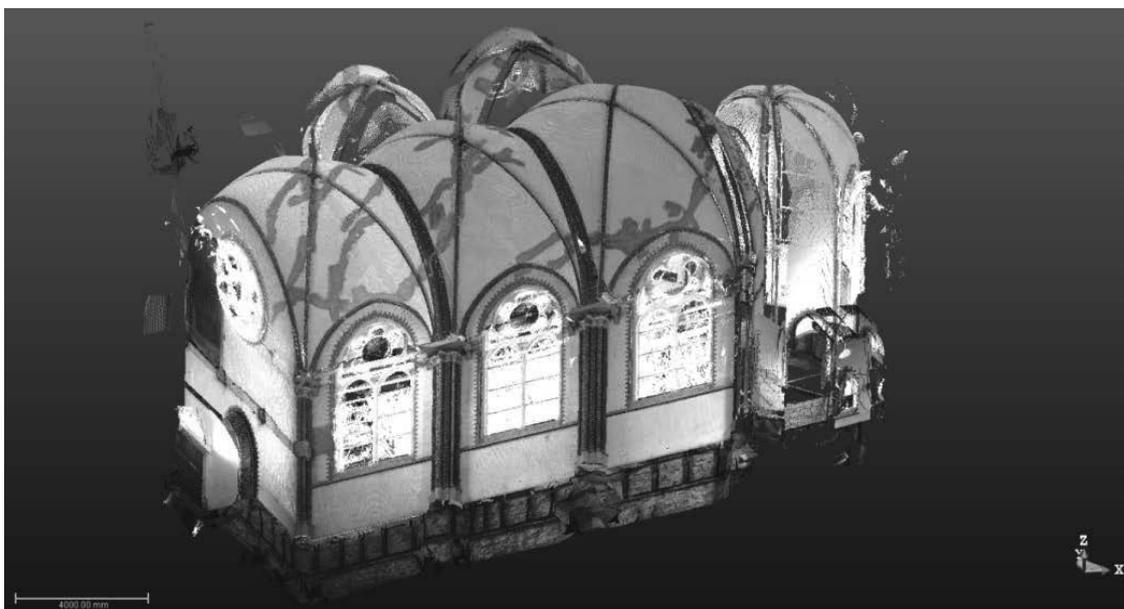
Fig. 9. 3D model of church building based on indoor surveys, north side view [6].

The object of scanning was building of Lutheran Church situated on Matki Ewy Street in Miechowice (section 2.1, Fig. 9). Indoor surveys were carried out using 3D Trimble TX5 scanner. The cracks of the church roof are shown in Fig. 9.

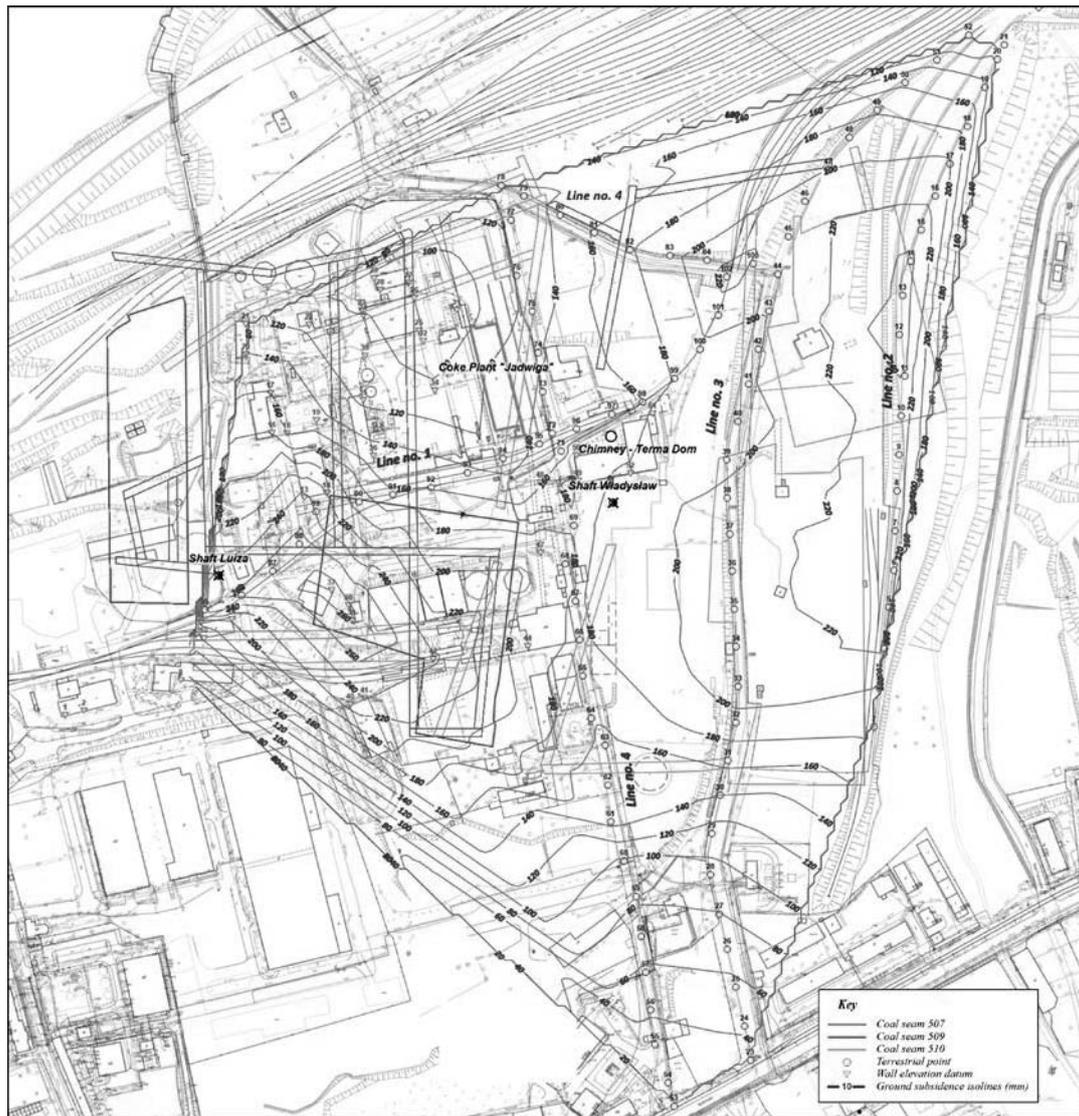
**Fig. 10.** Extraction of panels and headings in seams 507, 509 and 510 with subsidence contours.

The second field of scanning was in the area of coke plant placed in Zabrze-Biskupice where the "Siltech" mine extracts coal seams using experimental method leaving the coal pillars between backfilled headings. Fig. 10 shows extracted panels with headings system, observed subsidence during the 2015-2017 period and coke oven battery, 113 m high "Terma-Dom" chimney, which was captured using the above-mentioned 3D laser scanner on 09.06.2017.

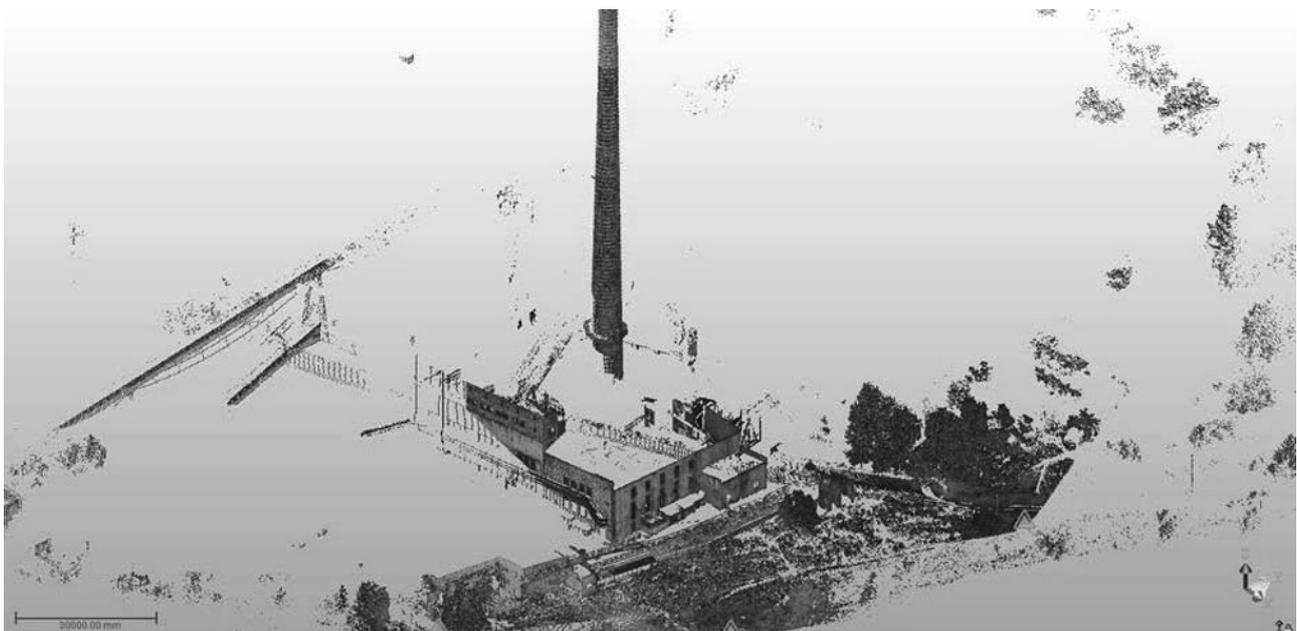
**Fig. 11.** Registered cloud of points and model of Terma-Dom chimney.

The results of measurements were points cloud and model of chimney (Fig. 11). cross-sections were made to analyze the body of chimney (Fig. 12). Calculated inclination of top of the chimney based on scanning is equal to 575 mm with azimuth 33° in mathematical system and 57° in geodetic system (north-east direction).

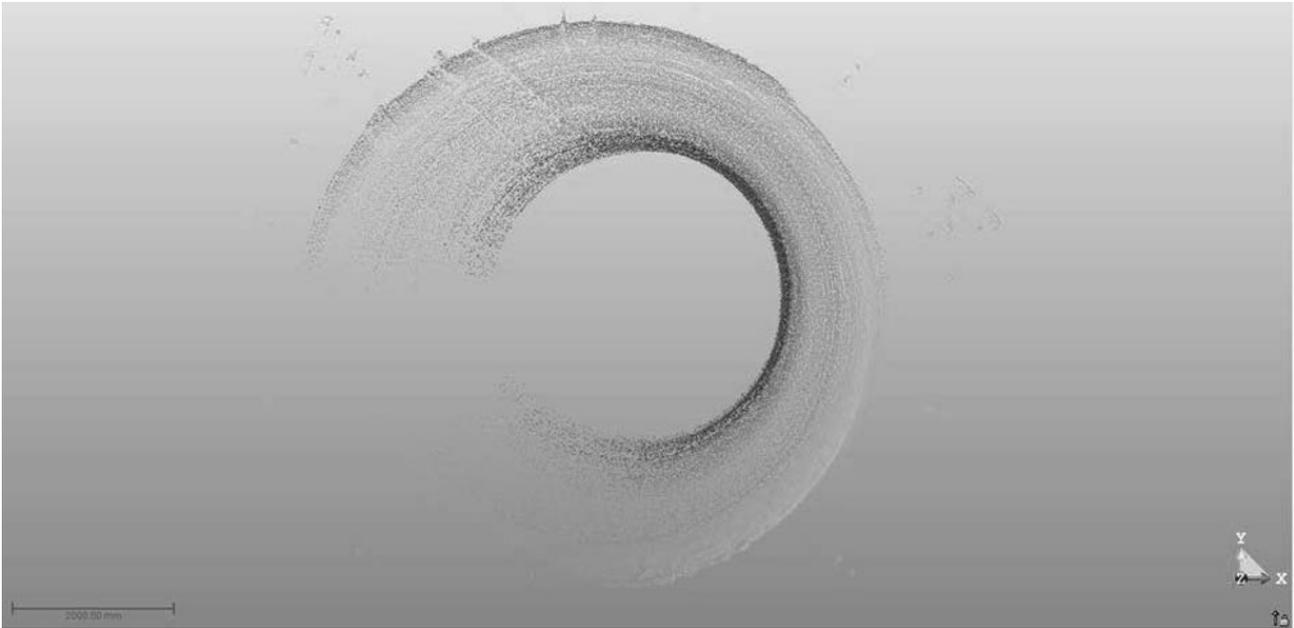
**Fig. 12.** Horizontal cross sections of 3D chimney model.

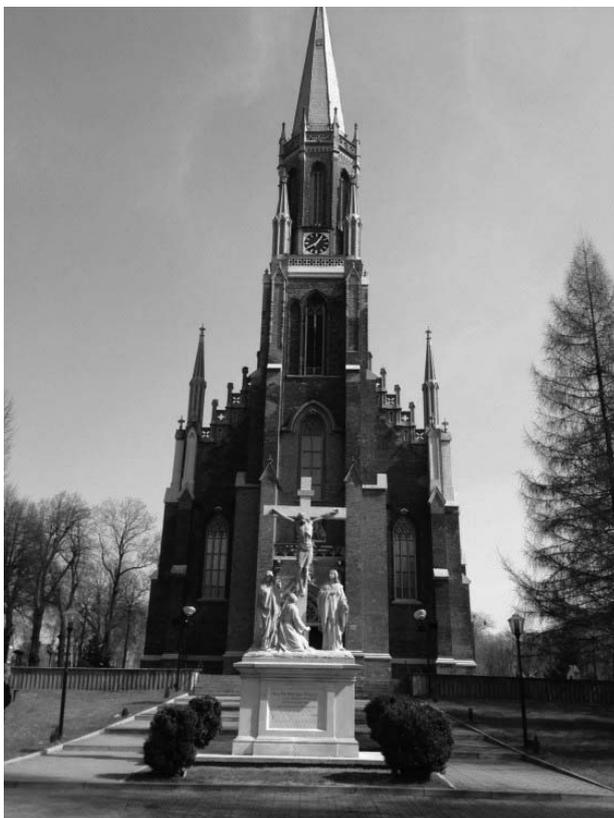
Another example of laser scanning applications is related to the building of Saint Cross church in Bytom-Miechowice, Fig. 13. The aim of measurement was to determine curvatures of masonry construction as an indicator of effort construction.

**Fig. 13.** Building of St. Cross church in Bytom-Miechowice.

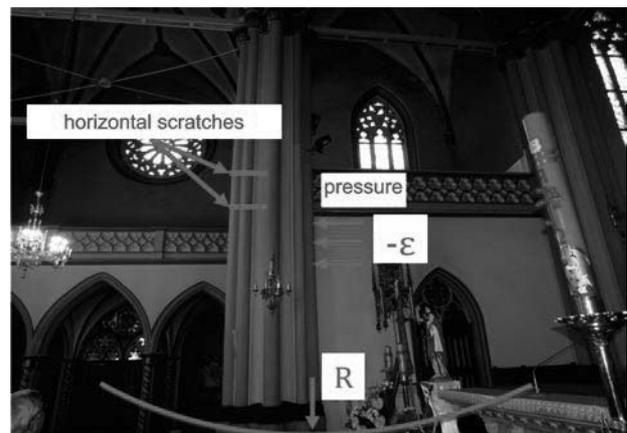
**Fig. 14.** Scheme of interaction of deformation indicators on construction of church building.

Vertical curvatures of the church walls (Fig. 14) were calculated on the basis of points coordinates along particular lines in plane of the walls (Fig. 15).

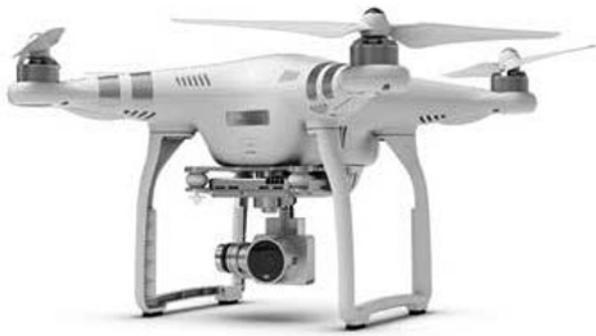
**Fig. 16.** Drone Quadrocopter Phantom.

In Central Mining Institute two types of drone are in service, the larger one Quadrocopter Phantom (Fig. 16) and the smaller one scout DJI Mavic Pro (Fig. 17).

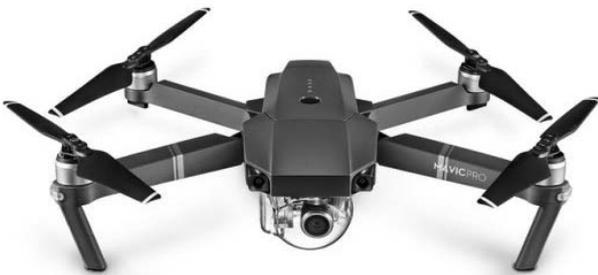
**Fig. 17.** Drone scout DJI Mavic Pro.

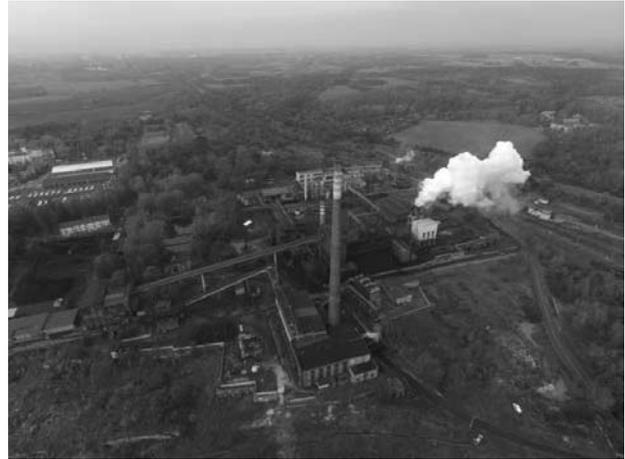
**Photo 1.** View of Jadwiga coke plant and structures of heat station with Terma-Dom chimney.

In last year (2016-2017) drones are more popular to review the condition of inaccessible parts of structure construction. Among others they are used to review the condition of brickwork of high chimney Terma-Dom (section 2.3) and damages of the Saint Wawrzyniec church building in Ruda Śląska-Wirek.

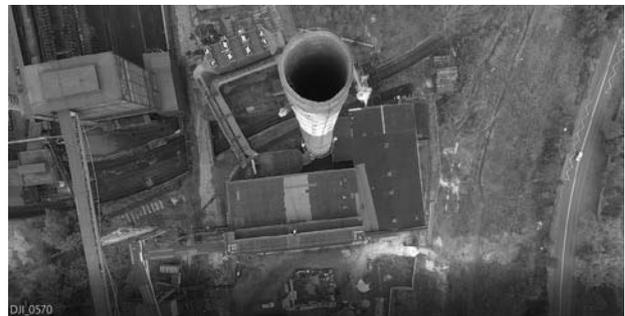
**Photo 2.** Top of Terma-Dom chimney.

The review results of 113 m high chimney (application of Quadrocopter Phantom drone) and church building (application of DJI Mavic Pro drone) are shown sequentially in photographs 1-7.

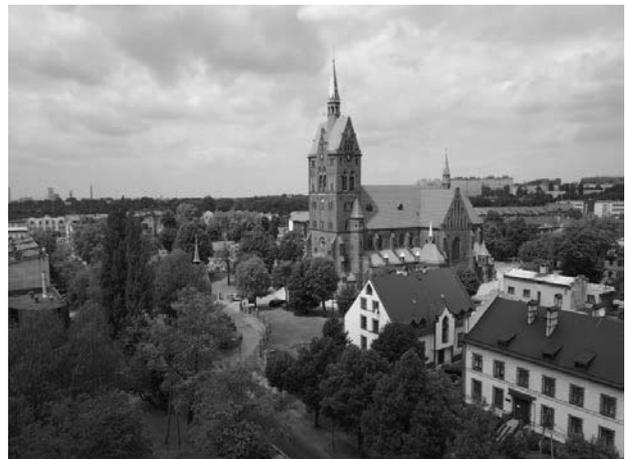
**Photo 3.** View of St. Wawrzyniec church in Ruda Śląska - Wirek.

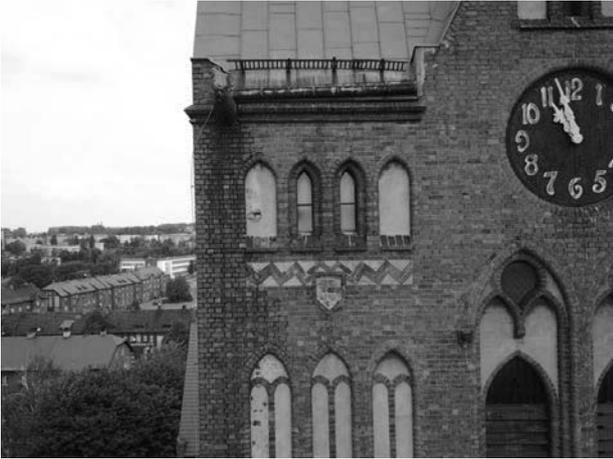
**Photo 4.** View of the church tower, close-up on the upper part of the tower for inspection of damages in the wall.

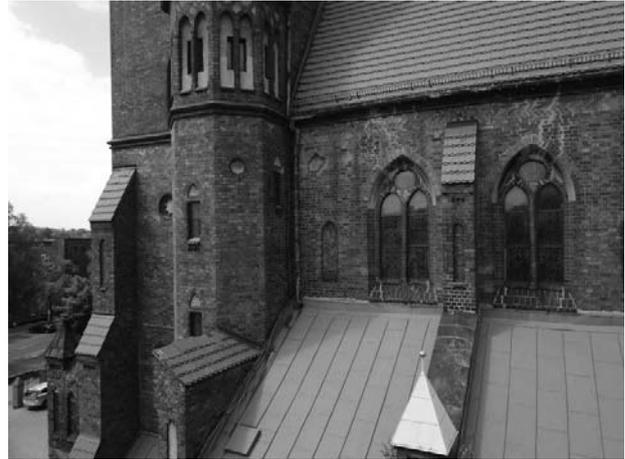
**Photo 7.** The Eastern wall of the church nearby tower (fissures and rosette deformation).

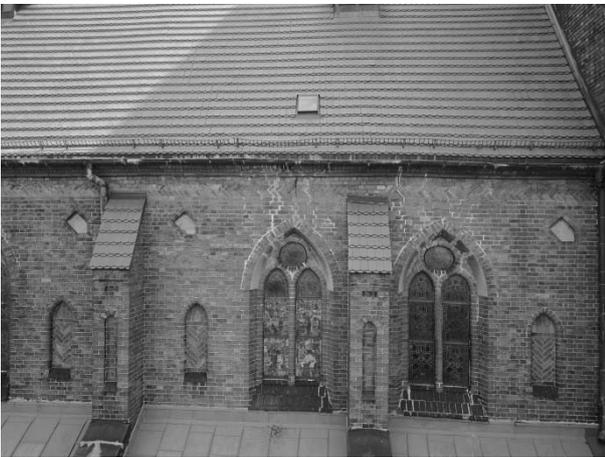
**Photo 5.** View of the western wall of the church nearby tower (cemetery side), visible fissures and rosette deformation.

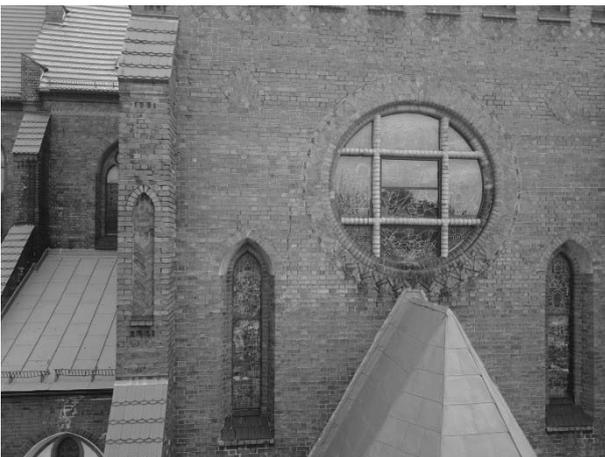
**Photo 6.** View of the western wall of the church nearby transept (vertical fissures).
