# Uprooting of tree induced by typhoon: a case study of super typhoon Mangkhut in university town of Shenzhen

**Abstract.** Super typhoon Mangkhut resulted a large number of fallen tree in form of uprooting in university town of Shenzhen (UTSZ), which hadn't happened for years. This study conducted a survey about tree uprooting induced by super typhoon Mangkhut in UT SZ, aiming to reveal main reasons for tree uprooting in UT SZ. Species of fallen trees were recognized. Fallen direction and height of fallen tree were measured. Also depth and diameter of root-soil plate and dry density of soil beneath root-soil plate were measured. The results showed that many fallen trees with uprooting in UT SZ had relatively small volume of root-soil plate which was not able to offer sufficient anchorage to tree during typhoon. One of solutions to avoid this phenomenon is not to select tree species with shallow root depth. Ponding was found in many places where uprooting occurred in UT SZ. Increase of degree of saturation of soil induced by ponding can significantly decrease soil strength which is a major component of anchorage of tree. Thus we recommend to modify the poor drainage condition of s

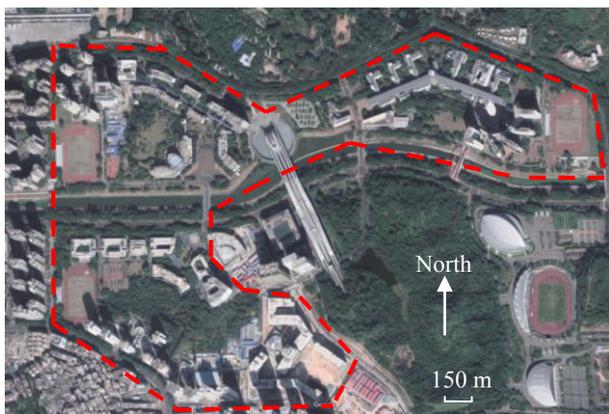
**Fig. 1.** Scope of survey of tree uprooting

Shenzhen is a coastal city in Guangdong Province, China. UT SZ is a university cluster, located near Xili Lake in the Nanshan District, Shenzhen. There are six higher education institutions located in the area, three of them are Harbin institute of technology, Shenzhen, Graduate school at Shenzhen, Tsinghua university and Graduate school at Shenzhen, Peking university. This study surveyed the situation of tree uprooting within the scope of these three education institutions, as shown in Fig. 1.

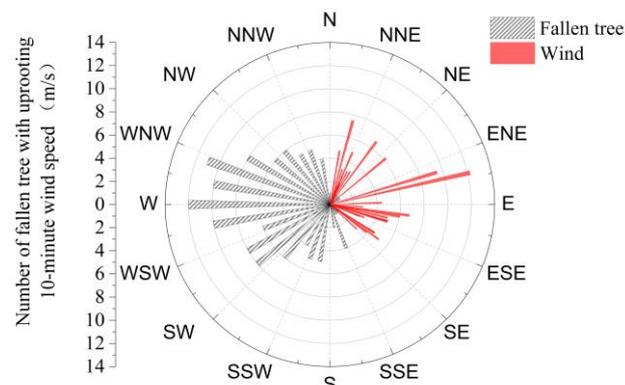
**Fig. 2.** Direction and speed distributions of wind (from 0:00 16 Sept to 6:00 17 Sept) together with fallen direction and number distributions of fallen tree with uprooting in UTSZ

Fig. 2 shows wind direction and 10-minute wind speed distributions in UTSZ during the period when super typhoon Mangkhut was close to Shenzhen. The wind came from the direction from north (N) to southwest (SE). This means the force of wind tend to blow down tree in direction from south (S) to northwest (NW). The maximum wind speed (i.e. 12.2 m/s) occurred at the range of direction from east-northeast (ENE) to east (E). This

means the strongest force of wind tend to blow down tree in direction from west-southwest (WSW) to west (W).

Fig. 2 also shows the fallen direction and number distributions of fallen tree with uprooting in UTSZ. The fallen direction of tree mainly distributed within the range of direction from south (S) to north (N), which is in accordance with the direction range of wind force applied on tree (i.e. from S to NW). In total, 125 fallen trees with uprooting were recorded in this study. Most trees fallen in the direction range from west-southwest (WSW) to west-northwest (WNW), which is also in accordance with the direction range of strongest wind force applied on tree (i.e. from WSW to W).

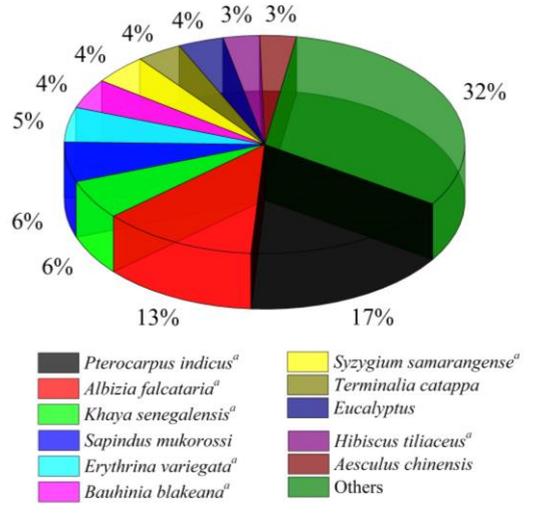
**Fig. 3.** Tree species distribution of fallen trees with uprooting in percentage in UTSZ (colour version of this figure is available online).

Fig. 3 shows the distribution of species of fallen trees with uprooting in percentage in UTSZ. In total, 39 tree species were recognized in this study. The main species of fallen tree were given in the figure. Many tree species (i.e. tree species with a superscript of a in the figure) were within the list of tree species which have shallow root depth or heavy crown [8]. According to Dupuy et al. [7], depth of root has strong positive correlation with anchorage of tree. Meanwhile, horizontally displaced weight of the crown would strengthen the turning moment applied on trees [4]. Thus many tree species recorded in this study are vulnerable to fall down upon typhoon.

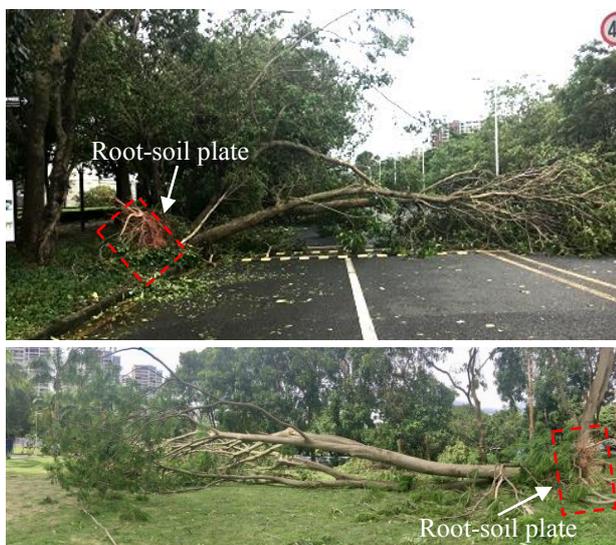
**Fig. 4.** Typical cases of tree uprooting in UTSZ

Fig. 4 shows two typical cases of tree uprooting in UTSZ. The size of root-soil plate is relatively smaller than the size of stem and crown above ground surface. Fig. 5 shows the volume of root-soil plate and corresponding height of tree recorded in UTSZ. For a given height of tree, volume of root-soil plate varied significantly. For the trees with height between 10 m to 15 m, more than half in number has a volume of root-soil plate less than 2 m<sup>3</sup>. Relatively small volume of root-soil plate indicates relatively small weight of root-soil plate for tree. Thus resistant moment attributed by weight of root-soil plate against the turning moment on tree would be small.

1. Many fallen trees with uprooting in UTSZ had relatively small volume of root-soil plate which is not able to offer sufficient anchorage to tree against turning moment. One of solutions to avoid this phenomenon is not to select tree species with shallow root depth.
2. Ponding was found in many places where uprooting occurred in UTSZ. Increase of degree of saturation can significantly decrease soil strength which is a major component to anchorage of tree. We recommend to modify the poor drainage condition of soil in UTSZ.
3. DOC of soil beneath the root-soil plate is relatively high in UTSZ, thus DOC of soil may not be a main factor related to tree uprooting in UTSZ.

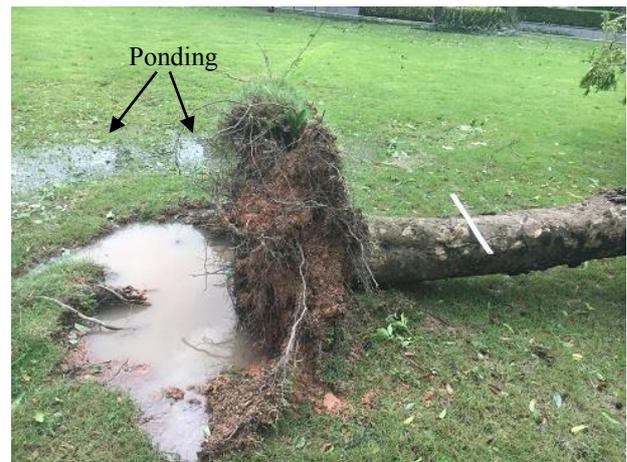
**Fig. 6.** Ponding around tree uprooting

Soil strength also depends on degree of saturation of soil [9]. During survey of tree uprooting on the very next day of typhoon Mangkhut in UTSZ, ponding was found at a lot of places where tree uprooting occurred, as shown in Fig. 6. This means soil around roots was in high degree of saturation during tree uprooting, thus the contribution of suction to soil strength was limited. One

reason for the high degree of saturation of soil is the intensive precipitation upon the typhoon Mangkhut, as shown in Fig. 7. Another reason is the poor drainage of soil layer around the tree, which should be modified in future work.
