DIC (Digital Image Correlation) method in the research of RC beams strengthened with PBO-FRCM materials

Abstract. The article presents tests of a reinforced concrete beam strengthened in a shear with PBO-FRCM composite materials. Measurement of the deformation of the composite was carried out using two methods - with strain gauges and the optical DIC method (Digital Image Correlation). The DIC method consists in taking a series of photographs of the tested object before and during loading. The surface of the tested element must have randomly spaced spots that are applied to the object before measurement. During the study, the cameras monitor the shifting of spots against each other, which in comparison to the reference image before loading gives information about strains and stresses of the tested element. Measurements of deformation of composite materials using strain gauges are difficult to clearly analyse, because the strain gauge is in a specific, limited place, which does not correspond to the work of the entire composite. In addition, the strain gauge tends to break at the place of crack. The article discusses this problem by presenting the results of deformation of PBO-FRCM

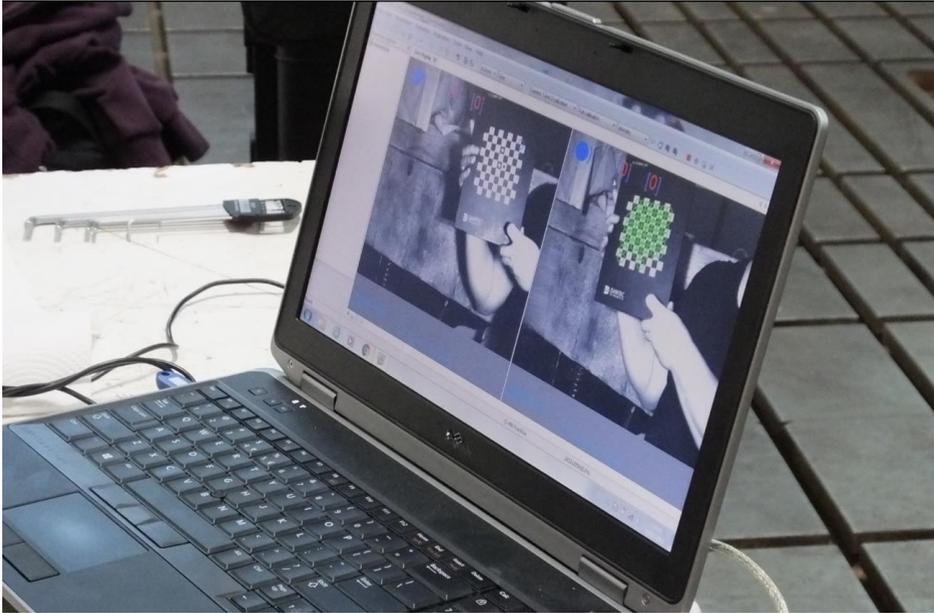
Fig. 1. Calibration using a reference plate.

Digital Image Correlation is an innovative non-contact, full-field surface, optical technique for measuring displacement and converting it into strain. The measurement consists in making a series of digital photographs of the tested object before and during loading and tracking the movement of the naturally occurring, or applied surface pattern. The surface of the tested element must be properly prepared by applying a random speckle pattern on it, using airbrush, spray aerosol, transferable stickers or rubber stamp. The first reference photograph is usually made at zero load of the element, before starting the tests. Next the image surface is divided into subsets – a series of boxes containing $n \times n$ pixels, with a recognizable pattern in each. During the test a cross correlation technique is used to analyse how each subset has moved. The measurement results are obtained in pixels, then they are scaled to mm using special boards with the pattern applied, whose image is registered in the reference photograph (Fig. 1).

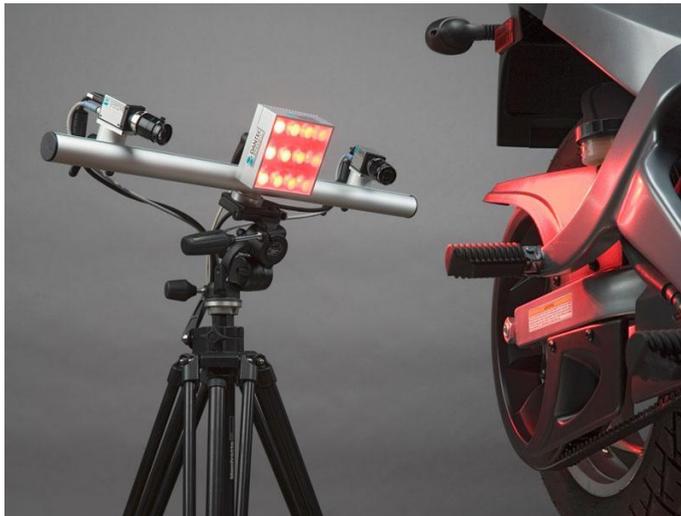
Fig. 2. Elements of DANTEC DIC system – two cameras on a tripod [9].

Images can be obtained from a variety of sources, including CCD cameras, digital cameras, macroscopes and microscopes. Typical hardware for 2-D image correlation systems includes a CCD (or CMOS) camera, a computer system with digital image acquisition components, a sturdy tripod with mounting head and a lamp emitting monochromatic light, that limits glare on the tested element. 3-D measurements require two cameras. The cameras are mounted on a tripod with a transverse beam on which their spacing can be adjusted, which depends on the size of the area under examination. For the measurement to be correct, both cameras must be directed to the same area of the tested element.

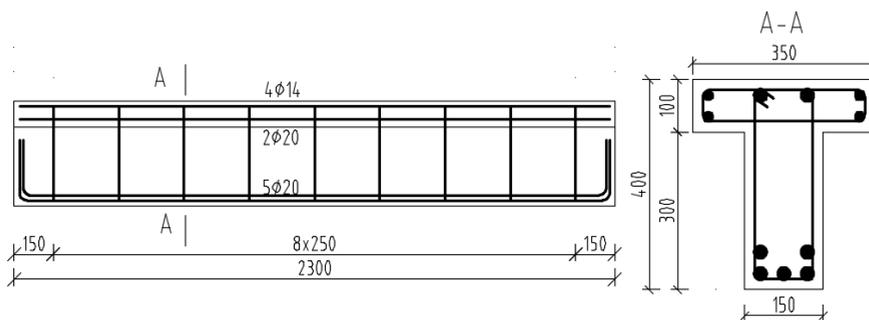
Fig. 3. The scheme of steel reinforcement and cross-section of beams.

Two 2300 mm long RC T-beams with 150×400 mm in cross section were subjected to tests. One beam was a reference beam, without strengthening, and the second one was shear-strengthened with a PBO (p-Phenylene Benzobis Oxazole) fibre mesh bedded in mineral mortar (PBO-FRCM). Flexural reinforcement in the form of 5 bars 20 mm in diameter was designed for prevent destruction due to bending before exhausting the shear strength. Stirrups in the form of bars 8 mm in diameter were spaced at every 250 mm along the whole length of the beam (Fig. 3).

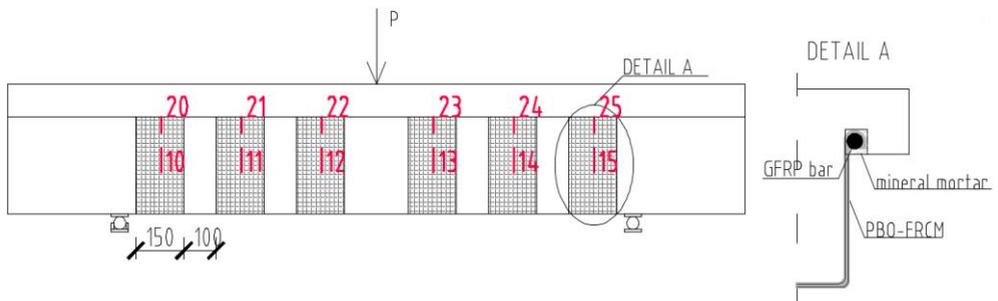
Fig. 4. The scheme of shear strengthening with end-anchorage.

The elements were continuously loaded to failure, in a three-point bending with concentrated force placed in the middle of the span (Fig. 4). Deformations of concrete, steel and composites were measured using strain gauges. On the outer stirrups made of PBO mesh, the 50 mm long strain gauges were glued at half the height of the beams according to the main direction of the fibers (Fig. 4 – strain gauges 10-15). Strain gauges were also glued to the place of anchors on both sides of the beam (Figure 4 – strain gauges 20-25). The strain gauges on anchors were 25 mm long.

The beam was strengthened with one layer of PBO mesh with associated cement mortar, discontinuously with 150 mm wide FRCM strips with spacing of 100 mm. FRCM strengthening was applied on the both sides and bottom of the web. This type of strengthening configuration is called U-wrapped. Before strengthening, surface of the beam was cleaned of laitance, dusted and washed. The corners of the beam were rounded in the areas where the outer composite stirrups were applied, in order to prevent the local stress concentration. The surfaces of the web were saturated with water for 15 min prior the placing the FRCM strips. Then first layer of the mortar was applied and fabric strips were placed. The PBO mesh was applied after application of the first mortar layer and then pressed slightly into the mortar. In case of anchoring, 20×20 mm cuts were made under the slab. After shear strengthening, the ends of the PBO strips were wound on a GFRP bar and glued in a cut under the shelf. The bar had a length equal to the length of the beam and together with the PBO strips were covered with an outer layer of mortar (Fig.4)

The maximum strain of the composite measured using strain gauges glued in the middle of the height of the PBO strip was 3.5‰, which means the use of its total capacity at about 20% (Table 1). At the anchorage, strains measured using strain gauges were at a maximum of 12‰, which corresponds to 68% of the total PBO-FRCM deformation limit (Table 1). These are values corresponding to the part of the span in which the destruction occurred. In the second part of the span, the maximum strain of the composite were 0.43‰ for the strain gauge number 15 (Fig. 4), and on the anchorage, 5.97‰ for the strain gauge number 24 .

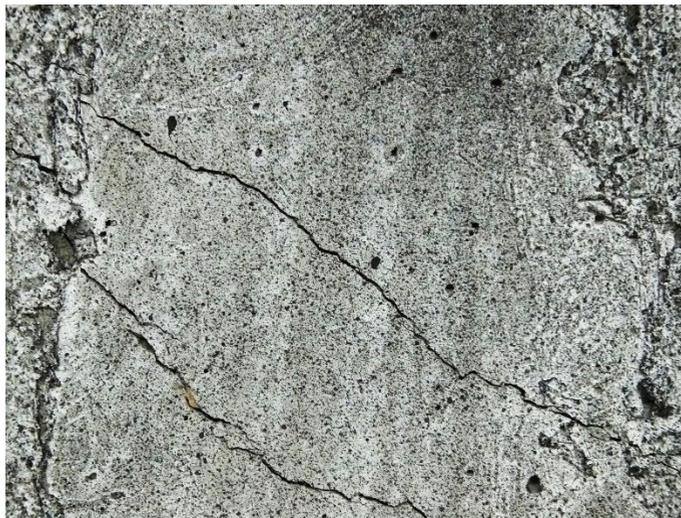
Fig. 5. Speckle pattern on the surface of the tested element.

Half of the beam span was also analyzed by the DIC method. Due to the construction of a testing machine, that has a pillar in the middle of the span, it was not possible to use the DIC method to analyze the whole beam, because the image from both cameras would not show the same area. The right half of the beam, from the point of concentrated force to the support, was prepared for DIC measurements, by whitening the concrete surface with lime and spraying it with a black spray to give the speckle pattern. The resulting spots on the concrete surface are shown in Fig. 5, and the test stand in Fig. 6.

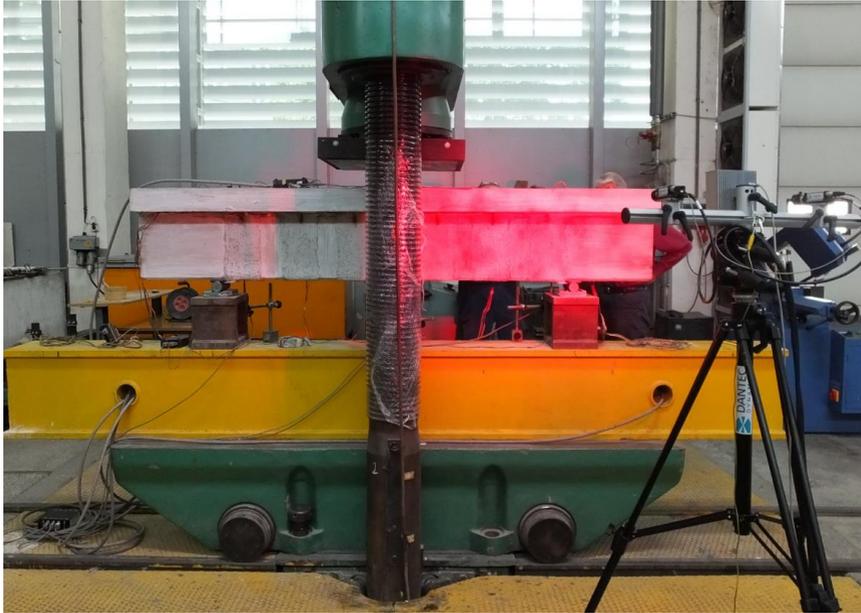
Fig. 6. Test setup.

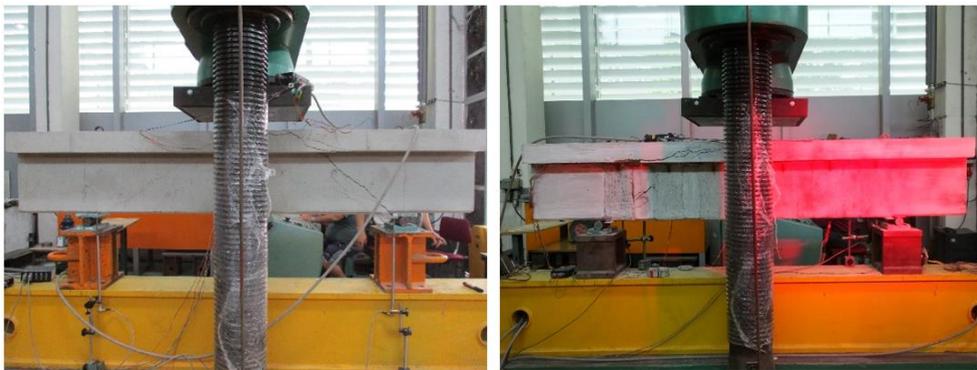
Fig. 7. Beam failure a) reference beam, b) strengthened beam.

The reference beam reached an ultimate load of 453.67 kN and failed in a shear after the formation of main diagonal crack on the shear span (Fig. 7a).

The strengthened beam also failed in a shear with formation of main diagonal crack, and reached an ultimate load of 527.40 kN. This diagonal crack developed on the half of the span, which was not included in the range of DIC cameras (Fig. 7b). Comparing the shear capacity of the strengthened beam to the capacity of the control beam, a load increase of 16% was obtained.

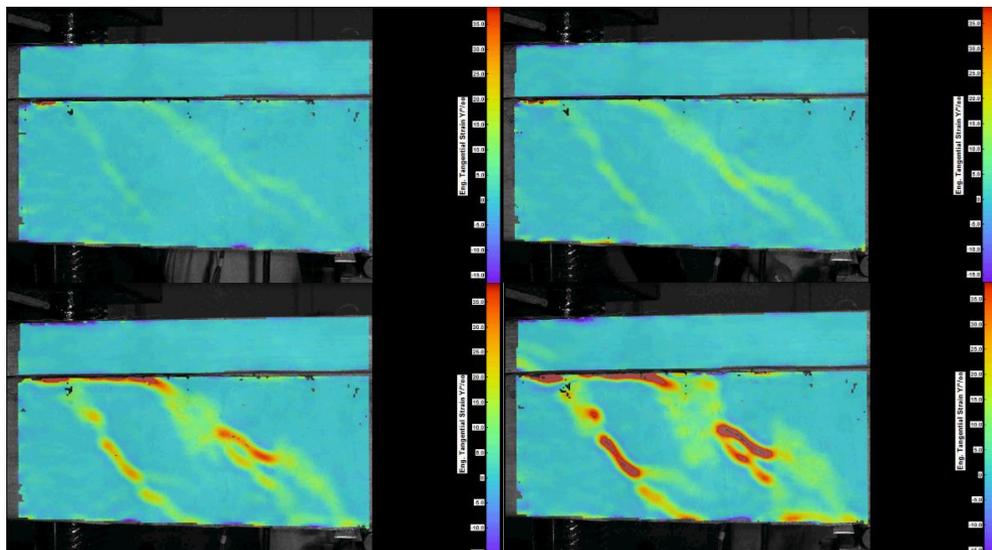
Fig. 8. Image from DIC cameras showing the development of diagonal cracks in the beam during test.

An advantage of the DIC method is the ability to analyze deformations over the entire surface of the element. Thanks to this, it is possible to observe the development of cracks and the distribution of deformations on the entire composite strip. During the test, it was shown that diagonal cracks passed under the PBO strips and developed between them (Fig. 8).

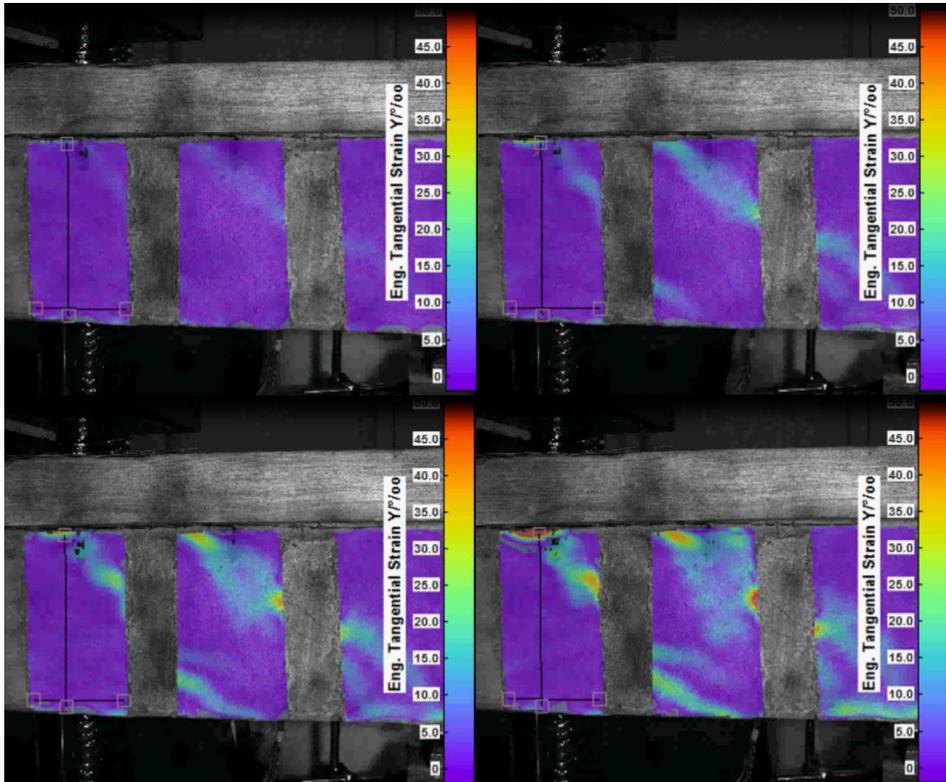
Fig. 9. Image from DIC cameras showing the deformation of PBO-FRCM composite strips with increasing load.

On the PBO-FRCM strips the first deformations occur in the place of the diagonal crack and then they are redistributed along the strip height. The maximum strains measured using the DIC method reached a value of more than 5‰ both at the anchor point for strip with number 13 and on the middle strip with number 14 (Fig. 9). On the basis of images from DIC cameras, it can be concluded that the maximum deformations of the composite occurred in other places than the strain gauges were glued, for example on the edge of the central strip at the place of diagonal crack, and on the left side of the anchor on the strip number 13. At the places where the strain gauges were glued, i.e. half the height and width of each PBO strip, very small deformations were recorded. These results are consistent with those of the strain gauges. In this case, the deformations obtained from strain gauges were not adequate to the real effort of the composite. In the case of testing beam with shear
