Gravel and boulders mining from mountain stream beds

Keywords: mountain stream, gravel mining, river bed, Carpathians

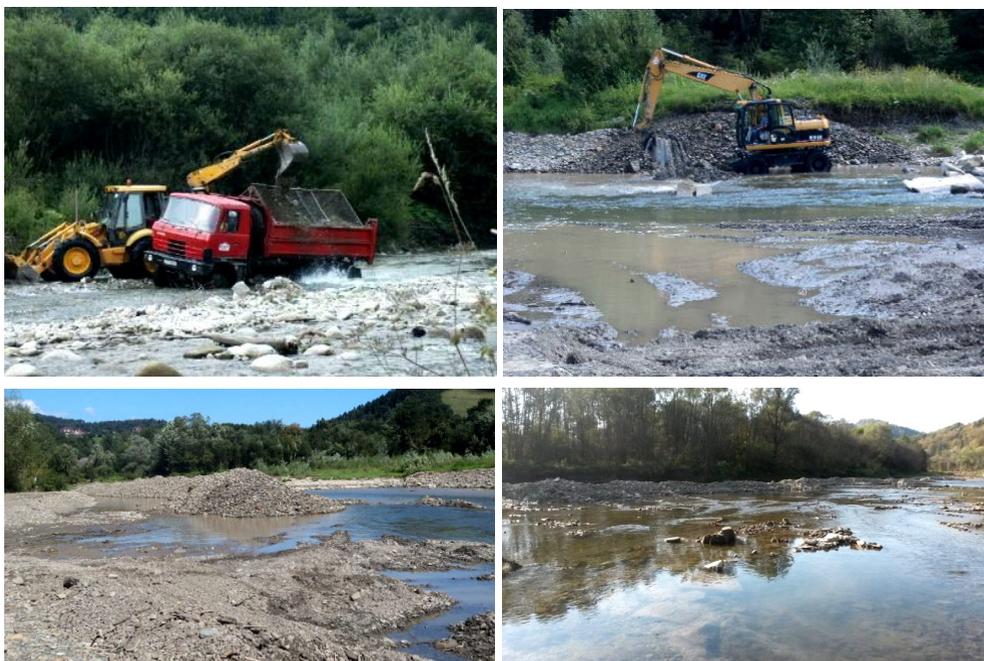
Fig. 1. Illegal gravel mining in Polish Carpathians: excavators and lorries in work and river gravel bed degradation after illegal gravel activity

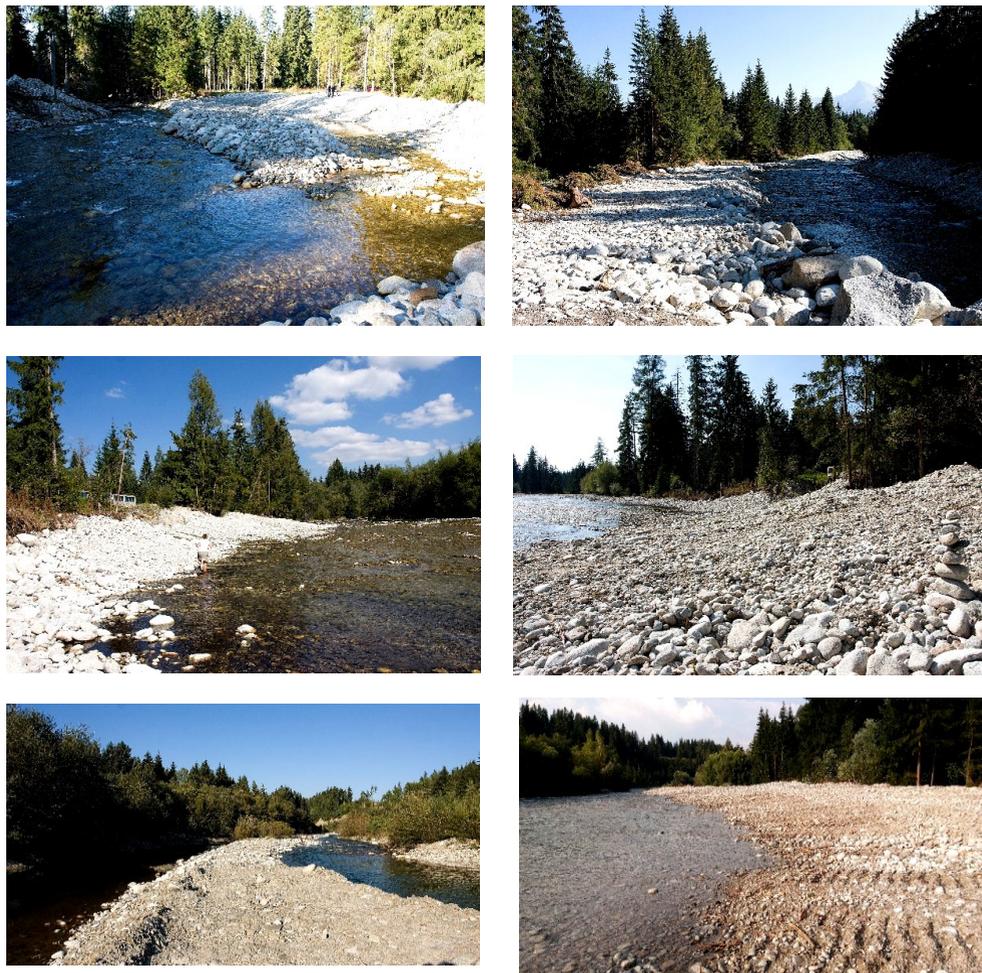
Fig. 2. River gravel bed degradation after illegal gravel activity on Slovakiens rivers.

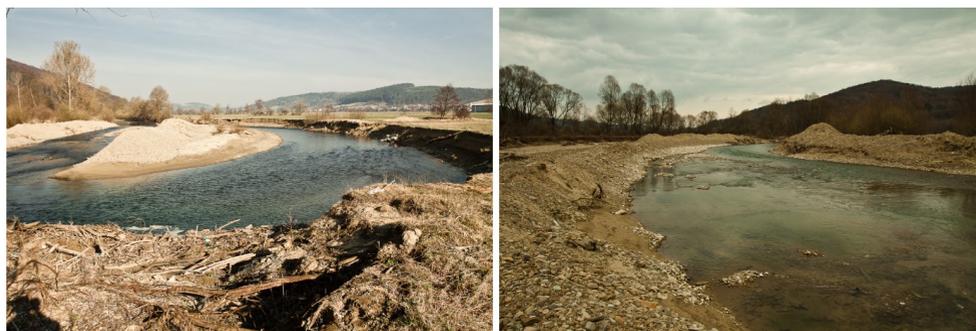
Fig. 3. River gravel bed degradation after illegal gravel activity on Slovakiens rivers.

floodplain area. Nowadays gravel extraction (2002 – 2009) is concentrating to active channel area where the volume of gravel mining is permitted by the mining license up to 1000 m³ per year for one company. This extracted sediment volume is aimed to restrict the sediment supply to the Domaša water reservoir. Channel bed is formed by gravel fraction (from 2 to 64 mm) with average proportion 84,1 % for the Topľa River and 81,8 % for the Ondava River. Average grain size D₅₀ is for the Topľa 33,09 mm (-5,02 Phi) and 35,23 mm (-5,08 Phi) for the Ondava. In addition to gravel extraction both rivers are lateral dynamic with intensive migration of channel. Erosion protection is ensured by channelization and artificial embankment in areas of settlements but in other section was channel modified and straighten to the original state, gravel materials are pre-load in the form of dikes near active channel without reinforcement (Fig. 3, 4).

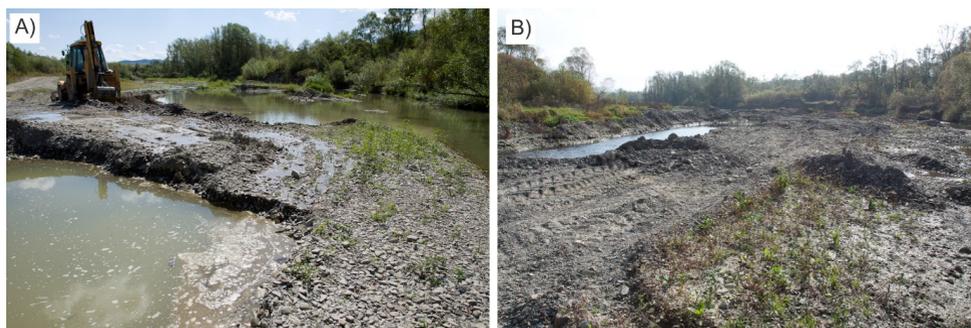
Fig. 4. Gravel mining on the Ondava River near the Breznica village (A) and channel destruction by mechanisms (B).

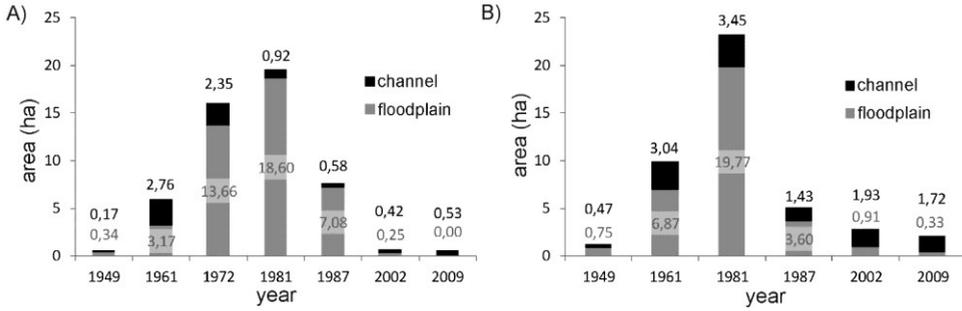
Fig. 5. The gravel pit area identified on the floodplain and active channel for the Ondava River (A) and Topľa River (B) during study time span 1949 – 2009.

The largest volume of gravel extraction, calculated on the basis of the excavation area, took place at both the Ondava River and the Topľa River in 1981, where the gravel pit area represented 19,52 ha on the Ondava River, respectively 23,22 ha on the Topľa River. Their area then decreased dramatically. The largest volume of mining in the study period was on the floodplain area (Fig. 5).
