# little-known facts about silicate bricks and fires

**Abstract.** The article presents a brief historical background about the epistemology of silicate brick. Well-known facts about silicate brick are given: the technological scheme of manufacture, modern grades for strength and frost resistance, information about thermal conductivity, classification by species, size and purpose. Advantages are considered, among which are noted: relatively low cost, environmental friendliness, compatibility with masonry mortars, aesthetics, wide color gamut, good geometric parameters, high strength characteristics, good soundproof ability, relatively high frost resistance, ease of processing. Disadvantages are given, among which are noted: high thermal conductivity, high water absorption, brittleness, and instability to acidic and alkaline aggressive environments. Particular attention is given to the consideration of the behavior of silicate brick and masonry from it in a fire. References to works devoted to this problem are given. The research of high temperature effects on the brickwork of the silicate bricks in the fire was held. A model for the possible collapse of brickwork as a re-sult of r

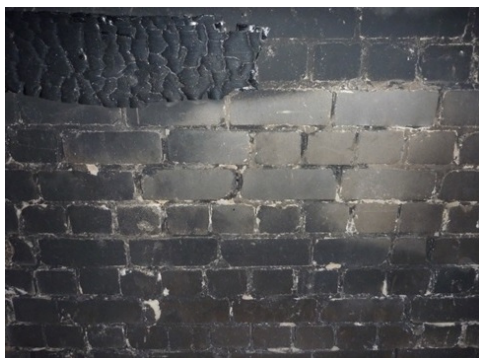
**Figure 1.** General view of the wall of the building after the fire.

Calculations carried out according to the method of [9] show that when the temperature is applied at 1000 ° C to the masonry for 50 min, the masonry decomposes to a depth of 39 mm. To verify the theoretical data obtained from the walls of the building in which the fire occurred, samples of silicate brick were selected (5 lots of 2 bricks). The fire in the building lasted 4-4.5 hours. The height of the room is 3.1 m. A general view of the walls of a building after a fire is shown in Fig. 1 and 2.

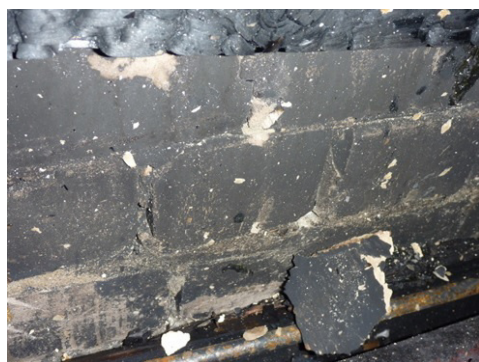
**Figure 2.** Dehydration of the surface layer of silicate brick.

With prolonged exposure to high temperatures on the brickwork, dehydration of calcium hydrosilicate and calcium oxide hydrate, which bind sand grains, breaks down the brick in the form of hair cracks. These cracks appear both across and along the masonry and can propagate quite deeply into the masonry body. As a result of the intersection of cracks, the masonry is crushed into flakes, as a result of which a partial collapse of the masonry in the zones of its damage can occur. If this happens with a load-bearing wall operating under load from overlying brickwork and ceilings, the situation is exacerbated even more. In this case, the cracks formed are both thermal and forceful. As studies have shown [5, 11], if force cracks pass through four (or even three) rows of silicate brick masonry, then this indicates its emergency state. As a result of the fire, the further use of silicate brick walls is no longer acceptable, without further examination to identify the technical condition of the brickwork and its operability. During fire fighting, there is also a danger of destruction of the brickwork. Currently, fires are extinguished by water, as it is economically viable. The water temperature is much lower (the minimum permissible water temperature in a fire truck is + 15 ° C) than the temperature in a burning room and on the surface of the masonry itself. With rapid cooling, temperature deformations lead to the appearance of cracks both in individual bricks and in brickwork as a whole. (An example is the task: "How to destroy a stone, being on the bank of the river? Answer: "Roll it into a fire, heat it and push it into a river." The consequences are obvious)

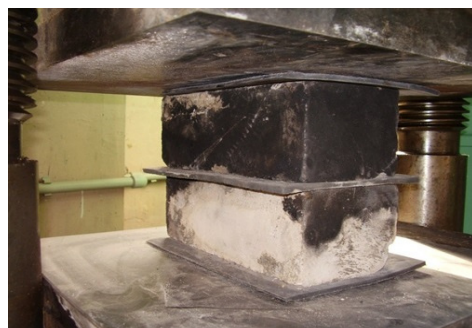
**Figure 3.** General view of the samples placed in the press P-125, before the test.

Samples of all five batches selected by height were tested in the P-125 press (Fig. 3).

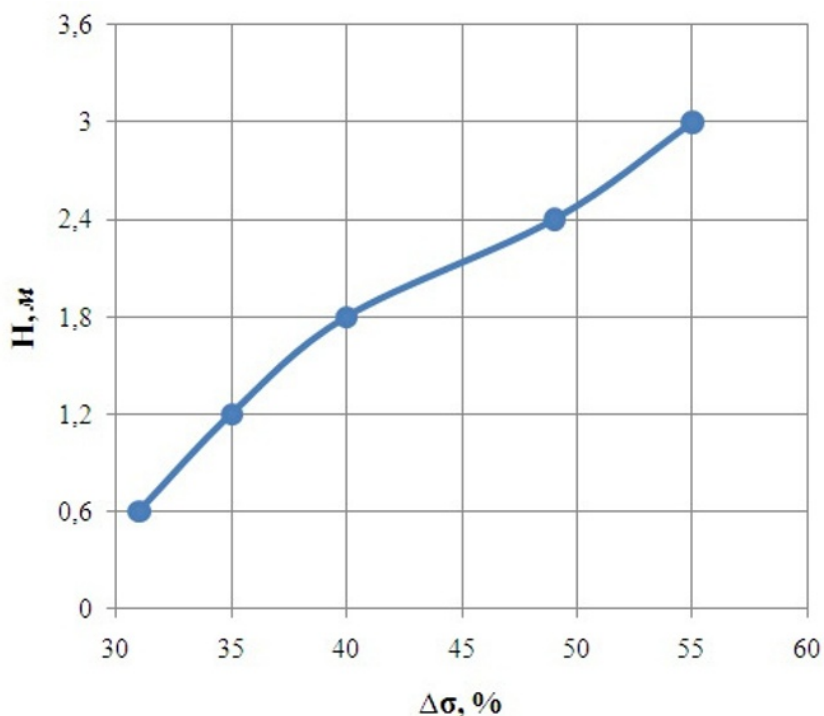
**Fig. 4.** The schedule for reducing the strength of silica brick at the height of the wall.

According to the test results, we can conclude that the decrease in the strength of silicate brick along the height of the wall occurs unevenly.

This is due to the fact that the indoor temperature during a fire is higher in the floor than in the floor. The test results are shown in table. 2

For greater clarity, according to the table.2 is a graph of the decrease in strength of silicate brick along the height of the wall (Fig. 4).
