# Slope Stability and Erosion-Sedimentation Analyses Along Sub-watershed of Muara Bangkahulu River in Bengkulu City, Indonesia

Department of Civil Engineering, Faculty of Engineering, University of Bengkulu, 38371 A Bengkulu, Indonesia.

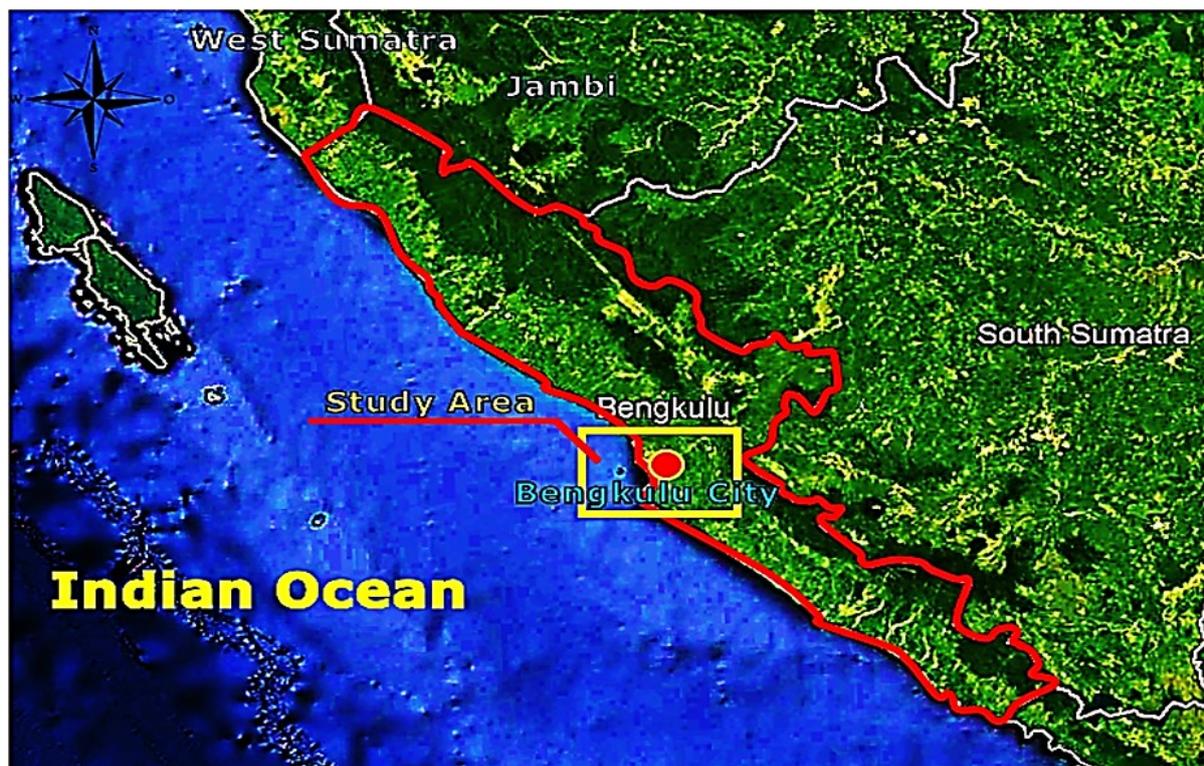
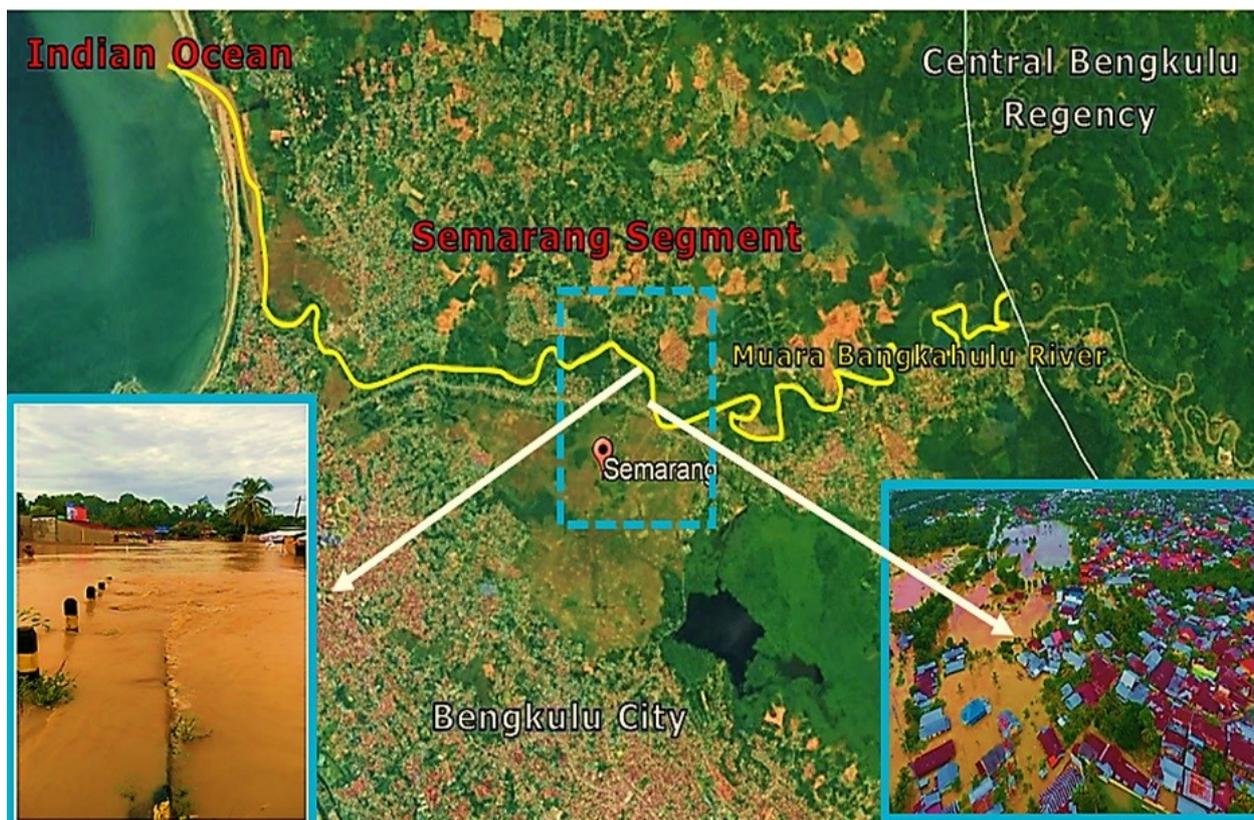
**Fig. 1.** Flood in Bengkulu City on 28-29 April 2019 (a) location of study area (b) Muara Bangkahulu Sub-watershed

Bengkulu City (Figure 1) is a capital city of Bengkulu Province in Indonesia. This city is categorised as one of most vulnerable areas to natural disasters in Indonesia [1]. Several natural disasters such as earthquakes, floods, climate changes, and droughts could happen in this city. Flood is one of most frequently natural disasters which occurs in Bengkulu City every year. During 28-29 April 2019, a high rainfall intensity occurred massively in Bengkulu Province (Figure 2). It was furthermore triggering the flooding in Bengkulu City. This event was later known as the 2019 Bengkulu Flood.

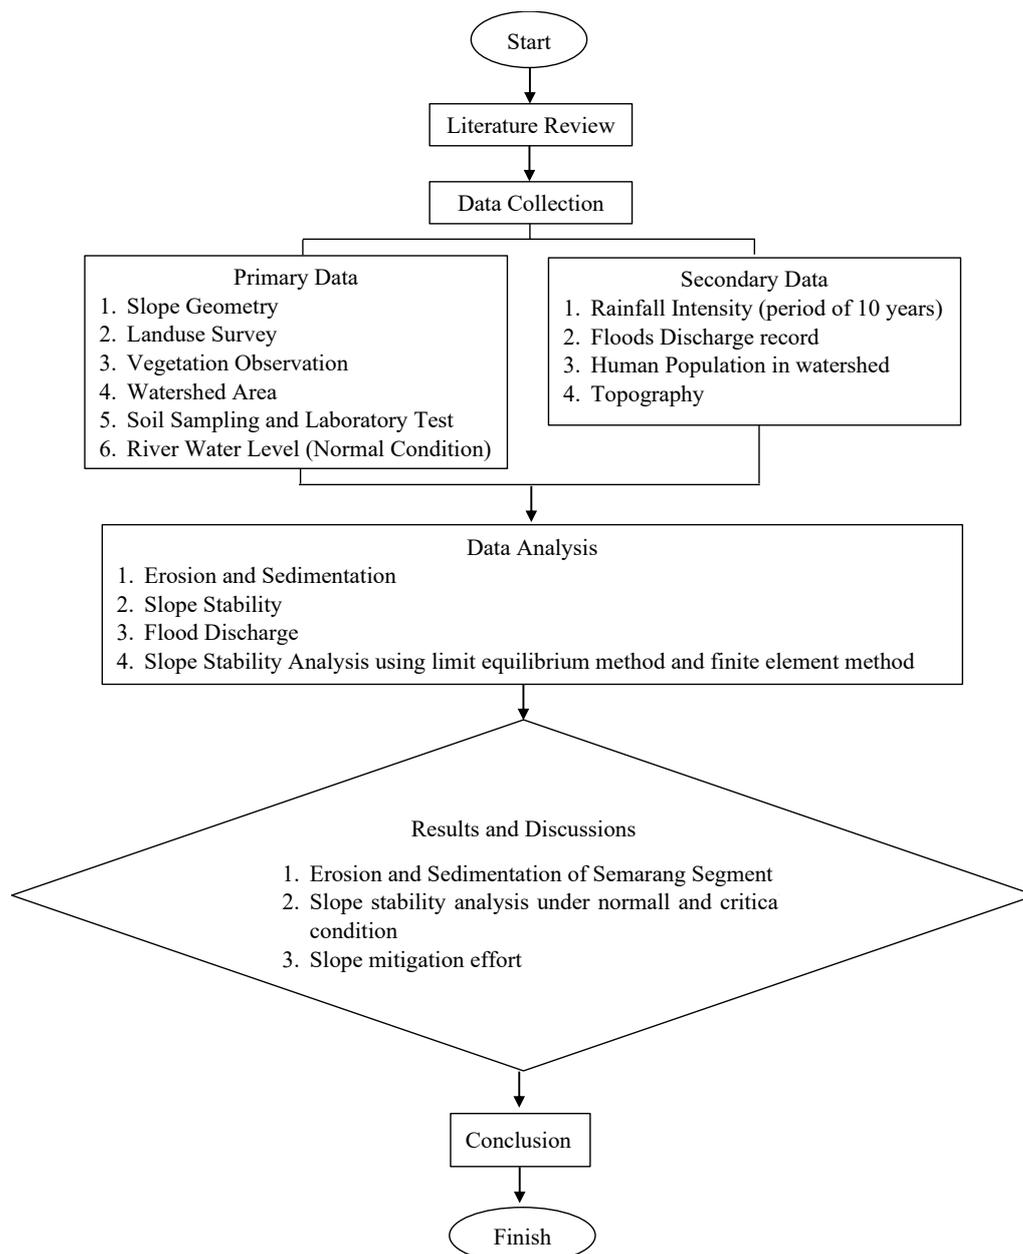
**Fig. 3.** Flow chart of this study

The framework of this study is presented in Figure 3. This study is aimed to investigate the hydrological aspect and slope stability along Muara Bangkahulu River of Bengkulu City, especially in Semarang Segment. This study was initiated by collecting several important data, i.e. primary data and secondary data. The primary data included the slope geometry, the soil properties, and the normal water level (before flood). The slope geometry could be obtained from the site investigation after the flood. The normal water level had been recorded periodically. Therefore, the water level in the normal condition could be obtained. The undisturbed soil sampling was performed along Semarang Segment. 10 cross-sections had been investigated. Furthermore, soil physical properties and soil engineering properties were investigated by performing the laboratory tests. The observation to the erosion and sedimentation characteristics were also performed. The secondary data used in this study were the rainfall intensity in Semarang Segment before the flooding occurred. Rainfall intensity within 10 years, i.e. 2009 to 2018 was used in this study.

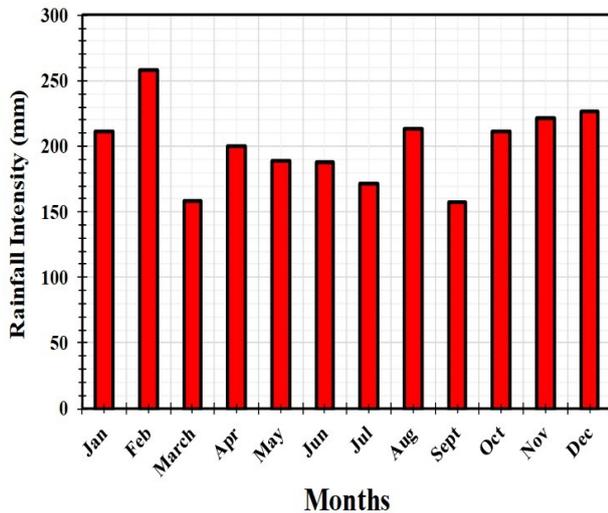
**Fig.4.** The average of monthly rainfall intensity [11]

The average of monthly rainfall intensity is presented in Figure 4. In general, the average monthly rainfall intensity during past 10 years in Bengkulu City is about 200.5 mm. The maximum rainfall intensity occurred in February, whereas the minimum one occurred in September. In this study, the rainfall intensity was used to estimate raining erosivity [22] or *R* by this following equation,

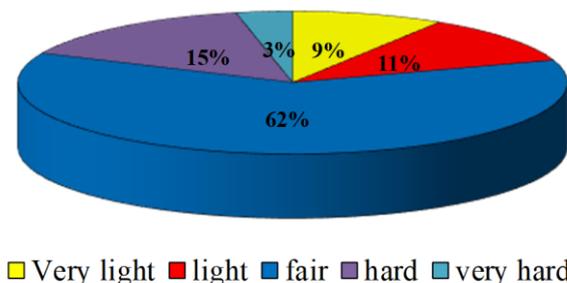
**Fig. 5.** The distribution erosion level in Semarang Segment (in percentage)

In general, the erosion occurred in Semarang Segment varied from very light to very hard. Based on the figure, it can be concluded that the level of erosion in Semarang Segment can be generally categorised as fair level.

In this study, soil conservation actions included soil benching, grass vegetation, soil cultivation, and no conservation actions were observed in Semarang Segment. Based on the analysis, the average annual soil loss in Semarang Segment is about 7.380 ton/acre or 120.992 ton/year. Percentage of erosion level in Semarang Segment is presented in Figure 5.

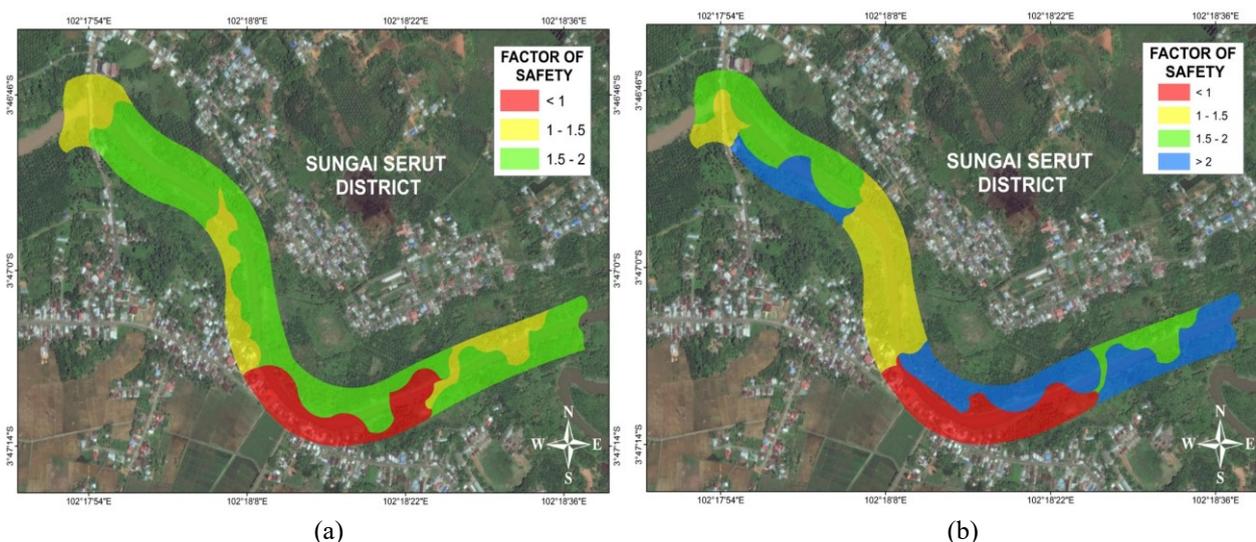
**Fig. 6.** The microzonation map of *FS* in Semarang Segment under normal water level condition (a) limit equilibrium method (Simplified Bishop) (b) finite element method

The results of slope stability analysis were then interpreted in microzonation map. Figure 6 presents the microzonation map of *FS* under normal water level in Semarang Segment resulted from limit equilibrium method and finite element method. In general, both methods showed that the unsafe to critical area (yellow to red shading) was spreading in the southern part of Semarang Segment, especially in the meander side. This zone was relatively critical to sedimentation and erosion. The erosion and sedimentation could result in the damage of soil structure which was able to reduce soil shear strength. Figure 6 also showed that the housing areas were generally centralised on this vulnerable zone. Figure 7 presents the microzonation of *FS* due to critical water condition. In general, the vulnerable zone to slope failure due to the critical water level are larger than the normal water level. Based on the analysis, the area would be more vulnerable to undergo slope failure could be found on the southern part of Semarang Segment, the middle part of Semarang Segment, the northern part of Semarang Segment, and the western part of Semarang Segment. Both methods generally showed the similar tendency in terms of the vulnerable zone. The results showed that during the flood, the housing area would be vulnerable to undergo slope failure. The results also recommended the local government to consider the slope failure in this segment. Figure 8 presents the microzonation maps of deformations in Semarang Segment under normal water level condition and critical water level condition. In this study, the maximum deformation is generated from the slope stability analysis using finite element method. Figure 8 was also separated two zonations i.e. the moderate deformation zone and high deformation zone. The moderate deformation zone was destined for the deformation ranging from 1 to 2 m, whereas the high deformation zone was for the deformation larger than 2 m.

In general, under the normal water level condition, Semarang Segment was vulnerable to undergo large deformation especially in the eastern and northern parts of Semarang Segment. This was due to the fact that in this zone the loose material transported are very critical to undergo slope failure. In addition, the sloping topographical condition in this section is relatively steeper than other slopes around Semarang Segment. Therefore, the maximum gravity force was relatively larger and it could lead to the slope failure in this area. Under the critical water condition, the large deformation could happen in the middle part of Semarang Segment. During the flood, the river stream tends to scrape away the soil particle on the slope. It would be a path for the

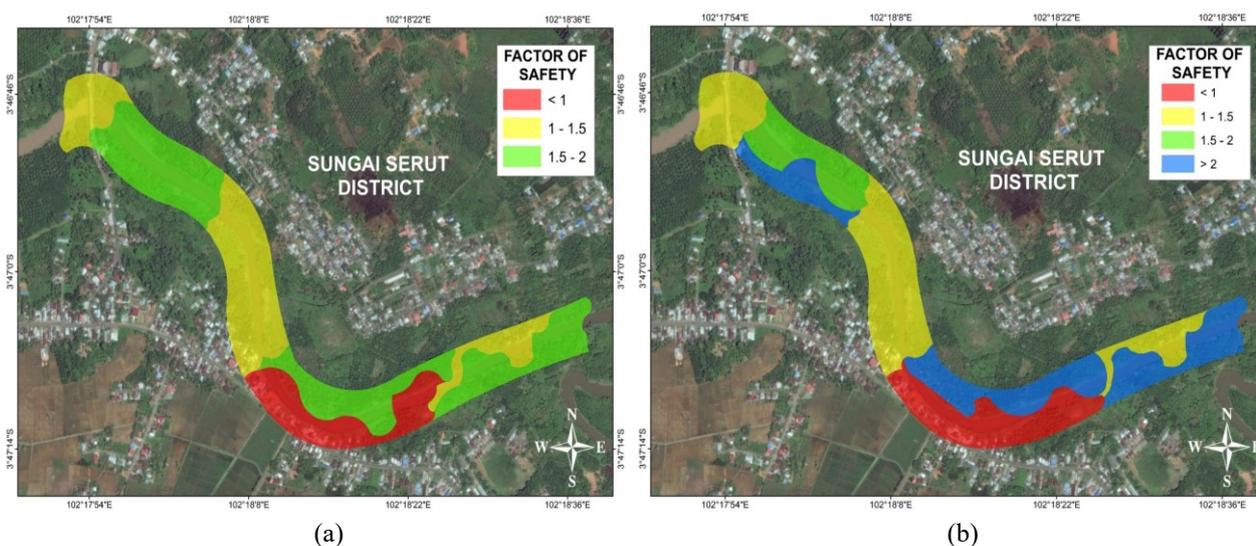
**Fig. 7.** The microzonation map of *FS* in Semarang Segment under critical water level condition (a) limit equilibrium method (Simplified Bishop) (b) finite element method

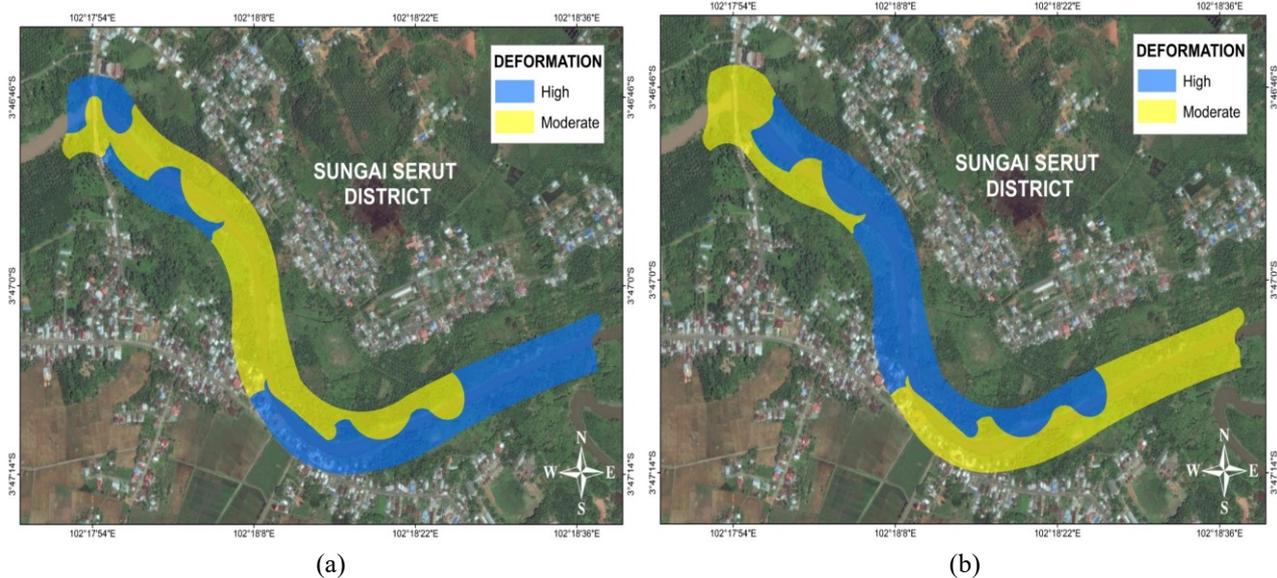
**Fig. 8.** The microzonation map of maximum deformation in Semarang Segment under (a) normal water level condition (b) critical water level condition

For other areas, the steeper slope tends to be more difficult for the infiltration. It might be the reason why the deformation in the northern and eastern parts of Semarang Segment is relatively moderate during the critical water level condition. Overall, the results of finite element analysis describe that the housing areas in Semarang Segment could undergo the significant soil damage in terms of maximum deformation on both water level condition. The implementation of slope stability analysis based on the hydrological analysis output, which is combined to the geotechnical analysis could describe slope stability in this area. The results of this study could help the local government to reduce the possible impact of slope failure due to flood in the Semarang Segment of Bengkulu City, Bengkulu, Indonesia.
