A new formulation of the protective coating for historical monuments

Mohammadia School of Engineers (L3GIE Laboratory), Mohammed V University, Rabat, Morocco

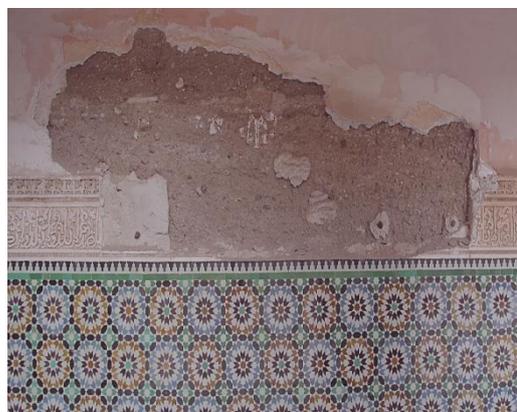
Fig. 1. Detachment of the plaster

Rainwater enters through the exterior facades as well as through the terrace, it is absorbed by the wall in rammed earth and solid brick whose thickness reaches up to 1.20m in some places, over time, a gravity flow of water is carried out at inside the wall to the base sound or it removes it as moisture, Fig. 1, this leads to erosion of the wall and a peeling of the coatings.

The repetition of this mechanism leads to a heterogeneous erosion of the supporting walls, whose thickness decreases over time and consequently their resistance to compression, in fact, a study was carried out on the durability of the rammed earth showed that, under conditions or annual precipitation is about 1000 mm, erosion of unstabilized rammed earth walls can reach 7mm after 20 years [11].

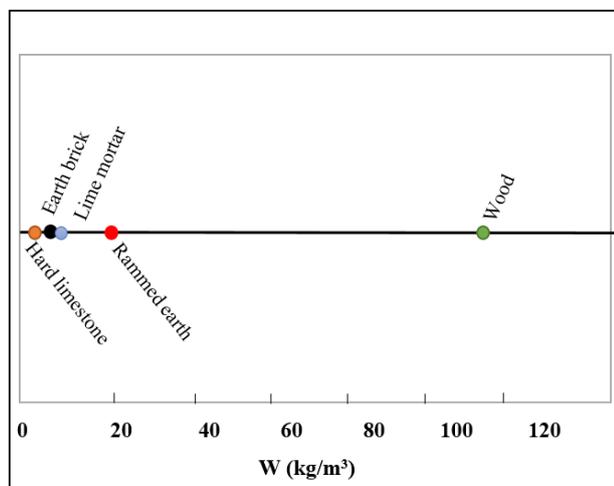
Fig. 2. Hygroscopicity of old materials (source: The notebooks "HYGROBA")

Also, it should be noted that the old materials in general and mainly the rammed earth, have a very important capillarity, nevertheless, the solid brick has a low capillary character compared to the rammed earth [12].

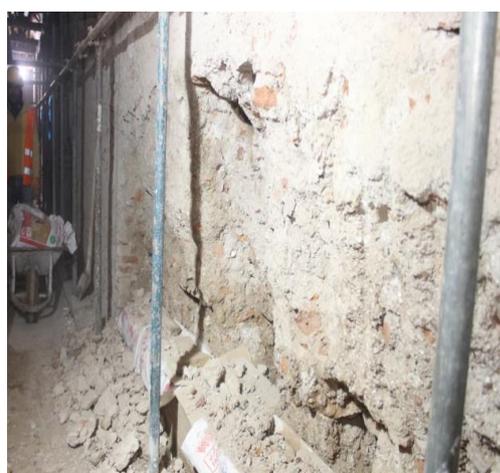
Fig. 3. Swelling and erosion of the foot of adobe walls

Another mechanism of degradation develops inside the building, swelling of the foot of the walls and erosion, this is the result of moisture caused by the hair up as well as by the ambient humidity, in fact, the building has a very architecture closed in some places which decreases homogeneous aeration and therefore does not promote the evaporation of the water stored by the walls.

The water content test carried out on the rammed earth in place gave an average water content of 25.6, this confirms the hygroscopic character of the rammed earth, Fig. 3.

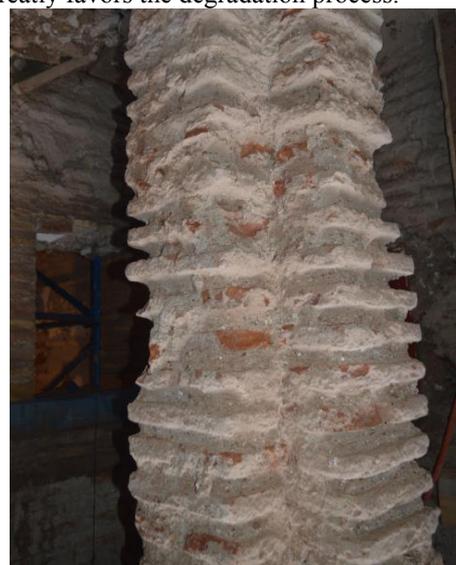
Fig. 4. Tampering of the solid brick at the low front of a pole

On the solid brick walls, the same pathologies mentioned above are noticed but in a less serious way, other pathologies and deformations of the brick facings are observed, often related to problems of humidity, are the blooms and the damage due to frost, Fig. 4, remember that the climate of the city of Marrakech is an arid climate where the monthly extreme temperature

varies between 16 ° and 45 ° in certain periods [14], which greatly favors the degradation process.

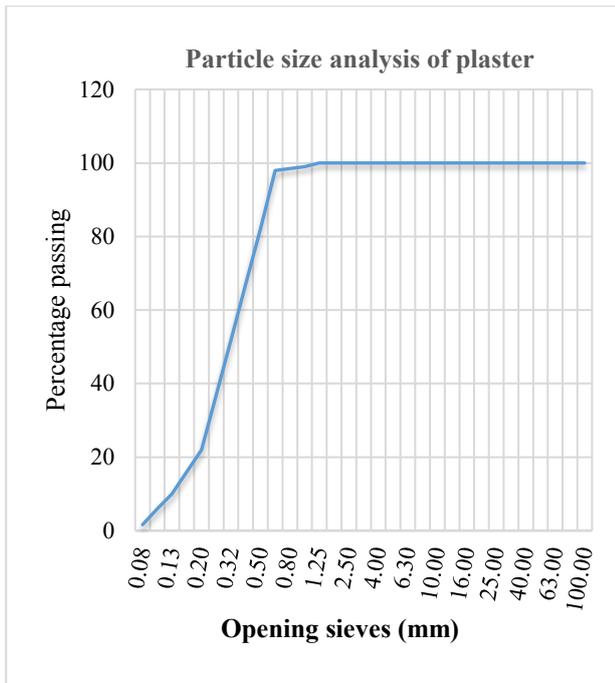
Fig. 5. Particle size analysis of plaster

The granulometry is an important parameter that influences the mechanical properties of plaster as well as its hydration [15]. The plaster used comes from Marrakech, and by analyzing the granulometry curve of our sample, we find that it has a tight grain size. Density, tensile strength and compressive strength are listed in the Table 2.

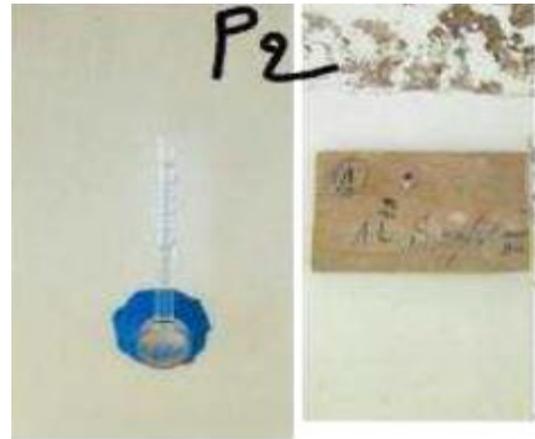
Fig. 6. Water absorption test at Karsten tube (the test carried out in situ).

The Karsten tube penetration test is a simple test to measure the degree of water penetration into building materials. The test consists of a glass tube filled with water linked to the material to be tested with plastic. The water pressure then exerts on the surface. A graduated scale indicates, over time, the amount of water or penetration into the surface Fig. 6.

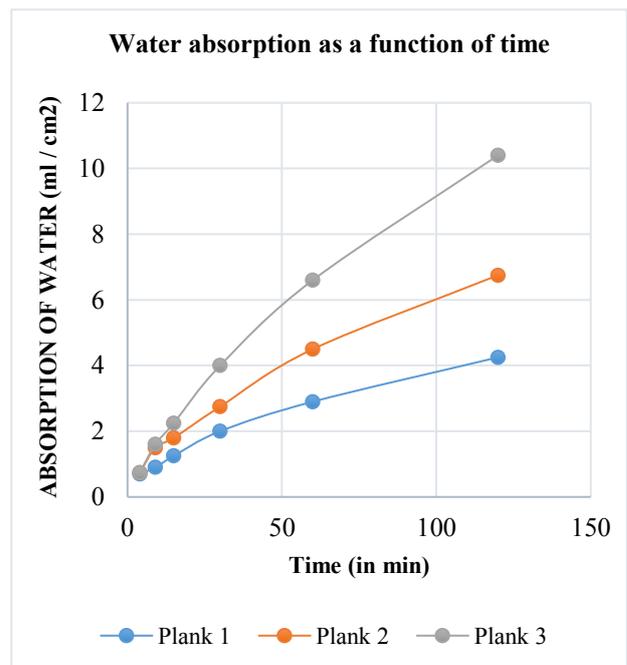
Fig. 7. Water absorption as a function of time

Through this trial, we found that the addition of adjuvants significantly improves the waterproof effect of the coating, after one hour, the mixing of plaster with Sika latex has reduced absorption by about 32% compared to the mixture of the plaster with the Sika waterproof mortar, Fig. 7.

After two hours, mixing the plaster with the Sika latex reduced the absorption by about 38% compared to the mixture of plaster with the Sika waterproof mortar, this reduction arrives up to 58% with the combination of plaster, Sika waterproof mortar and Sika latex.

- Mixing Sika latex with plaster has allowed the absorption by about 32% compared to the mixture of plaster with Sika waterproofing mortar.
- After two hours, mixing the plaster with the Sika latex reduced the water absorption by about 38% compared to the mixture of plaster with the Sika waterproof mortar, this reduction arrives up to 58% with the combination of plaster, Sika waterproof mortar and Sika latex.
- Initial water absorption is very important for the sample not treated by the liquid adjuvant "TECHNIPLATRE", therefore it is more sensitive to

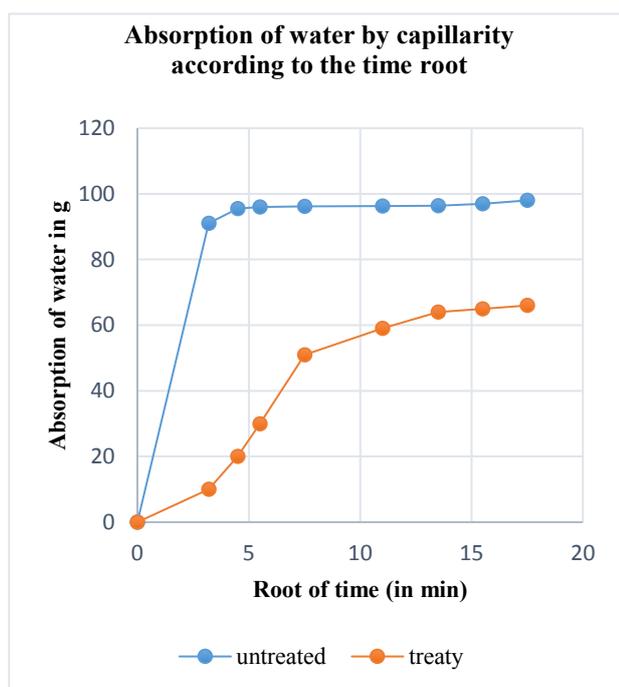
Fig. 8. Absorption of water by capillarity according to the time root

The water absorption test by capillarity was carried out on 4x4x16 cm³ specimens, measuring water absorption under the effect of capillary forces.

The method is based on the direct measurement of the capillary ascent of a liquid. The flat side of the slightly submerged sample is placed on the surface of the water to measure the amount of water absorbed according to the root of time.

On the graph, Fig. 8, we find that the two curves obey the same laws, all the time, the addition of the adjuvant has reduced the absorption of water by 45% after one hour of exposure and 31% after 5 hours of exposure.

Another parameter can also be deduced from this test, in fact, by analyzing the evolutionary curve, we find that it consists of two segments on the right:

- The first, fairly steep slope characterizes the initial water absorption A_{bi} . This water is held by the capillaries of larger diameters located on the surface. Generally this absorption is recorded during the first hour of the test [16]. Initial absorption refers to the mass of water absorbed after one hour; this value is sufficiently representative of the average radius of the largest capillaries [16].
- The second phase of low-slope absorption characterizes the filling of the increasingly thin capillaries. The slope of this part determines the

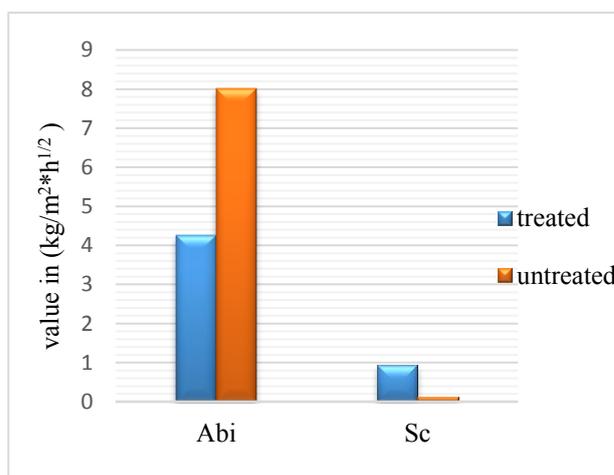
Fig. 9. Initial water absorption and sorptivity of prepared samples

On the graph, Fig. 9, we find that the initial water absorption is very important for the untreated sample by the adjuvant, this reflects the volume of the larger capillaries it contains, indeed, the initial absorption is a representative parameter of the size of the large capillaries [18]. Therefore, the untreated sample is more sensitive to the penetration of aggressive agents, which influences its durability [19].

In the second phase, the untreated sample has a greater sorptivity than the treated sample, this may mean that the addition of the adjuvant tends to slow down the kinetics of water absorption within the microstructure pores, let us recall in this sense, that some studies have shown that sorptivity is influenced not only by porosity but also by the distribution of pores [20].
