The mudflow dynamics of the river Gerkhozhan-Su in the section of the mudflow tray and mudslides protection of the city of Tyrnyauz (Central Caucasus)

Abstract. Based on the data of route inspection and video surveillance of the mudslides of the river Gerkhozhan-Su have been determined the features of the mudslides dynamics in the section of the mudflow tray. Areas of temporary mud accumulation were revealed, over which waves of mudflow periodically passed. Streams rushed through the tray at a speed of 9-12 m/s. The protective role of the mudflow tray and the need for its timely clearing of the mudflow deposits have been highlighted to ensure the anti-flood safety of the city of Tyrnyauz.

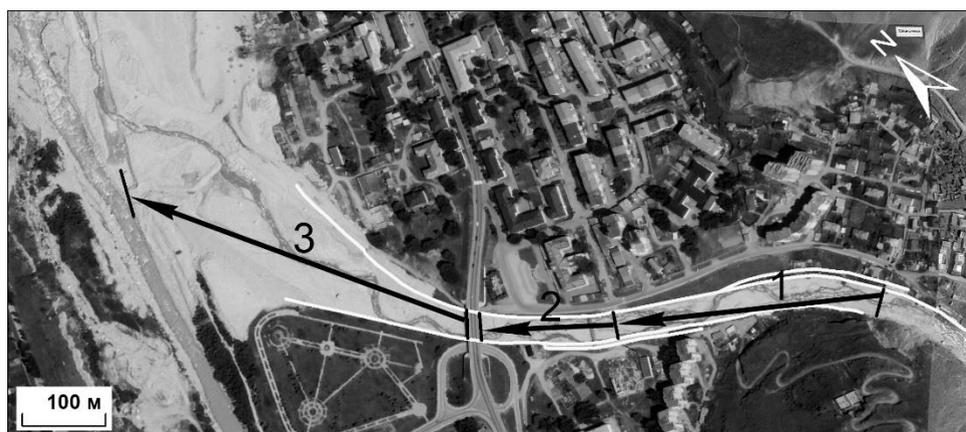
In total, three videos were selected: <https://www.youtube.com/watch?v=K10x70gUd3k>, <https://www.youtube.com/watch?v=df6pIO2eEo8>, <https://www.youtube.com/watch?v=8f6R3W0jflE>, on which the passage of mudflows on three sites of the tray, the boundaries of which can be clearly identified on the satellite image, is recorded to evaluate distance traveled by mudflow (Fig. 1)

Fig. 1. Sections of mudslide's velocity measurement in the mudflow tray on the satellite photograph 25.08.2018

Results of mudslides speed measurement on sections of mudflow tray are presented in the table.

<i>№ of section</i>	<i>Distance[m]</i>	<i>Time [s]</i>	<i>Speed [m/s]</i>
1	325	31	10.5
2	160	13	12.3
3	540	55	9.8
3	540	48	11.3

Thus, after each mudflow (according to mudflows of 2011 and 2017) on the end of section №1 of the mudflow tray (see. fig. 1), thickness of the mud deposits increases by 1.5 m. Mud also accumulates in the section №2 of the tray. Part of this section after the mudflow of 2011 and after clearing of the mud deposits (the sediment level is decreased by 2.0 m) is shown in the fig. 4.

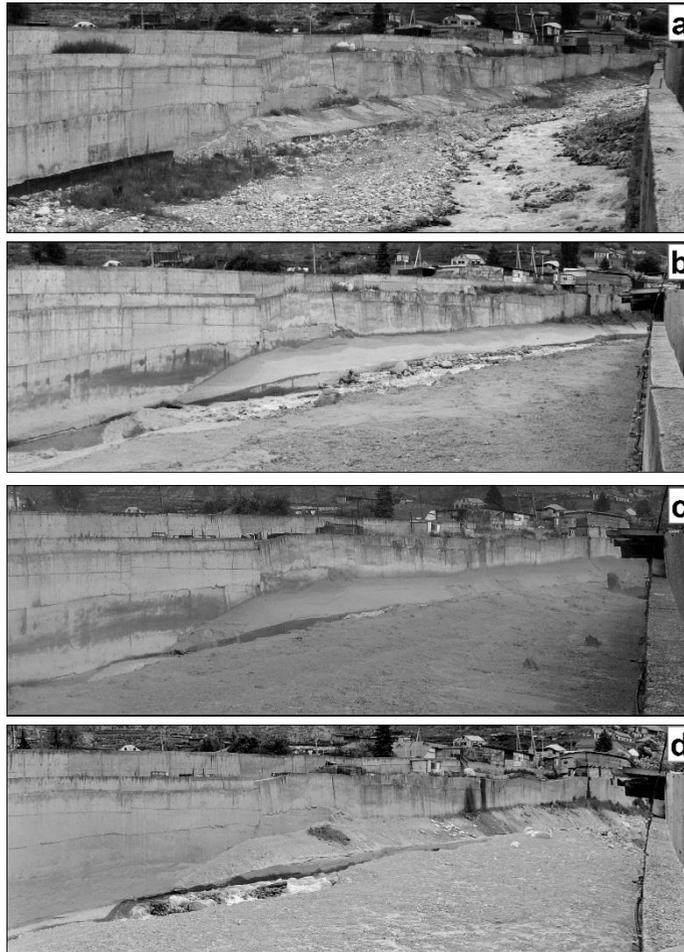
The examination of photographs of different years on sections of the tray before and after mudflows allowed us to identify differences in the dynamics of mudflows. In fig. 2 the upper part of section №1 of the tray before and after the mudflows of 2011 and 2017 is shown. (See fig. 1).

Fig. 2 shows that the level of mud deposits in the tray after the mudflows of 03.08.2011 and 15.08.2017 was almost the same. The marks of passing mudflows on the walls of the tray were at the same level. It can be concluded that mudflow spread in this section was the same, and the height of mud waves was up to 1.5 - 2.0 m. The mudflows passed this section in transit mode. Only closer to the middle of the area at the bottom of the tray a temporary deposition of mud occurred, and the level of marks from mudslides on the walls of the tray became higher.

Fig. 2. Condition of the upper section of the tray before and after mudslides:
a – 11.08.2010, *b* – 03.08.2011, *c* – 15.08.2017, *d* – 09.06.2018

The video data (<https://www.youtube.com/watch?v=Kl0x70gUd3k>) indicates that the deposits of mud did not exit the liquid phase and was just a mudflow that stopped for a while. The following mudflow waves streak its surface and set in motion the deposited mud. It sways, but remains in place. Subsequently, by the end of the mudflow process, the temporary deposited mud is carried away from the tray by the post-mudflow flood or by an even more powerful mud wave.

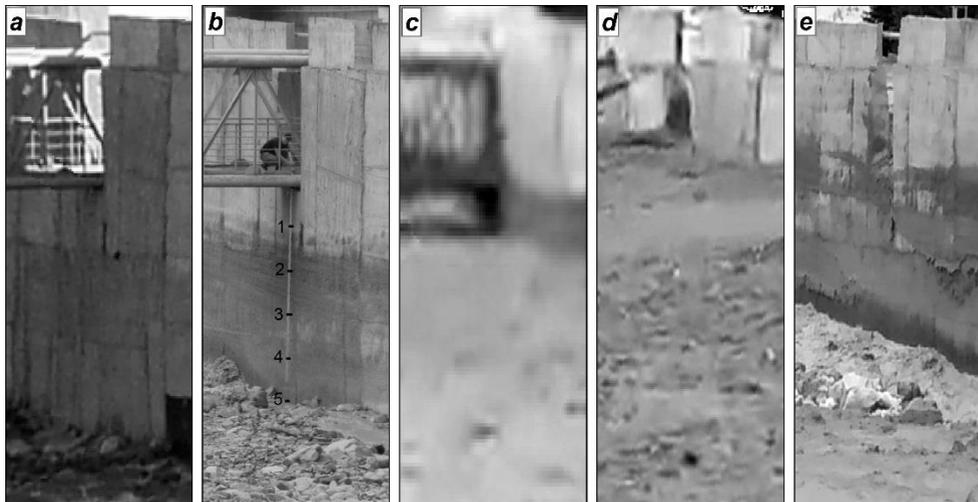
In fig. 3 a part of the pedestrian bridge across the mudflow tray (the end of section №1) is shown. From the comparison of photographs and video footage, several conclusions can be made:

- 1) the level of mud deposit in the tray under the bridge after the mudslide on August 3, 2011 (fragment *b*) had increased by 1.5 m;
- 2) after the mudflows on August 14-15, 2017, the level of mud deposits had increased by another 1.5 m (fragment *e*);
- 3) before the destruction of the pedestrian bridge, the thickness of mud deposit was 4.0 m and gap of 1.0 m remained under the bridge (fragment *c*);
- 4) the mudslide, which destroyed the bridge, swept through previously accumulated mud and was 1.5 m high (fragment *d*);
- 5) at the end of mudflow, the level of mud in the tray had lowered by 2.5 m (fragment *e*).

Fig. 3. The right wall of the mudflow tray on the section of the pedestrian bridge:

a - 28.06.2008, *b* - 04.08.2011, *c* - 14.08. 2017 before the destruction of the bridge by mudflow, *d* - 14.08. 2017 at the time of the destruction of the bridge, *e* – 15.08.2017 (*a*, *b*, *e* - photo by M.D. Dokukin, *c*, *d* - frames of the video)

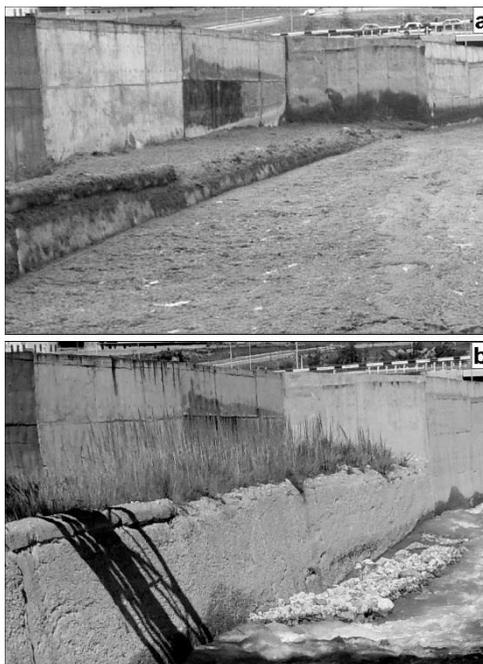
Fig. 4. Left wall of the mudflow tray in the middle of section №2: *a* – 04.08.2011, *b* – 31.07.2014 (photographs by M.D. Dokukin, view from pedestrian bridge)

After the mudflows of 2017 in the section of the tray, pictured in fig. 4, the thickness of mud deposits increased a little more after the mudslide of 2011 (fig. 5).

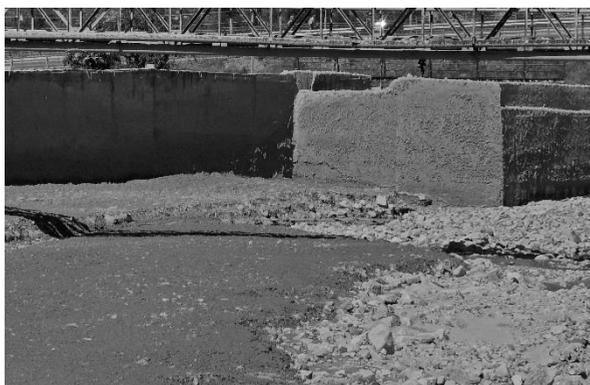
Fig. 5. Section of the mudflow tray with mud deposits 2017 (photo by M.D. Dokukin 22.08.2017)

Due to the fact that the mud mass was deposited in the tray, mudflows with a relatively low front in 2017, by hitting the transverse projection, overflowed through the wall of the tray in the area shown in fig. 5.
