Comprehensive approach to the restoration of historical and cultural monuments (example of the mansion of A. A. Polovtsov)

Analysis of the practice of restoration design and protection of cultural heritage. Engineering aspects of restoration of structures in the interior using the example of one interior of the building of the mansion of A.A. Polovtsov ("House of the Architect") located at the address: B. Morskaya street, 52, Saint Petersburg.

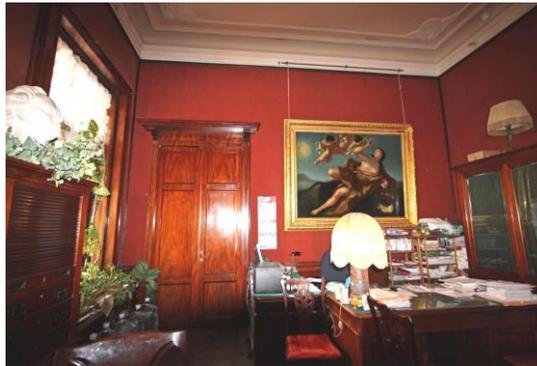
Fig. 1. General view. The studied room before restoration. Saturated with decorative fabrics and wood paneling on the walls.

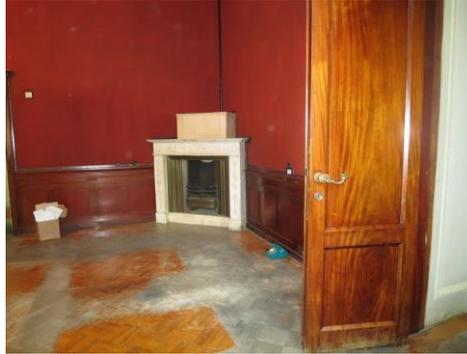
Fig. 3. General view after the removal of furniture. The walls are covered with decorative fabric. The lower part of the walls is decorated with panels. Floor - glued-laminated parquet.

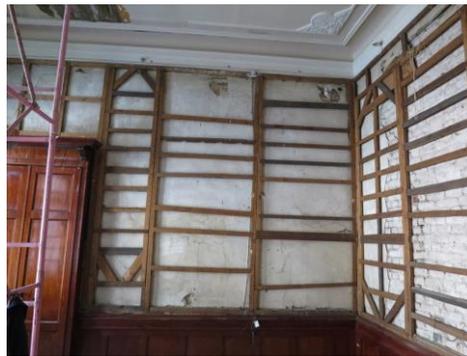
Fig. 4. View after dismantling decorative fabric. A wooden frame is visible. There are cracks in the masonry and crumbling plaster.

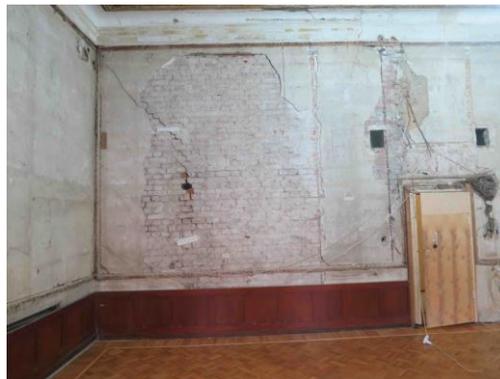
Fig. 5. View after dismantling the frame. The crack in the brick wall is clearly visible.

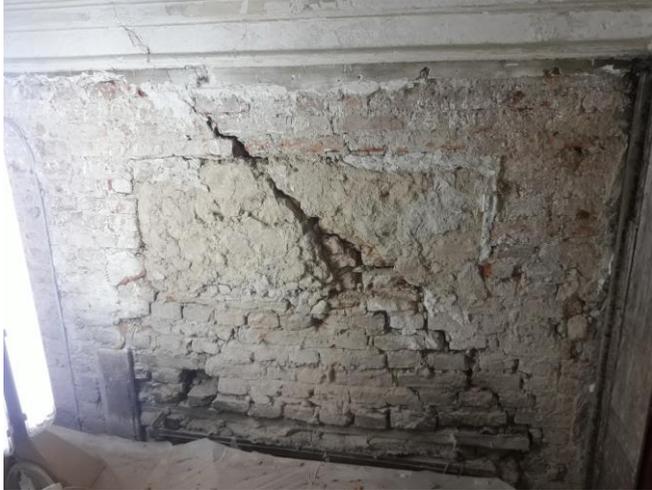
Fig. 6. View of the lintel of the doorway after removing the plaster. A structural crack and masonry destruction are visible. The wall sank and rested on the door filling.

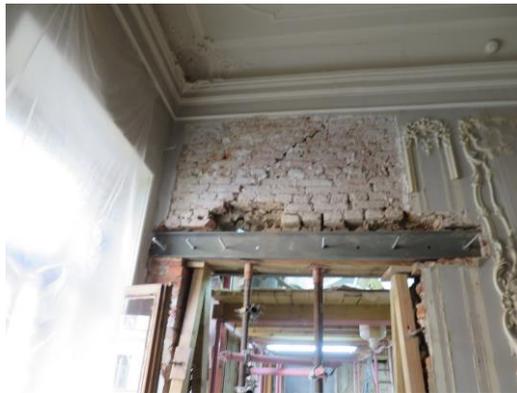
Fig. 7. View of the lintel during masonry reinforcement.

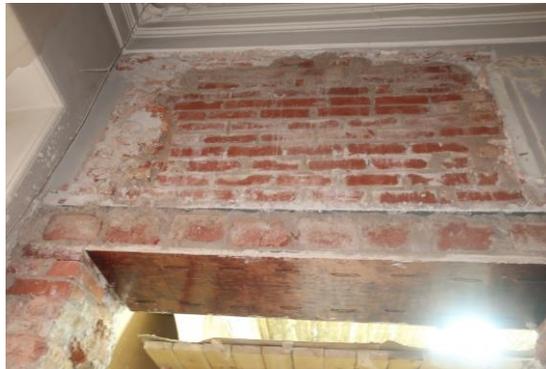
Fig. 8. Reinforcement of the lintel with the repair of brick.

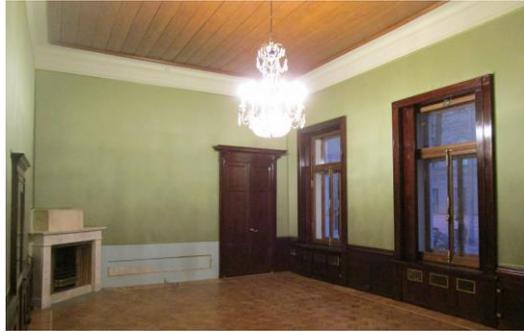
Fig. 9. View after restoration of the “Dressing room” interior.

According to the results of restoration work, 0.3 m³ of voids and broken channels were laid in the walls. The walls are completely re-laid with the addition of new material in a volume of 6 m³.

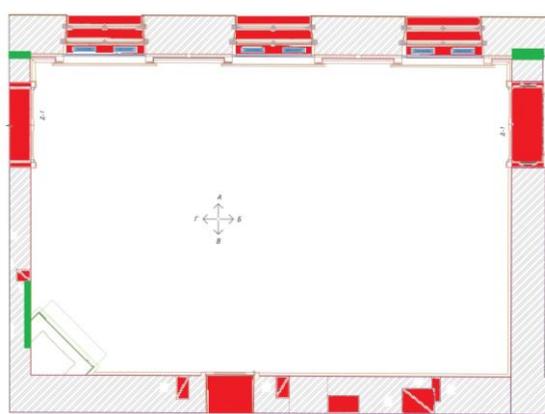
Fig. 10. The drawing showing the walls, smoke and ventilation ducts, door and window openings (indicated in red).

Figure 10-11 shows a horizontal section of the room indicating smoke shafts, ventilation ducts and places for cutting walls for installation of heating pipes (- 33% of the total wall area). In total, ventilation ducts and cutting walls for the heating system - approximately 6%. The drawing does not take into account the weakened masonry of smoke shafts made on clay mortar.

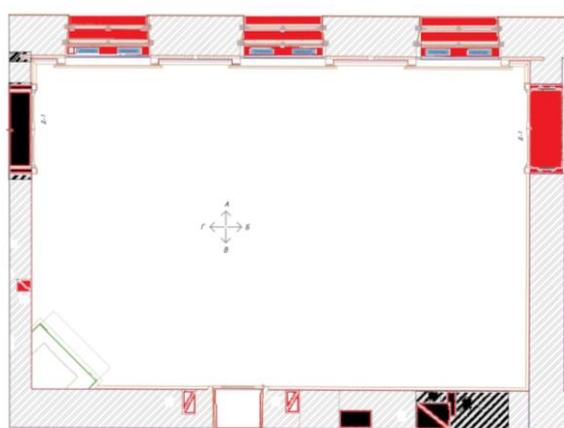
Fig. 11. The volume of re-laid and replenished brickwork during restoration work is shown in black.
