# Seismic damage mechanism of slope and lining in the mountain tunnel portal section

**Abstract.** A series of numerical simulations were conducted to study the seismic response in the mountain tunnel portal section. The seismic damage mechanism, including slope cracking and landslide, rockfalls and collapse, and lining cracking were analyzed based on the seismic damage characteristics of the Longxi tunnel during the 2008 Wenchuan earthquake in China. The results show that slope cracking due to the huge horizontal seismic inertial force which exceeds the strength of slope; landslide is caused by the connected cracks where the oblique component of horizontal seismic inertia force exceeds the shear strength of slope; rockfalls and collapse are caused by the cumulative tensile stress in loose soil and rock which exceed the strength of slope; the transverse lining cracks due to the alternate tensile and compressive action of the seismic load along the axial direction, which makes the lining tensile strain accumulates and exceeds the concrete ultimate strength. As for the longitudinal lining cracking, the transverse seismic load makes the bending moment direction in lining alternates,

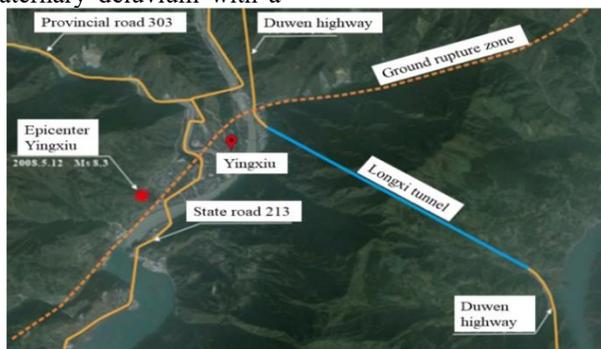
Figure 1. Location of the Longxi tunnel

The portal of the Wenchuan end of the Longxi tunnel is only 4 km away from the macro epicenter of the 5.12 Wenchuan earthquake in China (Figure 1). The tunnel is 3658 m long and belongs to an extra-long tunnel. The soil layer of the slope is a quaternary deluvium with a

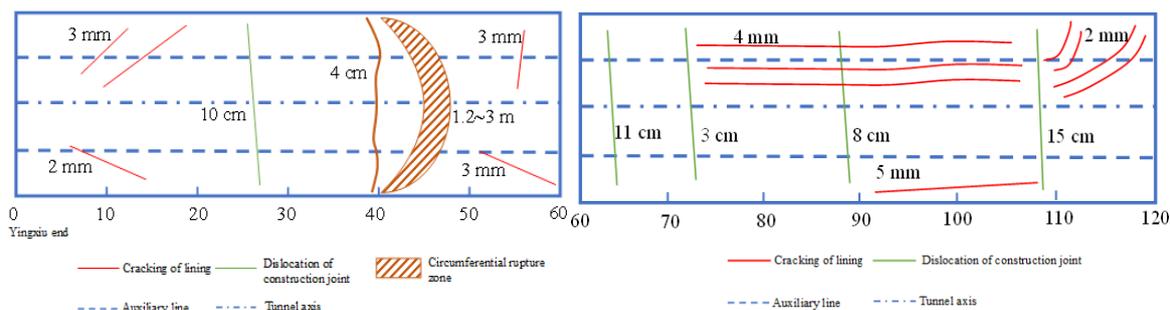
Figure 2. Surface development of lining damage at the Longxi tunnel

thickness of several meters to more than ten meters. The vegetation on the surface is dense and there are no adverse geological phenomena such as landslides and collapse. The angle of the slope is about 35°. The tunnel axis obliquely intersects with the slope. Seismic damage on the slope at the tunnel portal of mainly includes slope cracking, collapse, rockfalls, etc.; lining damage mainly includes horizontal and vertical cracks, surface peeling, staggered platforms, and circumferential rupture zones (Figure 2).

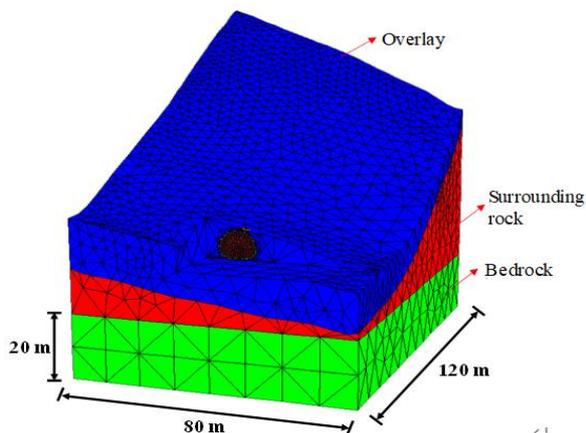
**Figure 3.** Numerical model of the portal section

With full consideration of the terrain and geological conditions, the finite-difference software FLAC3D was used to establish a 120 m severely damaged portal of the Longxi tunnel. A three-dimensional numerical model was established for seismic calculation and analysis. The model has an axial length of 120 m, a width of 80 m, and a maximum burial depth of 65 m. The overburden is silty clay and gravel soil, and the depth of the rock mass

below is 35 m. The lithology is mudstone (Figs 3 and 4). The typical cross-section parameters of the lining are adopted. The support is C20 shotcrete with a thickness of 20 cm; the lining is C25 concrete with a thickness of 40 cm.

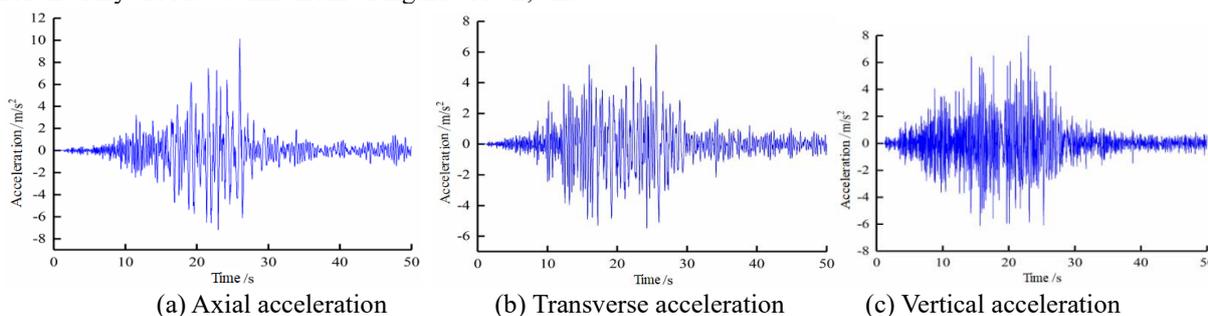
**Figure 5.** Acceleration time-history of Wolong wave at three directions

The Wolong seismic record with a duration of 50 s was recorded during the 2008 Wenchuan earthquake in China, and the acceleration time-history after filtering and baseline correction is shown in Figure 5. The Longxi tunnel is only about 4 km from Yingxiu Town, the

epicenter of the Wenchuan earthquake. Therefore, the acceleration time-history of the three directions of the seismic wave is loaded from the model bottom, and the loading intensity is 0.95g. Free-field boundaries are applied around the model. The local damping was performed.

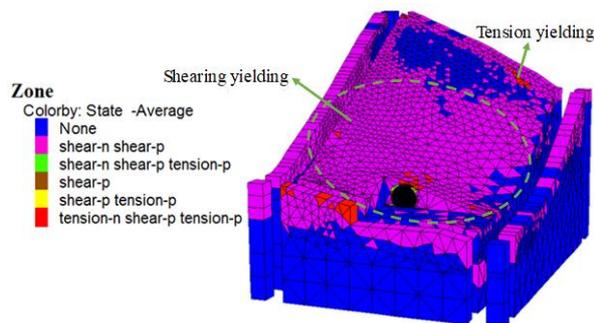
**Figure 6.** Zone state of tunnel portal slope

Figs 6 and 7 show that a large area of shear failure occurred on the slope of the tunnel portal, and the shear and tensile failure area on the near-mountain side was significantly more than that on the other side; the failure mainly occurs in the deluvium and eluvium. Slope cracking is caused by tensile plastic zone on slope surface. According to the field investigation, the slope surface nearing the tunnel portal is generally loose overburden with low strength. Under the seismic horizontal inertial force, the slope surface is subject to tension (Figure 6), which is prone to "tear" the surface to form cracks, especially in original-crack-existing places.

It can be seen from Figure 6 that a tensile plastic zone has been formed locally on the top back of the slope, indicating that the rock masses are subjected to a huge tensile force under seismic inertial forces. Due to the lower mechanical performance and developed joints and fissures of the rock mass the tensile strength is extreme low or even zero. When the seismic wave transmits from the bedrock to the strongly weathered rock masses, its energy can be significantly amplified, causing a larger seismic inertial force. Under the huge tension, the tensile stress in the loose soil and strongly weathered rock mass

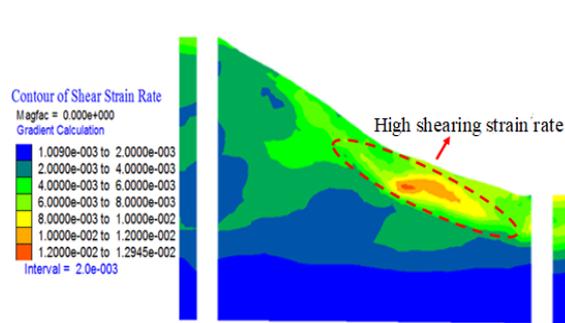
**Figure 7.** Contour of shear strain rate portal slope

It can be seen from the contour of shear strain rate (Figure.7) that the tunnel slope has formed a potential sliding surface under the seismic loading. The landslide is a result of various factors. First, after the forming of surface cracks, the oblique component of the horizontal seismic inertia force makes the slope cracks extend further. Second, with the continuous vibration, the cracks in the slope gradually expand, providing channels for underground water, thus causing a lower shear strength of the loose overburden. Third, with weak surfaces in the slope, the slope may slide along these surfaces [20]. The root is that the oblique component of the seismic inertia force and the slope weight force is greater than its shear strength, resulting in the gradual crack expansion.

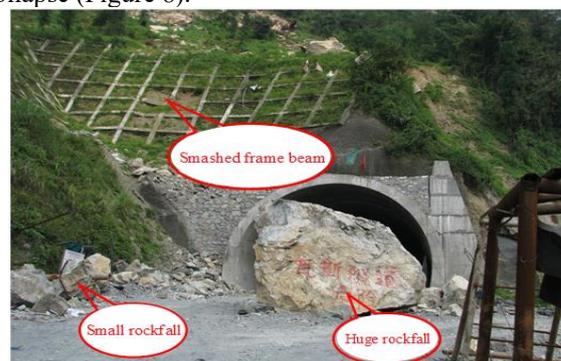
**Figure 8.** Rockfall and broken frame beam

surface can gradually accumulate. When it exceeds the tensile strength of the rock mass and soil itself, they can be thrown to the slope foot, resulting in the rockfall and collapse (Figure 8).

The rockfalls and collapses at the tunnel portal are caused by the continuous and alternate seismic inertia force, and the tensile stress in the loose soil and strongly weathered rock on the slope surface is gradually accumulated. Once exceeding the tensile strength of rock and soil itself, they are thrown to the slope foot.

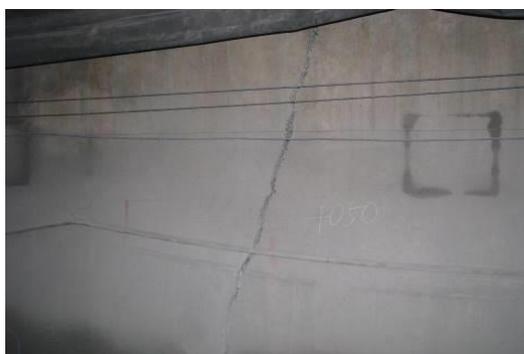
The investigation shows that the lining cracks are transverse, oblique (Figure. 9 (a)) and longitudinal (Figure. 9 (b)). The transverse and oblique cracks are mainly distributed on the sidewall, and the longitudinal cracks are mainly distributed on the vault, arch shoulder, sidewall and arch foot.

(a) Transverse and oblique cracking of the lining

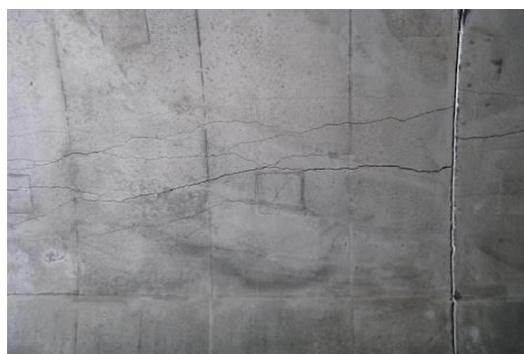
(b) Longitudinal cracking of the lining

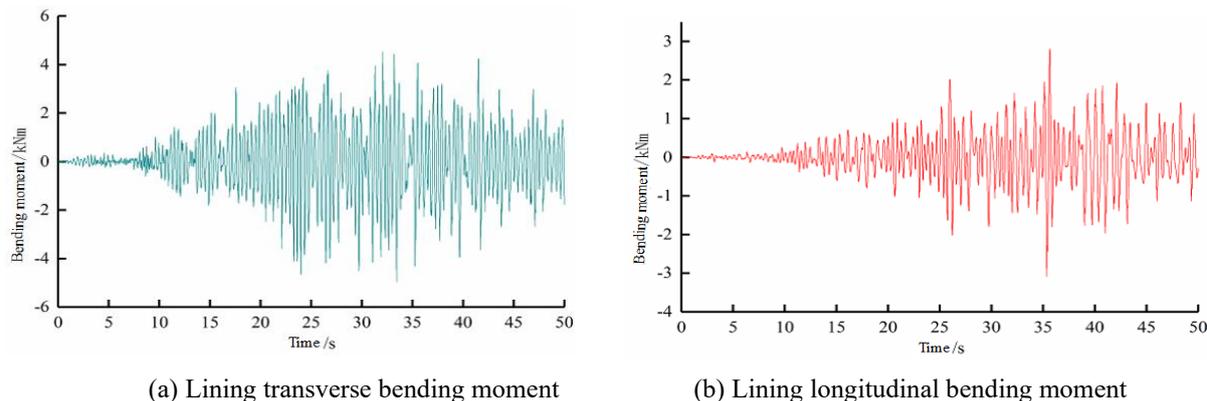
**Figure 10.** Transverse and longitudinal bending moment time history of lining

Figure 10 shows the time-history curve of the bending moments of the lining.

It can be seen from Figure 10 that the vertical and horizontal bending moments vary dramatically, indicating a back-and-forth deformation under horizontal transverse and longitudinal seismic loads.

**4.3.2. Seismic damage mechanism.** According to Figure 10 and the field investigation, the mechanism of lining cracking is that the direction variation of bending moments leads to the alternate changing of the direction of tensile and compressive stress in lining.

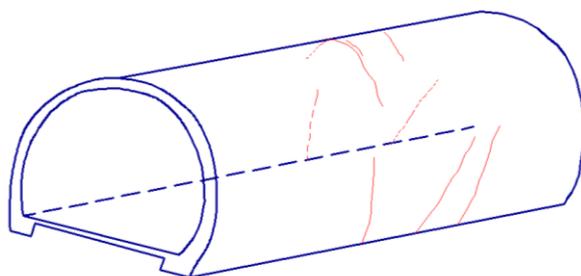
**Figure 11.** Schematic graph of transverse and oblique cracks in the lining

As for the horizontal and diagonal cracks (Figure 11), due to the small epicentral distance, seismic waves transmit through the tunnel at a small angle. S-wave generate an alternate tension and compression along the tunnel axis, or jointly acts with P-wave, thus generating a bending deformation [21] and an accumulated dynamic strain in lining [22]. when the strain of concrete exceeds its limit [23], the transverse cracks occur.

Transverse and oblique cracks of lining are caused by the alternate tension and compression or bending deformation along the tunnel axis, resulting in the strain accumulation in the lining. When the accumulated tensile strain exceeds the ultimate strain of concrete, the lining will crack laterally.

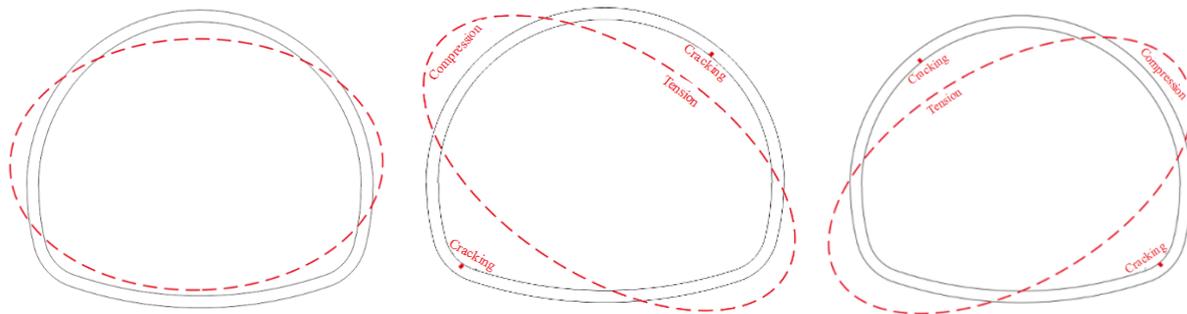
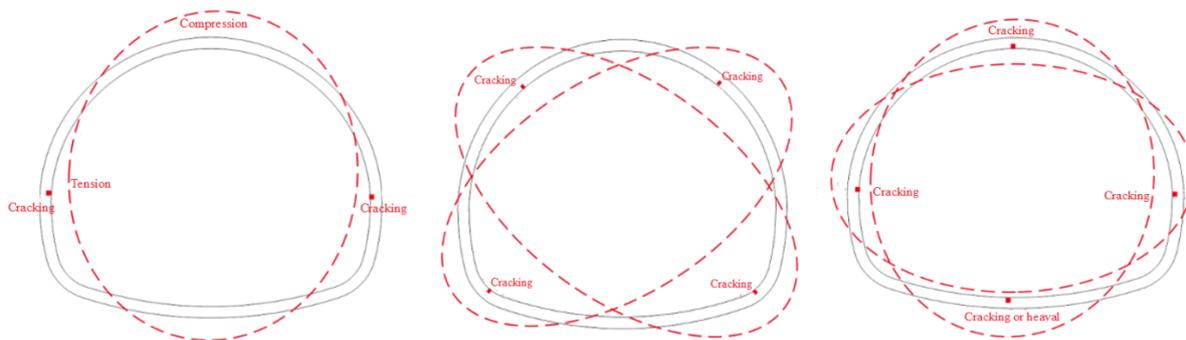
**Figure 12.** Schematic graph of longitudinal cracking of lining

For the longitudinal cracking of lining, the initial stress state of the lining under static loading (weight and surrounding rock pressure, etc.) is shown in Figure 12 (a). Under the transverse seismic loading, additional bending moments with rapidly alternate directions are generated, resulting in the transverse back-and-forth deformation of lining and surrounding rock. The stress mode of lining is shown in Figure 12 (b-d). These transverse deformation modes lead to an additive effect (Figure 12 (e-f)). The vault, arch shoulder, sidewall, arch foot, and invert are

subjected to alternate tension and compression in a very short period of time. On the one hand, the bearing capacity of the concrete reduces significantly; on the other hand, the tensile strain of lining accumulates rapidly. When the cumulative strain of the concrete exceeds the its ultimate strain, it can crack longitudinally [9]. Therefore, the longitudinal cracks of lining are mostly observed on the vault, arch shoulder, sidewall, arch foot, and invert under alternate tension and compression (Figure 13).

(a) Initial state of lining under static load (b) State of lining under transverse bending moment (c) State of lining under transverse bending moment

(d) State of lining under transverse bending moment (e) State of lining under alternating transverse bending moment (f) State of lining under alternating transverse bending moment

The longitudinal cracks of lining at the tunnel portal section are caused by additional alternate bending moments under the transverse seismic loading. When these transverse deformation modes act jointly, different parts of the lining (vault, arch shoulder, sidewall, arch foot and pavement) are subjected to alternate tension and compression in a very short time, which significantly reduces the strength of the concrete and makes it crack longitudinally.

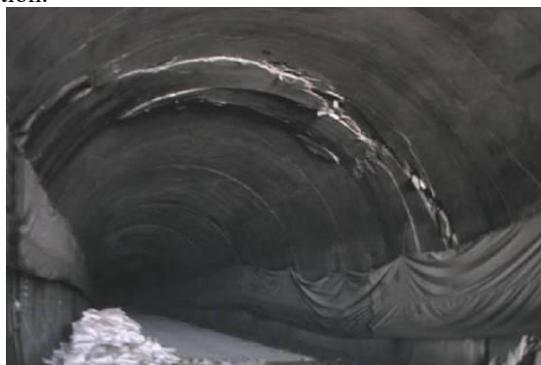
**Figure 14.** Circumferential crack in the bedrock-overburden interface

A width of 1.2–3.0 m circumferential rupture zone caused by the earthquake was observed at 40–45 m from the tunnel portal (Figure 14). As shown in Figure 14, the concrete peeled off and was crushed, the steels bended inward and the width of pavement cracks are 2–4 cm. The attitude of the bedrock-overburden interface is almost identical with the tunnel axis. In order to study the mechanism of the circumferential rupture zone, the principle stresses and shear force are analyzed in this section.

According to *code for design of concrete structures* (GB 50010-2010) [24], the compressive strength of C25 concrete is 16.7 MPa, and tensile strength is 1.78 MPa. Obviously, maximum compressive stress meets the requirements of the strength standard. But many parts of lining of maximum tensile stress exceeds the tensile strength of concrete, thus resulting in the concrete is extremely prone to crack. Especially, in the vicinity of the bedrock-overburden interface, the tensile stress of the vault is the greatest one, followed by the vault, arch shoulder, sidewall, and arch foot. Meanwhile, the cracks extend from the vault to arch foot (Figure 14).

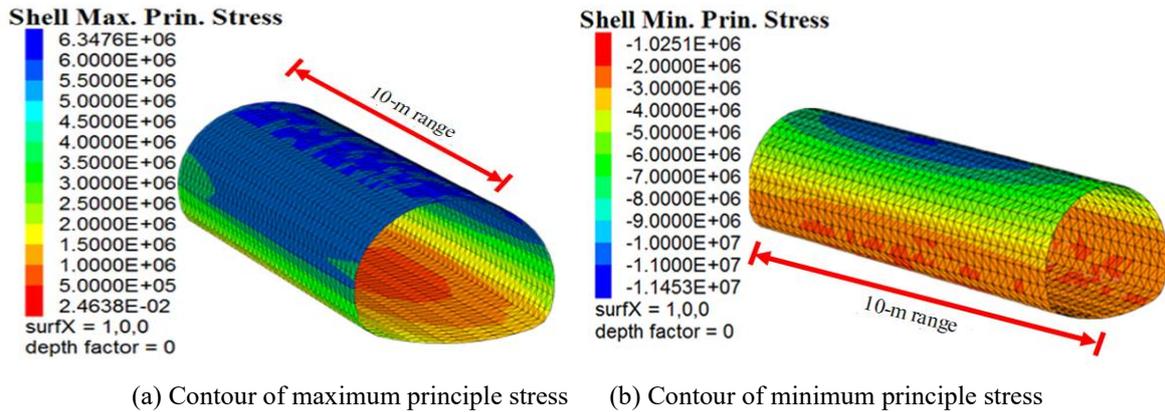
**4.4.1. Principle stresses nearing the bedrock-overburden interface.** Under the strong earthquake, the maximum principle tensile stress of the lining is about 1.0–6.0 MPa. The minimum principle compressive stress is about -1.0–11.0 MPa. In particular, a larger response of the maximum and minimum principle stresses of the lining within a range of 10 m nearing the bedrock-overburden interface are observed (Figure 15), with the maximum and minimum principle stresses of the lining reaching 6.3 MPa and -11.45 MPa, respectively.

(a) Contour of maximum principle stress (b) Contour of minimum principle stress

**Figure 15.** Contour of principal stresses within 10 m nearing the bedrock-overburden interface

**4.4.3. Seismic damage mechanism.** As shown in Figs 15 and 16, the primary reasons for the circumferential rupture zone are two-fold: (1) tensile and compressive stress concentration at the vault nearing the bedrock-overburden interface results in the first cracking of vault; (2) the huge shear force occurred in the bedrock-overburden interface due to the landslide.

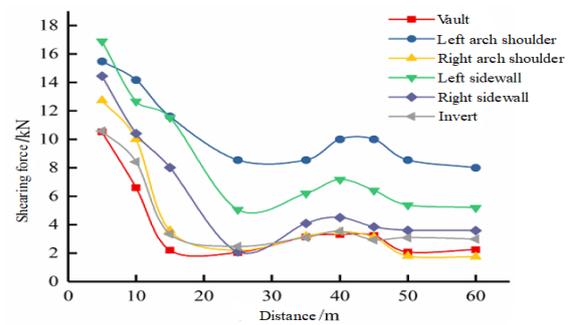
**Figure 16.** Curve of peak shear force vs. distance at different parts of lining

**4.4.2. Peak shear force nearing the bedrock-overburden interface.** Figure 16 shows the curves of shear peaks at different parts of the lining along the tunnel axis. As shown in Figure 16, some conclusions can be presented as following:

- (1) The peak shear force in the near-mountain side is generally larger than that in another side, thus indicating that the asymmetric pressure has a greater influence on the distribution of shear force. the peak shear force at about 10 m from the portal is relatively larger due to the asymmetric pressure and amplification effect of seismic waves nearing tunnel portals [25].
- (2) In the range of 40–45 m from the portal (bedrock-overburden interface), the peak shear force at different parts of the lining increase significantly. This indicates that the overburden above the interface sided under the seismic loading, thus exerting a huge additional shear force on the lining nearby and leading to the lining cracking.

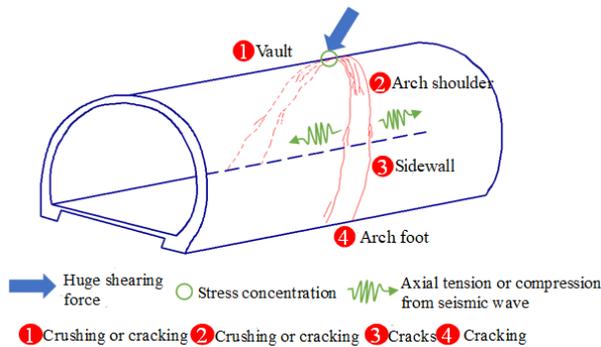
**Figure 17.** Schematic graph of the development of circumferential cracks in lining

Due to the difference in the geotechnical properties on both sides of the bedrock-overburden interface, there is an obvious inconsistent in strain. Under horizontal seismic inertia force, the slope began to slide [26]. When the slope slides along the bedrock-overburden interface, a huge shear force is applied to the lining, as shown in Figure 17. This can lead to: (1) when the tensile and compressive stresses of the vault exceed the strength of the concrete, the vault cracks first; (2) under the axial seismic loading, the lining at arch shoulder is subjected to alternate tension and compression, thereby making the internal shear strain and tensile strain gradually accumulate. When the accumulated shear and tensile strain and exceed the ultimate strain of concrete, the arch shoulder begin to crack; (3) the cracks further extended to the sidewall and arch foot, which has an agreement with the results of Huang et al. [27]; When the fissures were connected, the circumferential rupture zone formed.

The circumferential rupture zone is caused by the huge shear force produced by the landslide, which results in the concentrated tensile and compressive stress in the vault at the bedrock-overburden interface. When the stress exceeds the tensile strength of the concrete, the vault will crack first. Under the alternate tension and compression of axial seismic loading, the cracks extend from the vault to arch foot, thus forming the circumferential rupture zone.
