Fracture analysis and countermeasures of the grid switch castings

Abstract. Based on the detection technology of direct reading spectrum, metallographic microscope and X-ray, the defects of the grid switch castings were analyzed. The four main forms of casting fracture were summarized as poor physical and chemical properties, material misuse, casting defects and designing defects. In order to strengthen the quality control of the source of the product, it was proposed to carry out targeted network inspection in the two stages of material arrival and infrastructure acceptance.

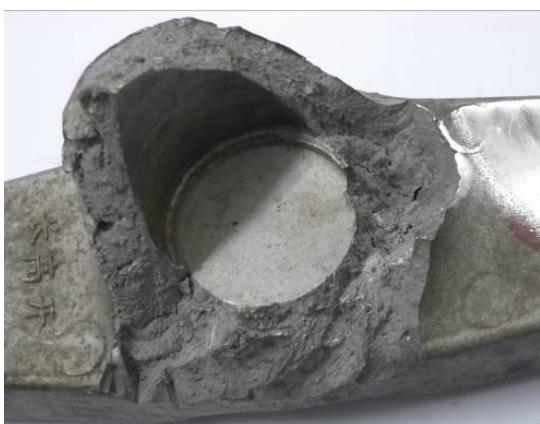
Fig. 1. Fracture morphology of the flange.

The GW16 switch vertical connecting rod flange broken during maintenance of a 220kV substation. The design material of this flange was die-cast aluminum alloy YL112. The flange broke in the middle. The fracture was flush and did not have any plastic deformation, which was a typical brittle fracture feature, as shown in Figure 1.

Samples were taken at the middle and end of the flange for tensile tests, and their tensile strengths were 184 MPa and 337 MPa, respectively. By consulting relevant research data, the design strength of YL112 at room temperature should be 330MPa. According to the technical requirements of GB / T9438-2013 aluminum alloy castings, the sample tensile strength of the I and II

castings with important bearing capacity should not be less than 75% of the design strength value[4]. Using the above standard calculation, the strength of the middle wall thickness of the hoop was about 55% of the design strength, which was unacceptable. It was confirmed that the performance of the wall-thickness part having the needle-like Si-Al eutectic structure was degraded.

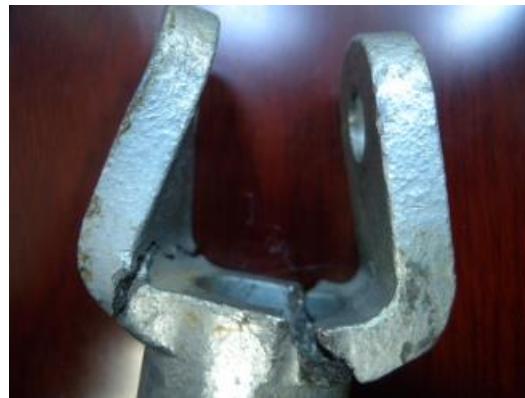
Fig. 4. Fracture morphology of the universal joint fork.

In an 110kV substation, a universal joint fork of the 5X14 switch broke during replacement and debugging, as shown in Figure 4. The joint fork design material was ZG270-500. For comparative analysis, a qualified universal joint fork of the same material and model was also provided.

By direct reading spectrum analysis, the C content of the fractured universal joint fork was 0.17wt.%. According to GB / T11352-2009 Standard for Casting Carbon Steel Parts for General Engineering [4], the C content of ZG270-500 material was 0.32-0.39%. The C content of the fracture universal joint fork was in the range of the

standard low-strength grade ZG200-400, which did not meet the ZG270-500 material requirements. Since C was the most important strengthening element of cast carbon steel parts, a decrease in the C content would lead to a reduction in the proportion of pearlite structure in carbon steel parts and a decrease in the strength of the material.

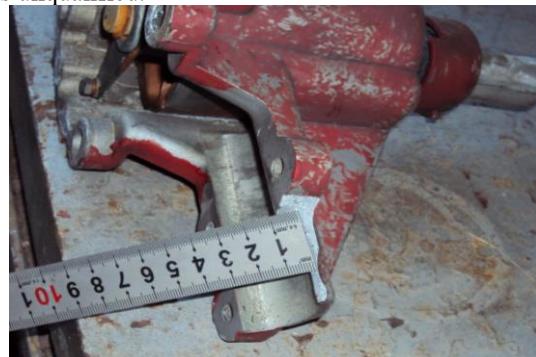
Fig. 7. Fracture morphology of the terminal block.

The GW4 switch terminal block in a 110kV substation was broken. The design material of this terminal block was die-cast aluminum alloy ZL102. The fracture position was at the clamping position of the terminal block bolt, and the fracture was a brittle fracture without plastic deformation, as shown in Figure 7.

Further measurement of the wall thickness at the break of the terminal block found that the thinnest part was less than 3mm. It was more important that this part bears the moment of the bolt and the conductive rod, which was an important part of the component. Compared with other manufacturers' products of the same type, the minimum wall thickness of this part was required to reach 6mm. The literature had reported that the cast aluminum parts fractured due to the thickness of the stress point at 5mm [6]. It showed that the insufficient design thickness of the terminal block bolt clamping was another major cause of fracture.
