Failure Analysis of Clamp Crack on TA Equipment in Converter Station

Abstract. Through macro inspection, chemical composition analysis, hardness test, tensile performance test, microstructure inspection and scanning electron microscope analysis, the causes of clamp crack on TA equipment in the 500kV AC filter field of the ± 800 kV converter station were analyzed. The results show that improper selection of the manufacturing process of the equipment clamps will cause more micro-defects inside it, leading to poor mechanical properties and excessive internal stress, which are the main causes of cracking. Corresponding measures are put forward to improve the manufacturing quality of equipment clamps, which can avoid similar failures from happening again.

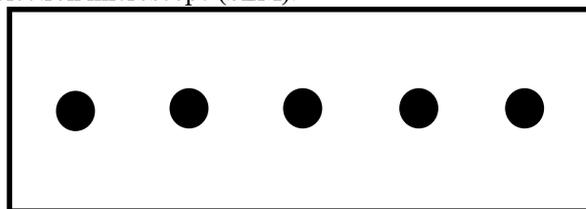
A FOUNDRY-MASTER PRO Oxford full-spectrum direct-reading spectrometer was used to analyze the chemical composition of the cracking equipment clamp. Three 60mm \times 20mm \times 8mm samples were cut from the wiring board, and the hardness was tested on the HBE-3000A electronic Brinell hardness tester. The detection position is shown in Fig.1. Cut 3 rectangular

Fig. 1. Schematic diagram of hardness testing position

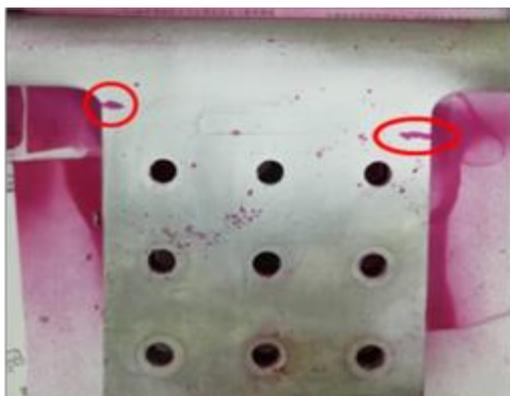
Penetration testing is performed on the cracking equipment clamps, and the crack locations are located on both sides of the wiring board, as shown in Fig.2. Further inspection found that cracks on both sides penetrated the side of the terminal board, as displayed in Fig.3.

Fig. 2. Cracking location of equipment clamp

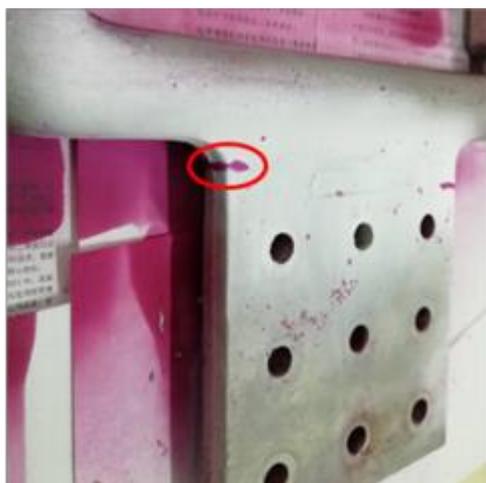
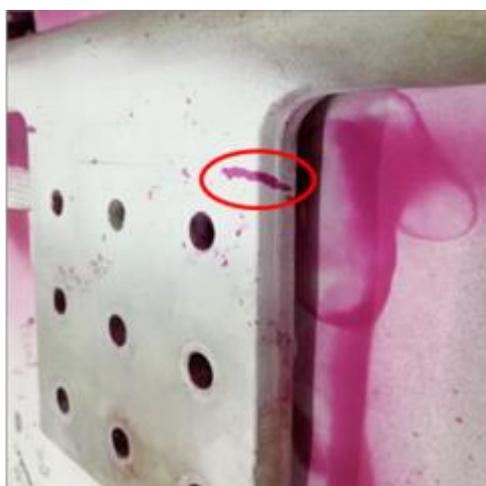
Fig. 3. Crack penetrates to the side

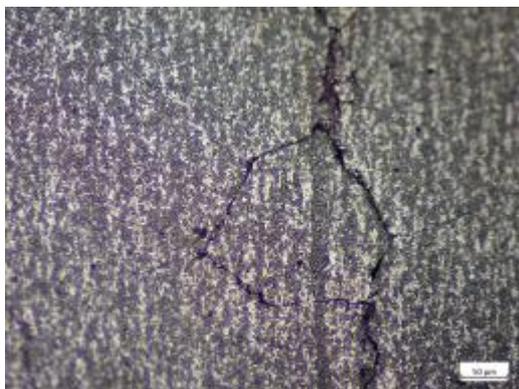
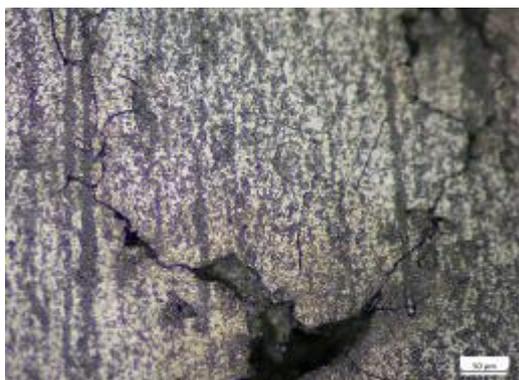
Take samples from the wiring board part of equipment clamp, and perform metallographic test after grinding, polishing and etching. The metallographic structures of the area near the crack and far from the crack are shown in Fig.4 and 5, respectively. It can be seen that there are a lot of micro-cracks in the structure in both area, which indicates that the casting process of the equipment clamp is poor^[8].

Fig. 4. Metallographic structure near the crack

As can be seen from the foregoing analysis, the equipment clamp is made of L3 industrial pure aluminum, which is formed by the casting process. The casting performance of pure aluminum is not good. Directly using pure aluminum casting production equipment clamps, it is prone to bring in various microstructure defects and reduce its mechanical properties. It is proved by the foregoing test that the hardness meets the standard requirements and the tensile strength does not meet the standard requirements. On the other hand, the casting structure is affected by many process quality control points such as the length of the pouring time, the speed, whether it is stable, whether it is interrupted, etc. It is also prone to be the problems of uneven structure and excessive internal stress. If heat treatment is not performed after casting, it is easy to crack during use.

2) It is recommended to conduct a comprehensive inspection of the same type of equipment clamps of the same manufacturer, and replace them in time if cracks are found.

3) The newly replaced equipment clamps are recommended to be manufactured by the process of aluminum tube pressing and welding with aluminum plates, and the welding quality should be checked to ensure that the equipment clamp quality is acceptable.

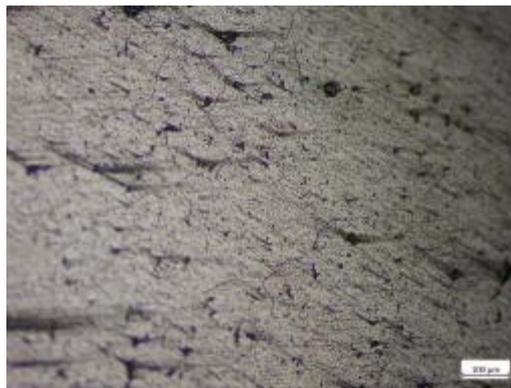
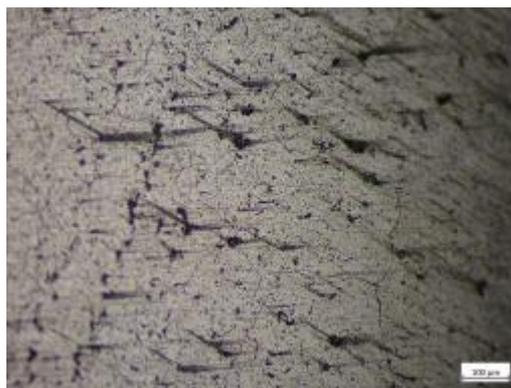
Fig. 5. Metallographic structure away from the crack

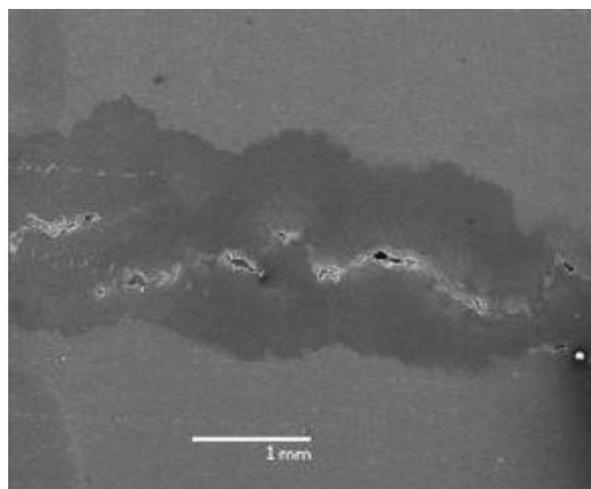
Samples were taken from the area near the cracks of the equipment clamps, and after grinding and polishing, further scanning electron microscope analysis was performed. The secondary electron image is shown in Fig.6. It can be clearly seen that there are obvious contrast differences in the tissues near the cracks, which shows that there may be segregation in the tissues^[9], and the tissues is extremely uneven. The enlarged structure is shown in Fig.7. It can be seen that the microstructure has more micro holes and the structure is relatively loose and not dense.

Fig. 6. Secondary electron image near crack

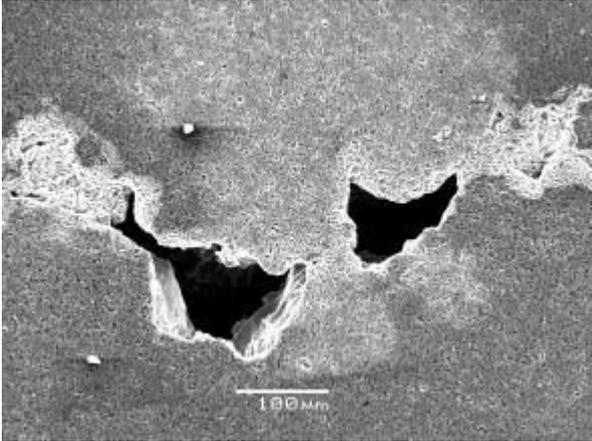
Fig. 7. Enlarged tissue
