Evaluation of the risk of decay of wooden beams embedded in internally insulated walls by long-term measurements

¹ Belgian Building Research Institute, Energy Division, Av. P. Holoffe 21, 1342 Limelette, Belgium

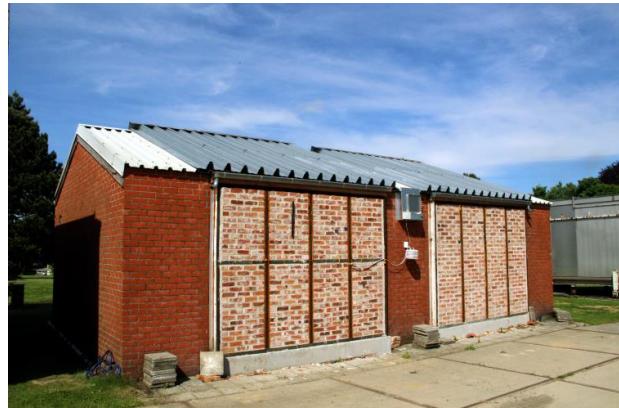
Fig. 1. Test house from the outside. The rain gauge and T/RH-sensor (with radiation shield) are positioned between the two test chambers.

A test house located on the research facility of the Belgian Building Research Institute (BBRI) is used to investigate the hygrothermal performance of wooden beams embedded in masonry walls. The test house consists of two chambers with an open south-oriented side (angle of 190° clockwise from north). In these two openings of 3 m by 2 m, different masonry walls with a thickness of 30 cm are constructed (Fig. 1) using recuperation bricks and a hydraulic lime mortar. No external rendering is applied. This wall composition corresponds to the walls of a common Belgian dwelling built prior to 1945. Each masonry wall is separated using cellular glass, limiting the thermal and hygric influence between the walls. The walls were constructed in December 2015. Measurement results are however only presented starting from September 2017, as before, there is a clear influence of the built-in moisture.

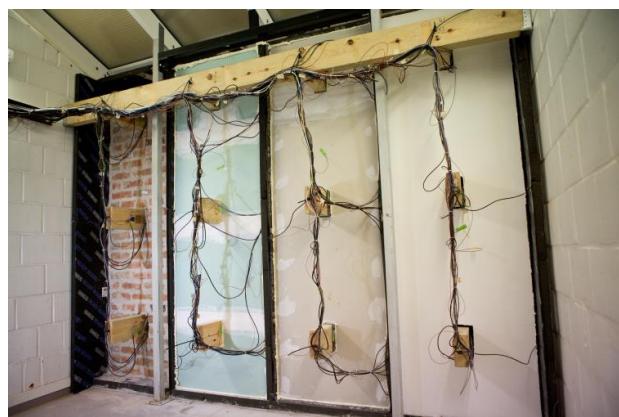
Fig. 2. One of the two test chambers from the inside. From left to right: non-insulated wall, EPS, mineral wool and calcium silicate. The three beams per wall represent a different connection between masonry and beam. The top beam parallel to the wall only serves as a structural support for the wall.

In total, nineteen wooden beams are embedded in the different walls at a distance of 9 cm from the indoor brick surface (Fig. 2). All beam junctions are airtightly sealed, either by using a flexible foam or a tape. No flooring or ceiling was installed. Each wooden beam represents a different situation. Firstly, different insulation materials are used to insulate the masonry walls from the inside. Next to that, the beam is embedded in different ways. Thirdly, the thermal insulation of one wall is interrupted, creating a thermal bridge. Finally, a water repellent is applied on a wall.

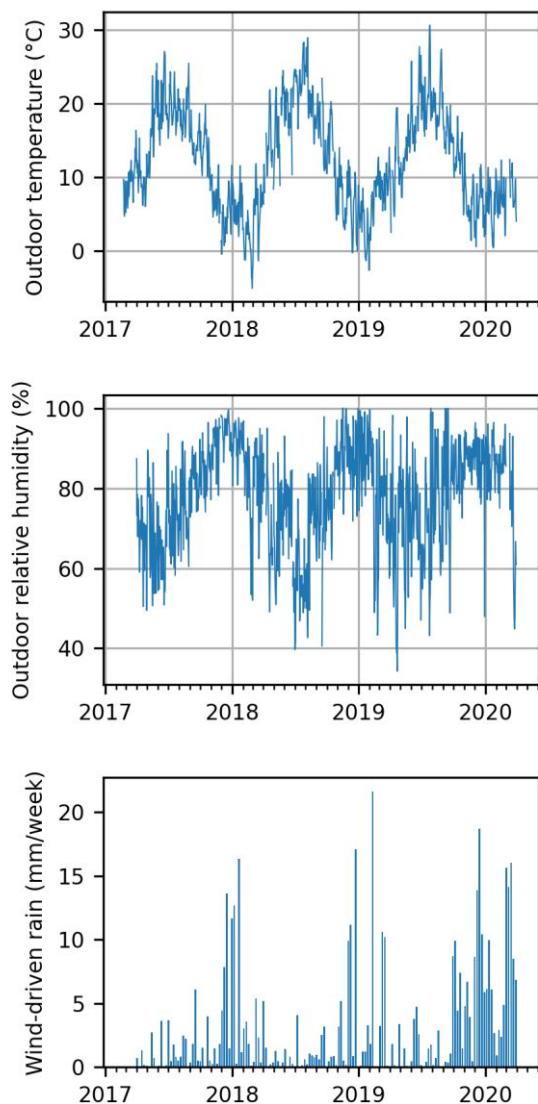
Fig. 3. Outdoor climate conditions during the measurements (daily average for temperature and relative humidity).

The indoor climate of both test chambers is controlled and kept at 20°C and 50% RH during the whole measurement period. The outdoor temperature, relative humidity and wind-driven rain (using a rain gauge) are monitored (Fig. 3). The annual amount of wind-driven rain equals 135 mm in 2017, 125 mm in 2018 and 187 mm in 2019 and is higher in wintertime than in summertime.

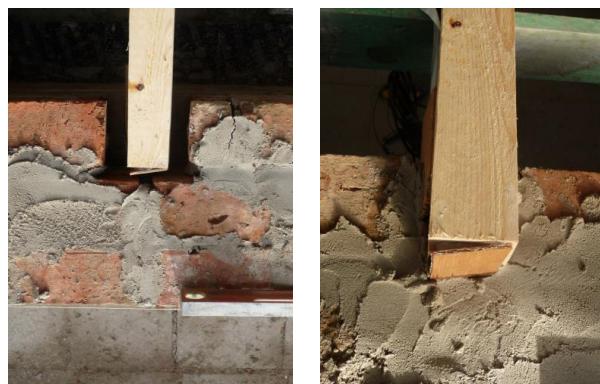
Fig. 4. Top view during construction of the beam with an air layer (left) and a joint filled with mortar (right).

In the test house, the joint between beam and masonry is executed in two ways: either completely filled with mortar or with a continuous air layer (except below and above the beam end) (Fig. 4). The hygrothermal influence of this joint is examined for an internally insulated wall with EPS, mineral wool and calcium silicate.

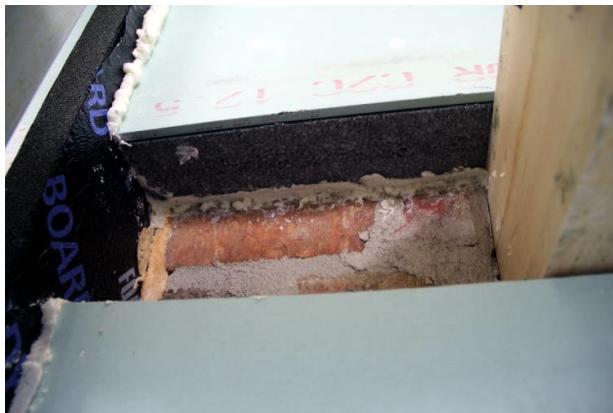
Fig. 5. Local interruption of the internal insulation, creating a thermal bridge which might promote the drying rate.

To investigate the impact of the thermal bridge, the insulation of one of the test walls is interrupted next to the beam ends (Fig 5). No airtight sealing was provided, as if the wooden beam would have been inaccessible. However, as the beam is embedded in a completely filled mortar joint, no convective air flow is expected. In case of an air layer around the beam, the convective flow

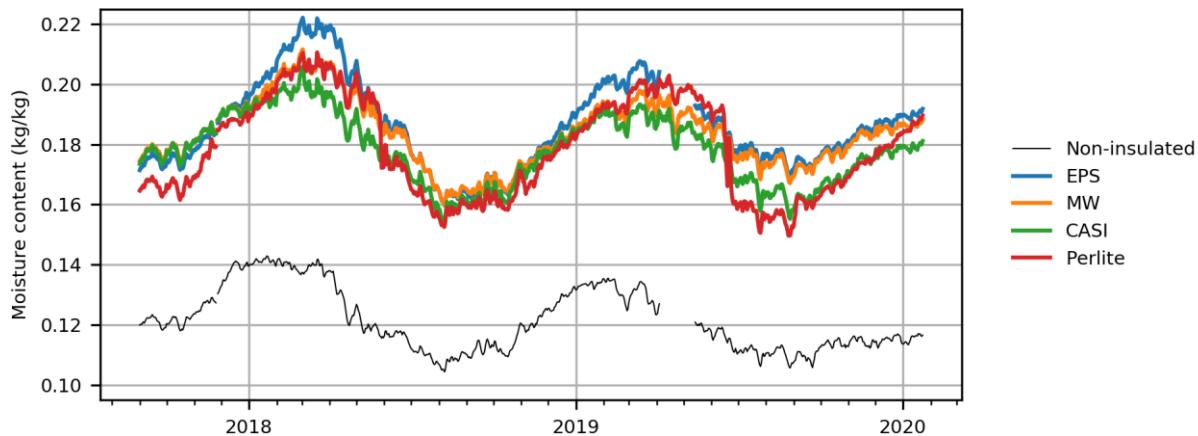
Fig. 6. Moisture content at the beam end for different insulation materials. Vapour tight systems are slightly more humid, however the differences between materials are small compared to the difference to the non-insulated wall.

All beam ends of the internally insulated walls show significantly higher moisture contents than the non-insulated wall. Moisture contents for all beams have a very similar course: the highest moisture content around March, the lowest around August (Fig. 6). From July 2017 to January 2018, a lot of rainfall has been measured, whereas the rest of 2018 was very dry with a high global solar radiation [32-33]. This could explain the difference in peak moisture contents between the beginning of 2018 and 2019. It also shows the impact of wind-driven rain and drying potential on the moisture content at the beam end.

The highest moisture content at the beam end are measured for the wall insulated with expanded polystyrene, having the highest vapour diffusion resistance. From the insulated walls, during the critical heating period, the lowest moisture content is measured at the beam end insulated with calcium silicate. The other capillary active system, perlite, leads to the lowest wood moisture content during the summer period, however more humid conditions were measured during the winter period. The measurements might also be

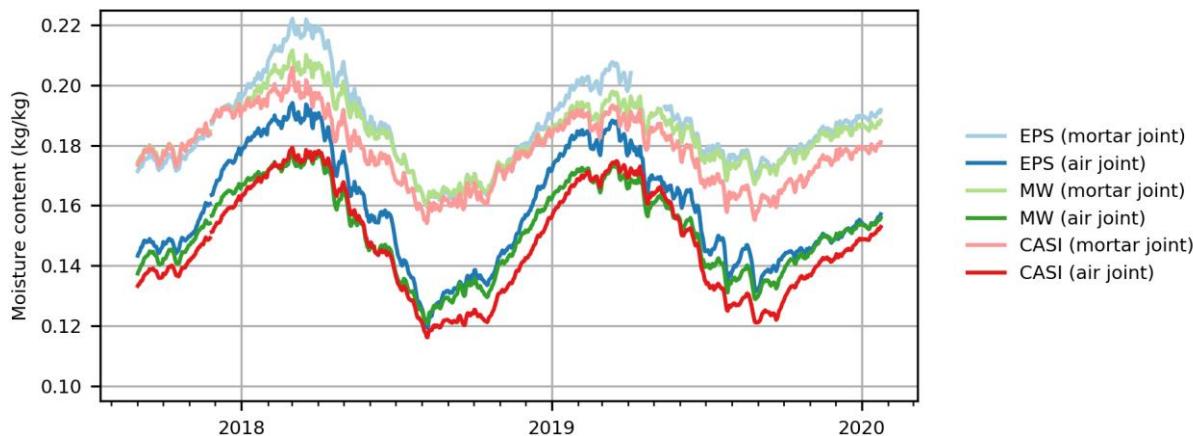
Fig. 7. Moisture content at the beam end for a mortar or an air connection around the beam end. In the case of an air joint, the moisture content is lower for all the insulation materials, indicating a higher hygric resistance compared to a mortar joint.

For all the tested insulation materials, the beam ends with mortar joints are more humid than the ones with an air layer (Fig. 7). The course of all graphs is very similar. The difference between an air joint and mortar joint is 0.024 kg/kg during the high moisture contents in February - April, and 0.037 kg/kg during the lower moisture contents in August - October (average values over all materials and over both periods in 2018 and 2019).

The air layer serves as a hygric resistance, slowing down the moisture transport from the humid masonry to the beam end. When assessing the risk of wood decay, it is thus advisable to verify the layer between beam and masonry before assuming an air layer.

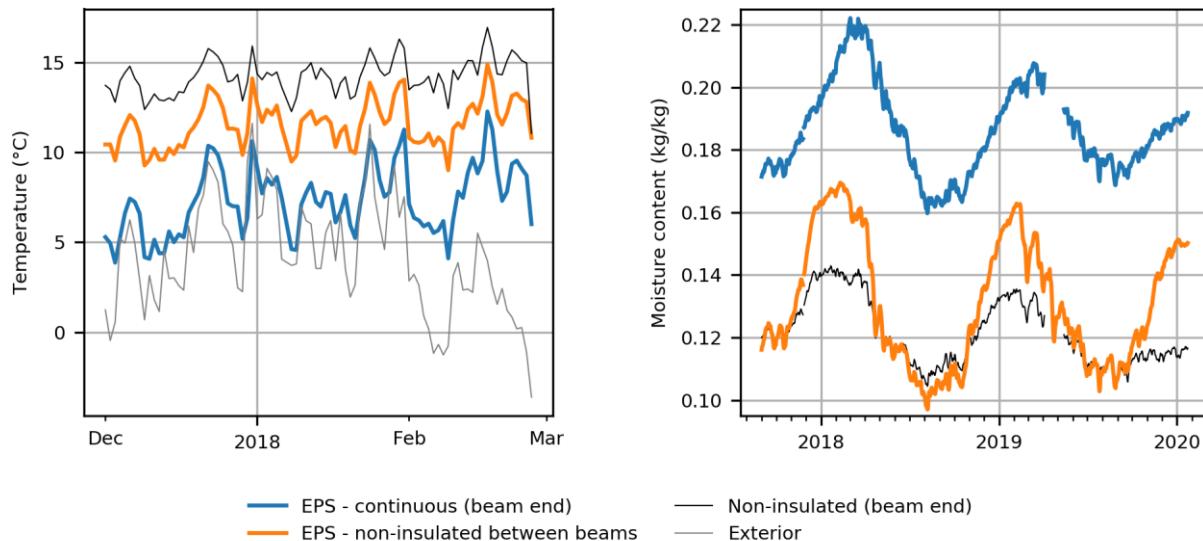
Fig. 8. Temperature (left) and moisture content (right) at the beam end for the test wall with a continuous and an interrupted insulation layer. The thermal bridge has a favourable impact on the moisture content of the wooden beam.

When the area next to the beams is deliberately not insulated, the temperature at the beam end significantly increases. The average outdoor temperature during the plotted winter period (December 2018 to March 2019) equals 4.2°C. During the same period, the average temperature at the beam end equals 7.4°C for the continuously insulated test wall, 11.6°C for the test wall with thermal bridge and 14.2°C for the non-insulated wall. The temperature at the beam end with thermal bridge is closer to the non-insulated situation than to the continuously insulated one (Fig. 8, left).

The moisture content measured at the beam end is significantly lower in case of a thermal bridge. During summer, moisture contents are as low as the non-insulated case (Fig. 8, right). Compared to the wall without thermal bridge, the wood moisture content for the wall with interrupted insulation is 0.052 kg/kg lower from February to April and 0.062 kg/kg lower from August to October (values averaged over these periods, both in 2018 and 2019).

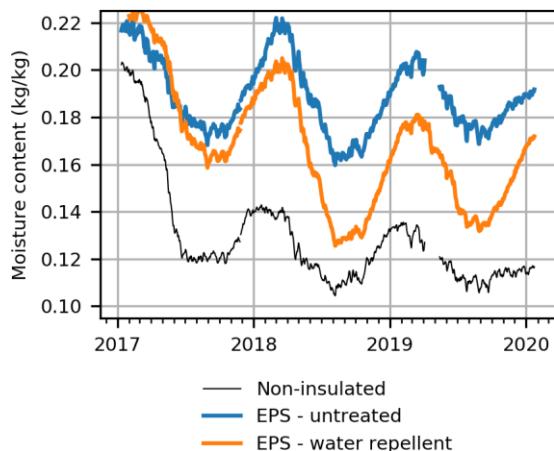
Fig. 9. Moisture content at the beam ends of the walls with and without a water repellent treatment. The water repellent has a favourable impact on the moisture content, but reduces the drying rate.

At the start of measurements in January 2017, the wood moisture content of the hydrophobized wall is higher than the untreated wall (Fig. 9). Starting from mid-2017, the two lines cross and with time going, the difference between treated and untreated wall increases. After treatment, the moisture (most probably built-in moisture from the wall construction) took thus longer to dry out, confirming the reduced drying speed after applying water repellents.

When the built-in moisture is evaporated, the wooden beam end of the hydrophobized wall is significantly drier than the untreated wall. The strong reduction of the wind-driven rain absorption has a favourable impact on the hygrothermal conditions at the beam end.
