Microbial growth behind tiles in bathrooms

Gunilla Bok^{1*} and Pernilla Johansson¹

¹RISE Research Institutes of Sweden, Built Environment, Box 857, S50115 Borås, Sweden

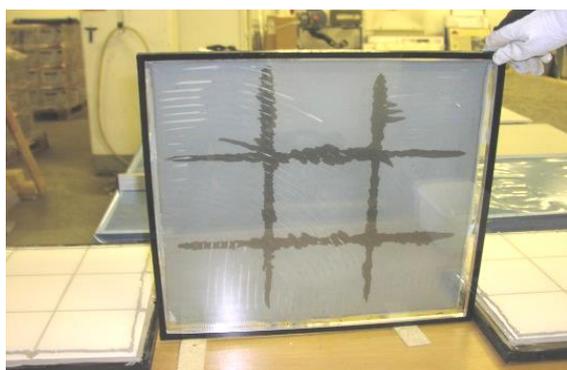
Fig. 1. A section of tiled wall. Water has been sucked to the back through the grout joints. The wall has been exposed to free water for two minutes. [1].

Walls and floors in wet rooms are exposed to free water either directly when water sprinkles from the shower against the wall/floor or indirectly by water splash. When the surface layers of walls and floors are covered with ceramic tiles these tiles are fastened to the wall/floor with cement-based tile adhesive. The tile adhesive, in turn, is applied to a waterproof membrane which stops further water transport into the wall/floor. In a tiled wet room liquid water is sucked by capillary actions into the wall through the grout joints between the tiles (Figure 1).

The wall dries through diffusion force. Diffusion is a weaker force than capillary force and therefore the drying takes longer than the soaking of the wall. The result of these differences in tiled walls and floors frequently exposed to free water is an accumulation of water in the layer of the tile adhesive. It is calculated that a tiled wall exposed to water for 15 minutes needs roughly six months to dry out. Therefore, in a bathroom used on a daily basis, free water will always be found behind the tiles in the tile

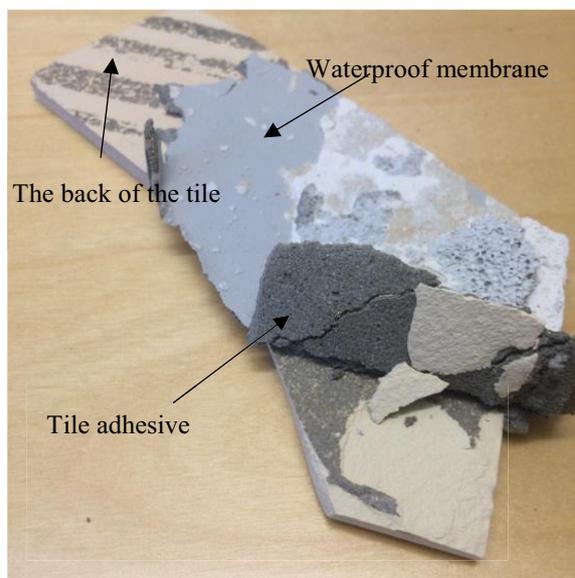
Fig. 3. A specimen taken from a bathroom wall which including all the different components of a tiled surface.

A total of 120 specimens were taken out with a jackhammer. Each sample consisted of tile, cement-based adhesive and waterproof membrane (Figure 3 & 4). The specimens were taken from the same places and in the same manner in all the bathrooms. Six specimens (A-F) were taken from an area expected to have been frequently exposed to free water (Figure 5) and two specimens (G and R) were taken from places expected not having been exposed to free water (Figure 6a & 6b).

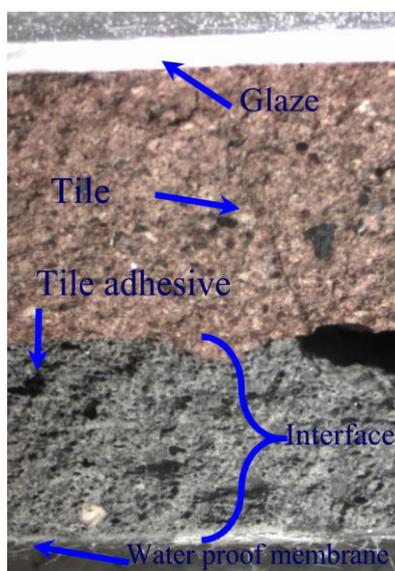
Fig. 4. Magnification of the examined interface between the backside of tile and the sealing layer.

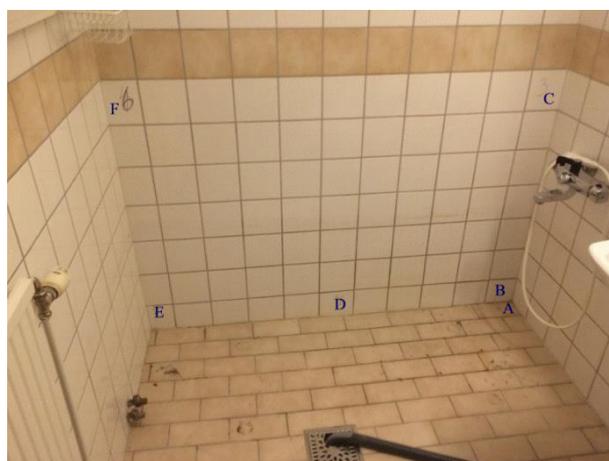
Fig. 5. The places (A-F) from which the specimens were taken after the bathtub has been removed.

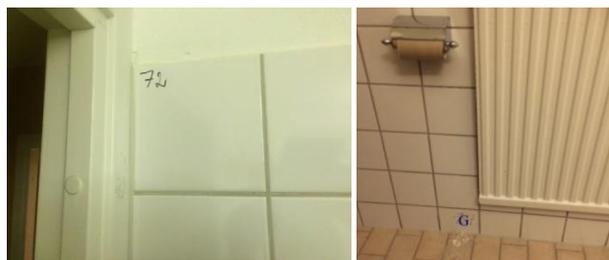
Fig. 6a & 6b. The places expected not have been exposed to free water. R-specimens were taken in the upper corner next to the entrance doors. G-specimens were taken under the radiator.

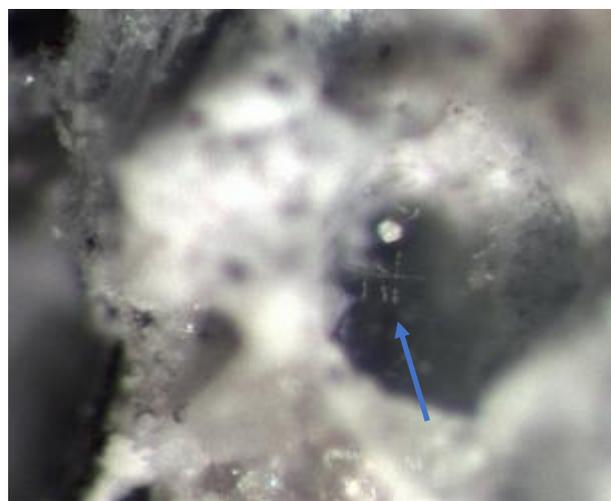
Fig. 7. Hyphae and conidiophores (arrow) in the layer of tile adhesive.

Hyphae, conidiophores (Figure 7), and chains of actinomycetes were found, but also individual bacterial cells. Actinomycetes and fungi were found growing both together and separately. Microbial structures were detected in the adhesive (Figure 8), on the water sealing (Figure 9), and on the back of the tile (Figure 10). Of the samples taken from spot A & B (Figure 5), 8 samples out of 14 had microbiological growth. This part of the bathroom was the area assessed to have been exposed to liquid water to the highest degree. Microorganisms were found on four samples out of eleven on the samples taken from spot C. This spot was considered to have less exposure to liquid water compared to spot A. From spot E & F one sample out of eleven had microbiological growth. No growth was found on the reference samples taken from spot G and R.

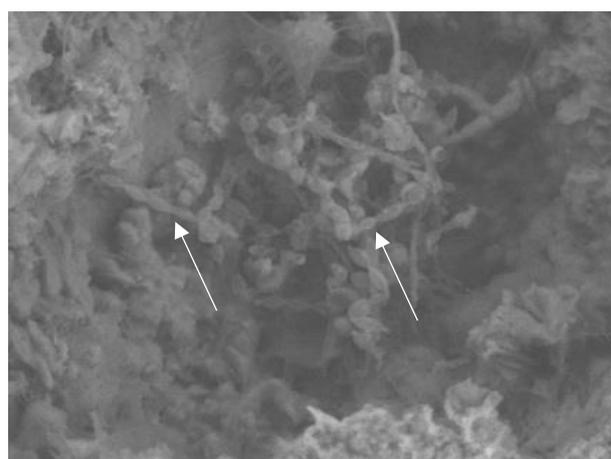
Fig. 8. SEM-picture showing microbial growth in the adhesive layer. Cells are growing in a cavity of tile adhesive.

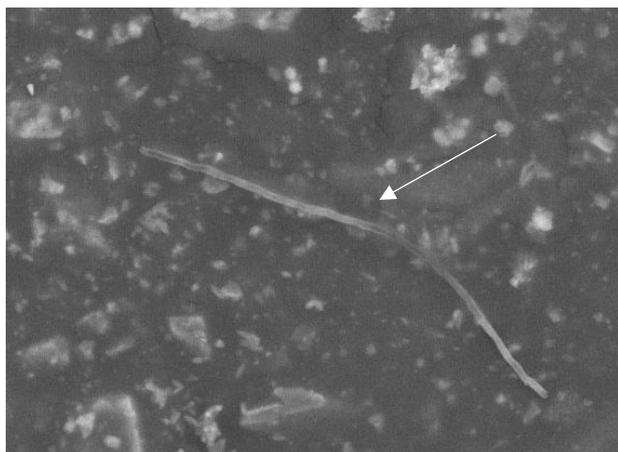
Fig. 9. SEM-picture. Hyphae on a sealing layer.

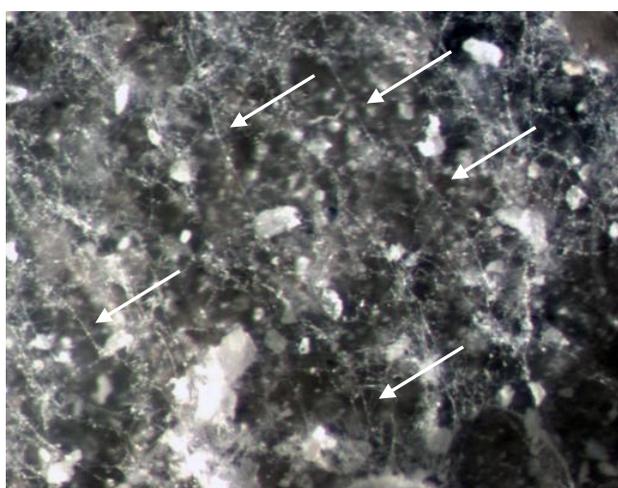
Fig. 10. Hyphae on a tile's back (arrows).
