Analysis of defects and their impact on the production losses using Pareto diagrams

Abstract. The Pareto diagram is a powerful tool for identifying the significant factors influencing objects, processes, services, etc. In the production sphere, it is very suitable for analysis of defects and their impact. In this work are summarized the types of defects that occur in the production of headrest covers for car seats. Analysis was made of both the frequency of occurrence of defects and the financial losses from them. The research is done on the whole production range (all projects) proceeded in a given month, on product families and on specific products. The three defects with the highest frequency of occurrence were identified. For them, additional study was conducted to determine the impact of the type of used material on internal scrap calculated as an expense in euros. Based on the obtained results, recommendations are made for improving the work and its results.

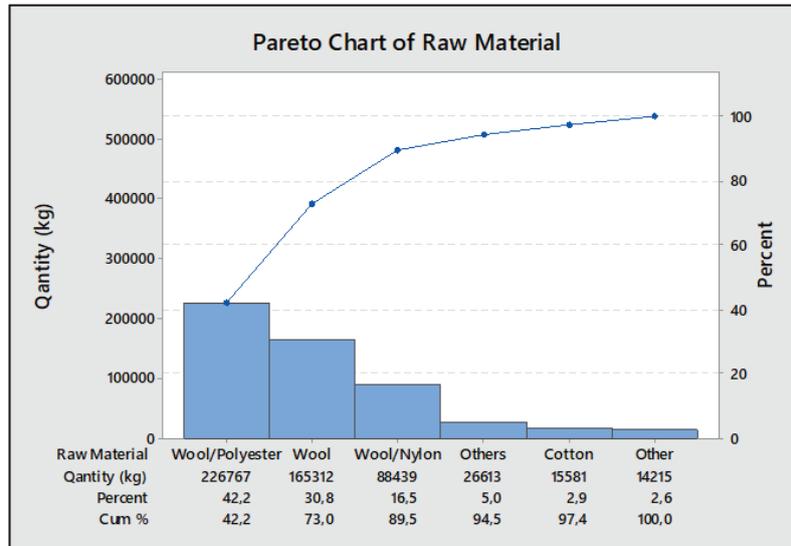
As seen from the diagram, the mixture Wool/Polyester forms 42.2% of the total production, followed by pure Wool (30.8%) and Wool/Nylon (16.5%). The remaining materials constitute 10.5% of the production that is less than 20%. This means that 3 materials form over 80% of the total quantity of dyed materials.

Fig. 1. Pareto diagram of raw material quantities [2].

For example, on Fig. 1 is given a Pareto diagram presenting the most used raw materials that are dyed in Turkey [2].

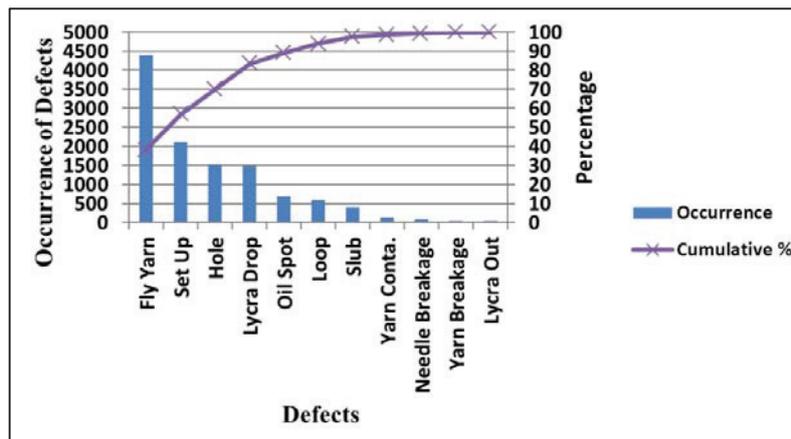
Fig. 2. Pareto chart for identifying major defects [3].

From 10 investigated defects 7 are responsible for 95.56% of total defects. They are arranged and included in the presented Pareto chart. Four of them form over 80% of all faults.

In [3] is carried out an investigation on the application of different techniques like Pareto chart, Ishikawa's fish bone diagram and Six Sigma for quality control of knitted fabrics. In Fig. 2 are shown the results from the Pareto analysis.

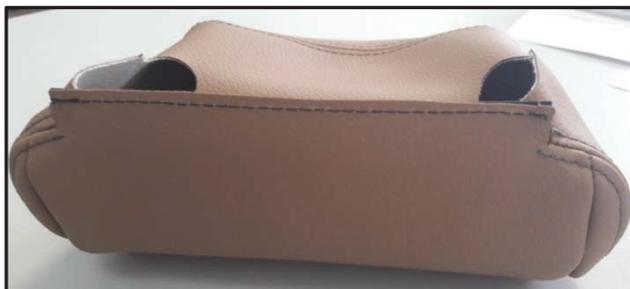
Fig. 3. Picture of a finished headrest G3Y for BMW.

The study was conducted in Grammer AD, Bulgaria. The object of investigation is the production of rear middle headrest (Fig. 3).

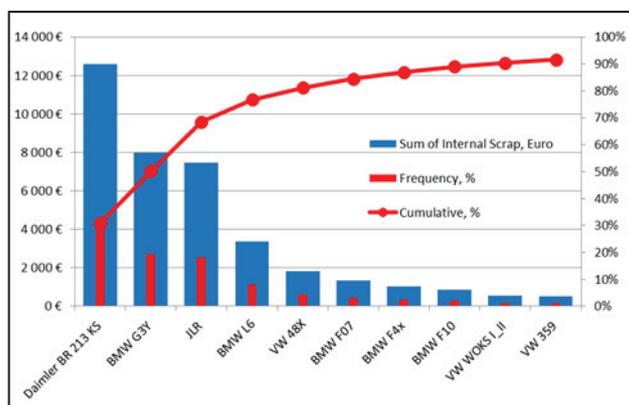
Fig. 4. Losses from internal scrap by projects

The graph shows that the leading projects in terms of scrap losses are Daimler BR213KS, followed by BMW G3Y and JLR. These are the projects with the most

expensive products and even with a small amount of discarded products, the losses are high.

A statistical analysis of the data was made and a Pareto diagram was drawn, which is presented in Fig. 4.

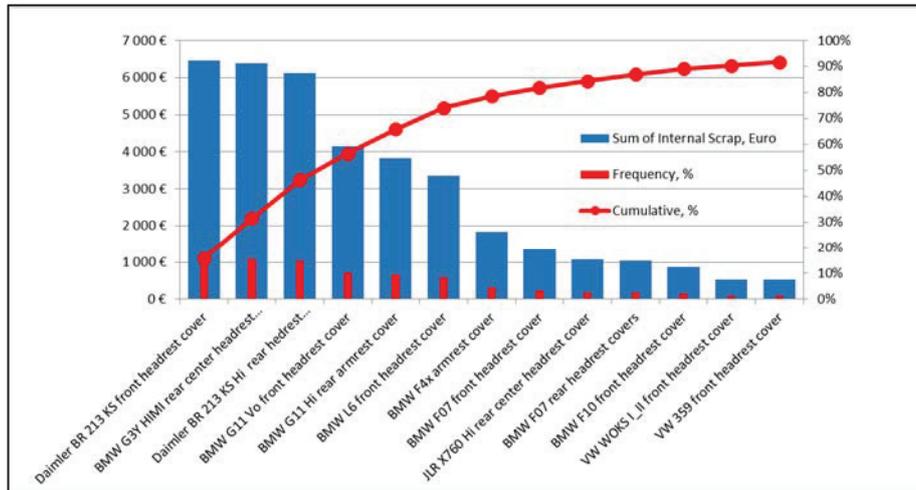
Project BMW G3Y appears again in the first positions with one of its product families - BMW G3Y HIMI cover for rear middle headrest. It includes products made from leather (Dakota, Saddle and Merino), which are expensive materials.

Fig. 5. Losses from internal scrap by product families.

Table 3 presents the collected data on the expenses of internal scrap by product families. In Fig. 5 they are ranked by size.

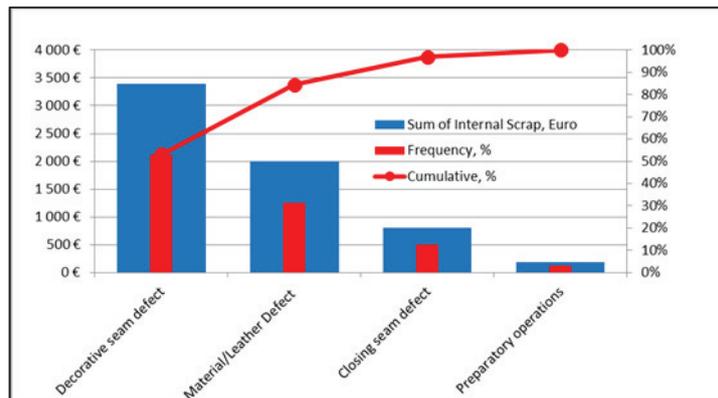
In Fig. 6 are presented the losses by the origin of the defect. The predominant defects are in decorative seam that defines the good appearance of the product.

Fig. 6. Losses from internal scrap depending on the origin of the defect.

The other two groups of defects have less impact, as can be seen in Fig. 6.

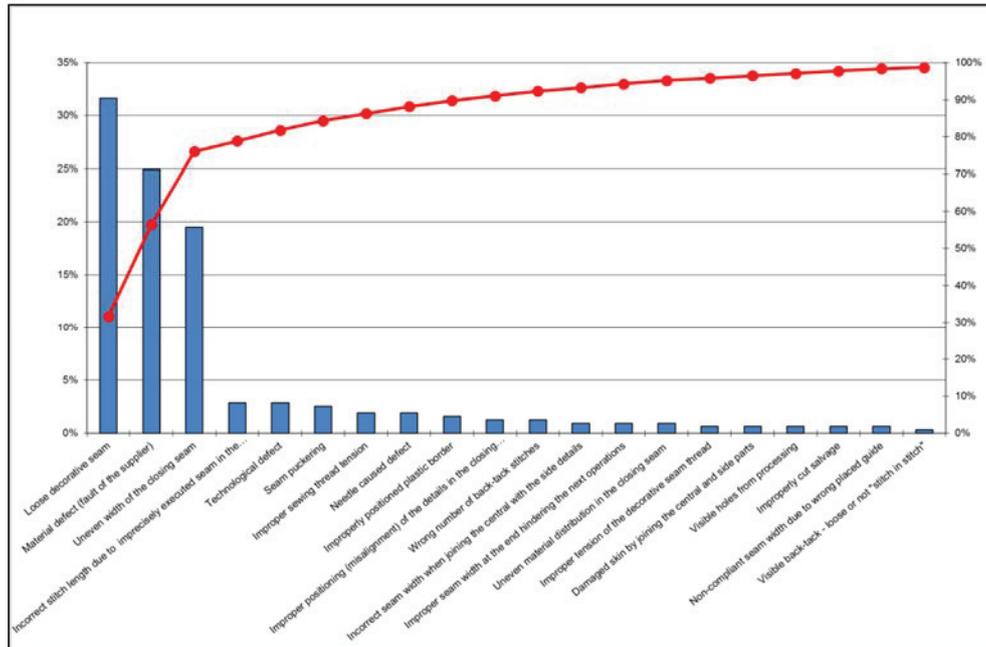
Fig. 7. Pareto diagram of defects in a product family BMW G3Y HIMI cover for rear middle headrest.

The diagram shows that the first three defects stand out sharply: Loose decorative seam - 32% of the total number of all rejected products, Material defect (defect not found on Incoming control and admitted to the production line) - 25% and Uneven width of the closing seam - 19%.

These three defects form 76% of the product family's scrap.

After processing the results, the Pareto diagram is drawn, presented in Fig. 7.

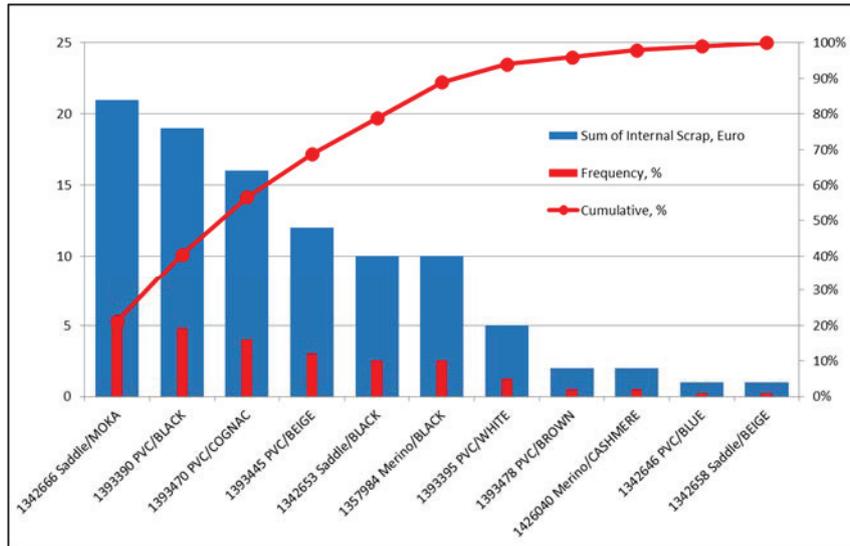
This defect was found in eleven products. The Pareto chart with the number of defects in each material is shown in Fig. 8.

The first three materials form over 50% of the total number of detected defects. The first commodity number is made of leather Saddle, followed by covers made of artificial leather and leather Merino. The behaviour of all three materials during the sewing process was analysed. The feedback of the operators who sew a double decorative seam

Fig. 8. Pareto diagram by product due to Loose decorative seam

was taken into account; the qualitative criteria for a decorative seam and the admissible tolerances were discussed. On the recommendation of the technologist, additional training was made for certain operators who make the most mistakes in the sewing process.

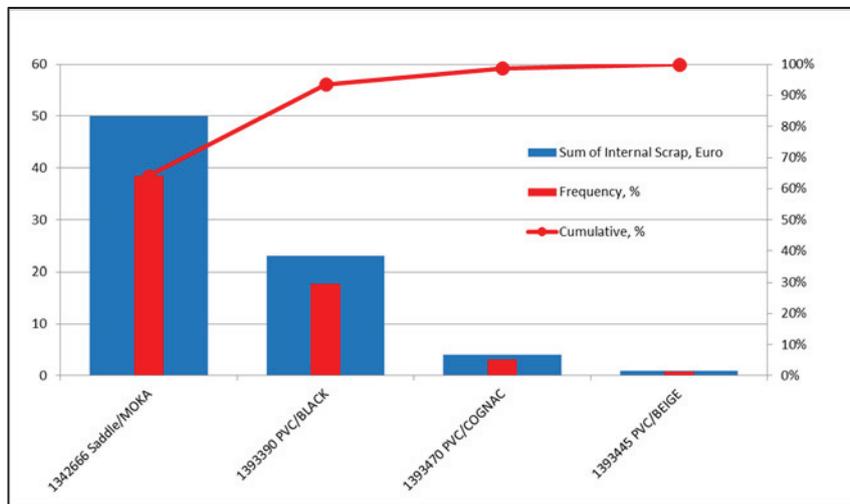
Four products have shown such a defect. 64% of all discarded products belong to only one product number (Fig. 9). This information was sent to the supplier in order to take measures and strengthen the Outgoing quality control. As an internal measure, Grammer AD has appointed a 100% inspection of each item of this commodity number.

Fig. 9. Pareto diagram by product due to Material defect.

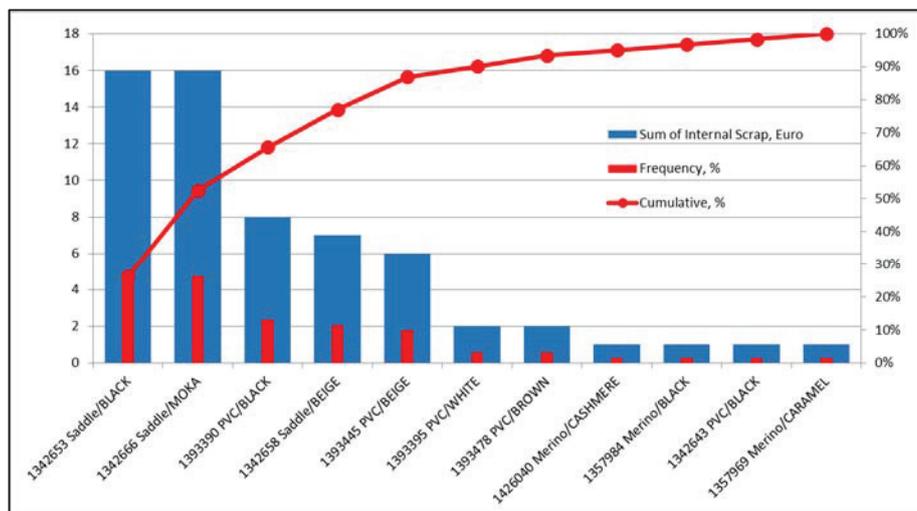
Fig. 10. Pareto diagram by products due to defects in the closing seam.

The Pareto diagram shows that most mistakes in performing the closing seam operation are made when processing Saddle leather. 63% of all discarded cases for the month are made of this material, which requires immediate corrective action. For performing this operation have to be chosen good operators. It is possible even to be revised the standard time for executing this operation.

The information for items discarded due to a defect in the closing seam has been taken from the database. The data was processed and the obtained Pareto diagram can be seen in Fig. 10.
