Defects of steel crane beams and methods of their strengthening

Abstract. Crane structures are the most vulnerable in buildings and structures because of their early wear in comparison with other building structures. The wear of crane structures is because of the appearance and the development of fatigue damage nature.

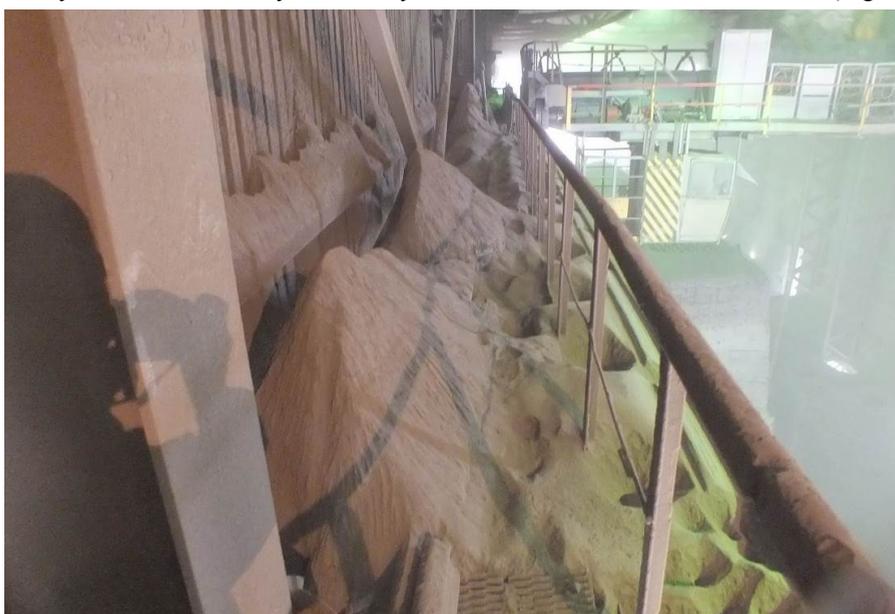
During the production of certain types of products because of imperfection of technological processes or their violations there are deposits of industrial dust on brake structures which negatively affect the durability of not only crane structures but also crane wheels (Fig. 1).

Fig. 1. Deposits of clinker on brake structures.

To prevent clinker accumulation on horizontal brake beams the authors recommend unloading them by installing holes in them. Work on the study of steel beams with walls with holes is currently underway in Kazakhstan. A round hole is possible at $\tau \leq 0.5R_s$, but with a diameter of not more than half the height of the wall while the hole should be located in the center relative to the height of the wall which are bordered by angle or sheet steel reinforced by paired vertical stiffeners. The following design schemes can be used in the case of high lateral loads (Fig. 2).

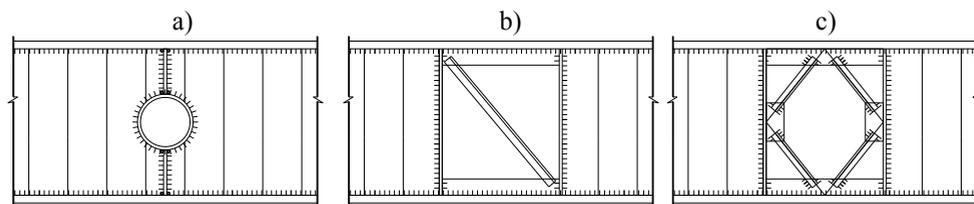
- a) a hole reinforced with edging and stiffeners;
- b) a hole reinforced with sheets and one brace from the corner;
- c) a hole reinforced with a rhombic paired corner lattice.

Fig. 2. Constructive solutions for holes in corrugated walls.

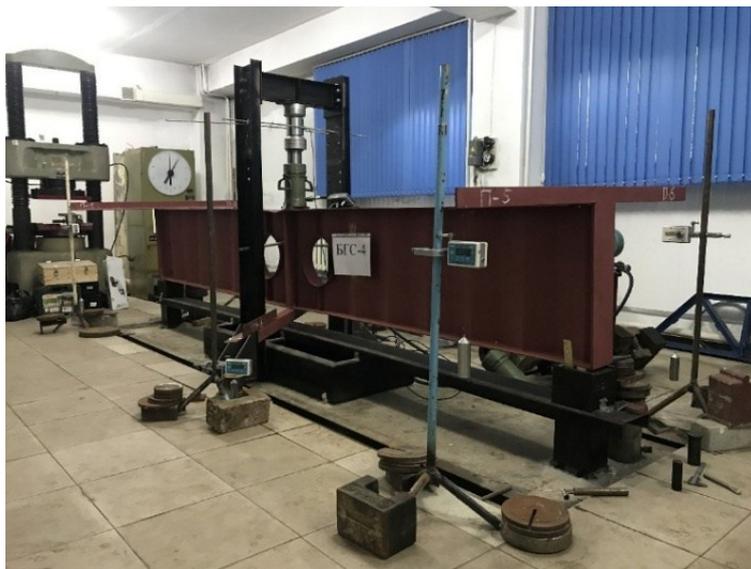
In 2019, in the laboratory of KazGASA LLP (Almaty), on the load-bearing floor, 5 models of beams with corrugated walls (BGS-1,2,3,4,5) were tested, weakened by round technological holes with various reinforcement options holes [2]. Tests [3] were carried out according to a single-span scheme for lateral bending by a concentrated force applied in the middle of the span (Fig. 3) while the beams are based on the supports.

Fig. 3. General view of the installation for testing the BGS-4 beam.

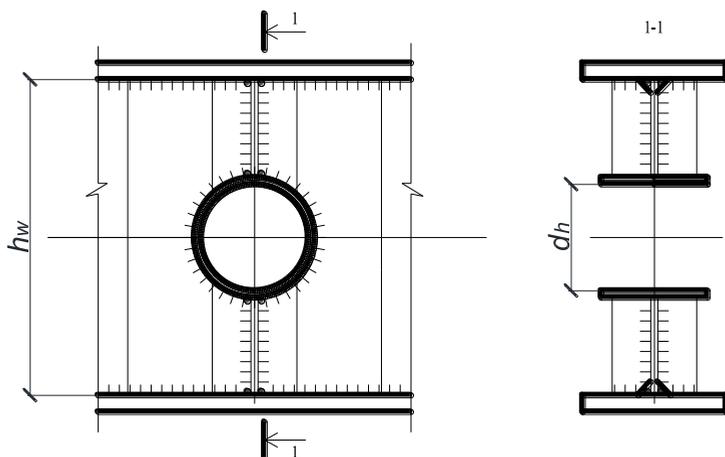
The reinforcement method described in SNiP RK 5.04-23-2020 "Steel structures" was chosen as the basis for reinforcing round holes, consisting of bordering the hole with sheet steel and installing paired vertical stiffeners on both sides of the wall (Fig. 4).

Fig. 4. Corrugated I-beam with a round hole bordered by sheet steel and paired vertical stiffeners.

This method, described in the regulatory documents of the Republic of Kazakhstan, does not contain specific data on the thickness of the metal for edging and stiffening ribs. Therefore, in the course of the study, it was determined that the most effective thickness of the edging and stiffeners for a hole with a diameter of $0.25h_w$ and a step of $2d$ is a thickness of 2 to 4 mm; for a hole with a diameter $0.5h_w$ and a step $2d$, the thickness is from 4 to 6 mm; for a hole with a diameter $0.75h_w$ and a step $2d$, the thickness is from 6 to 8 mm.

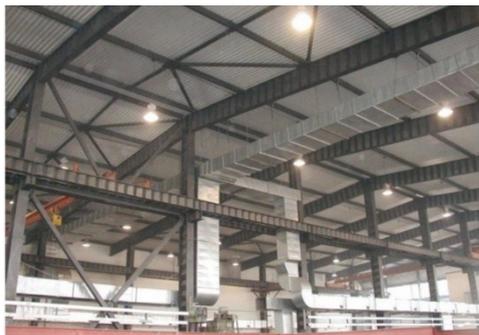
Fig. 5. One-story steel frame of the industrial building, in which the roof girders, columns and crane beams are made of welded I-beams with corrugated walls. Seismicity 10 points. 2007.

It can be used crane beams with corrugated walls to solve this problem. Kazakhstan has accumulated a lot of experience in the use of such beams (Fig. 5, 6).

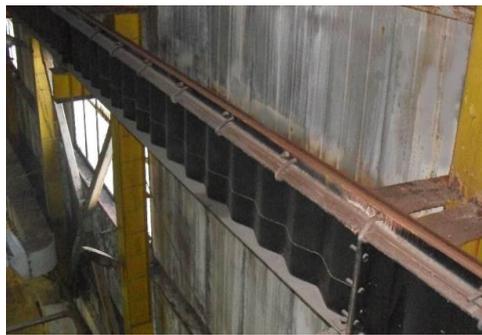
Fig. 6. Crane beams in the main building of the plant in Almaty region. The height of the beams is 640 mm, the thickness of the corrugated walls is 6 mm. 2001.

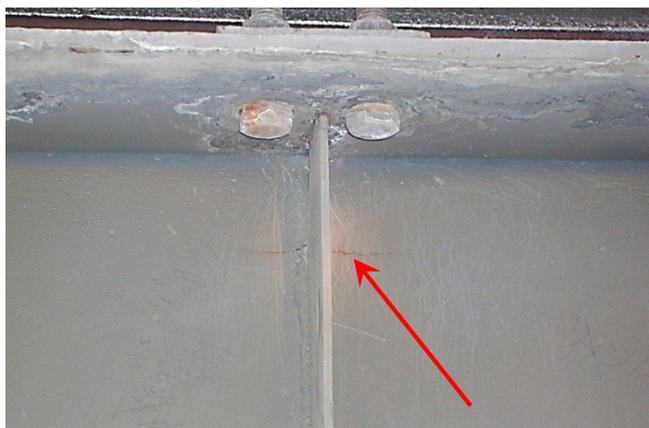
Defects and damages were found both in the frame structure and in the crane beams and their brake structures; significant wear of the crane wheel flanges and crane rails was noted. The most common defects in crane beams were fatigue cracks in their walls, which were found in 40% of crane beams. Cracks were found only at the ribs of the walls of the crane beams (Fig. 7).

Fig. 7. Crack in the wall of the crane beam.

Verification calculations of crane structures carried out in accordance with the requirements of SNiP II-23 made it possible to establish that the main reason for the appearance of fatigue cracks in the walls was the presence of unacceptable eccentricities between the rail axes and the wall axes. The massive appearance of cracks in the walls of the crane beams was facilitated by the increased deformability of the frames caused by the lack of an assembly connection of the I-beams of the upper and lower parts of the individual columns of the frame along the A axis which also refers to installation defects of the frame structures.

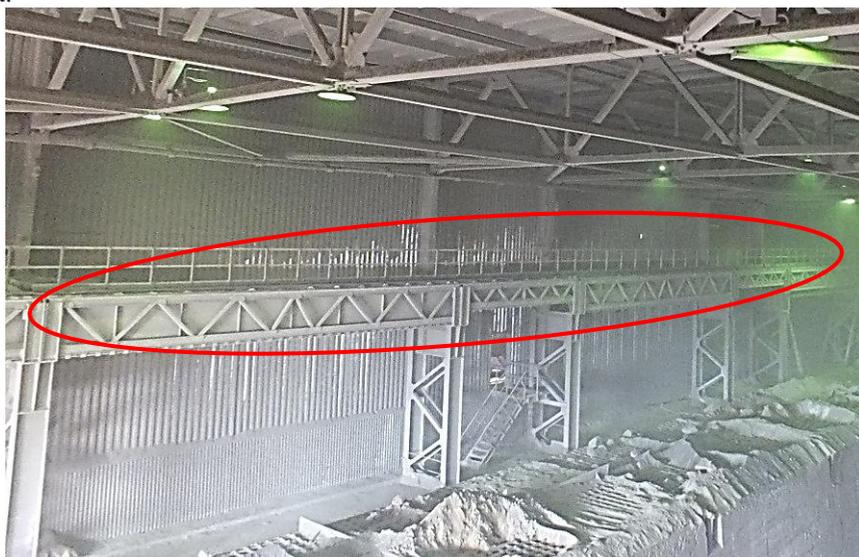
Fig. 8. General view of reinforced steel crane beams along the A axis with spans of 12 and 6 m.

The authors developed and implemented a project to restore their operability by strengthening the walls of damaged steel beams without stopping production which made it possible to significantly reduce the stresses in walls of beams from the moment caused by the eccentricity of load application from the crane wheels. Reinforcement of the crane beams is made on the outside of the eccentricities of the application of loads from the crane rails by creating a truss structure parallel to the I-beam (Fig. 8). The truss belts are made of I-beams, the diagonal lattice is made of steel bent closed welded square profiles (GOST 30245).

The constructive solution of reinforcement made it possible to significantly reduce the magnitude of local stresses from moments, the magnitude of transverse forces and, consequently, shear stresses, which are the main factors in the appearance and development of fatigue cracks in their walls [7]. When the reinforced beams were re-examined along the A axis in 2017 after 8 years of operation, no new fatigue cracks were found in their walls.

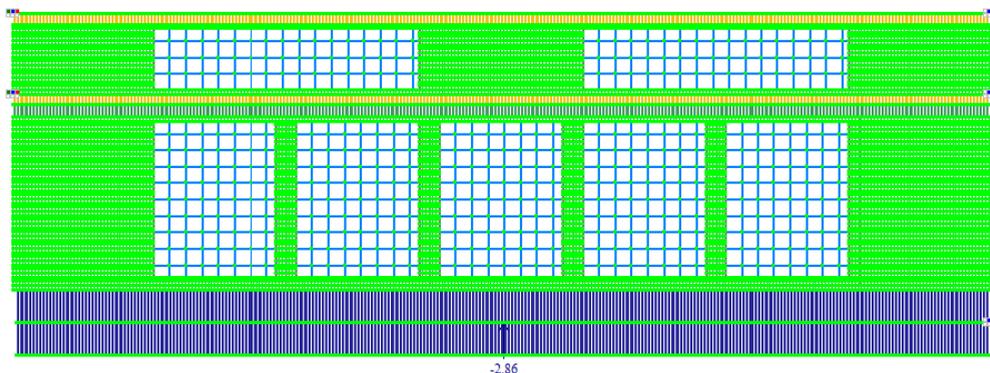
Based on the research carried out by the authors and to prevent clinker accumulation on horizontal brake beams with spans of 6 and 12 m the authors have developed a project that provides for making rectangular holes in them covered with a mesh of expanded metal sheets of PV 510 grade according to GOST 8706 or a steel mesh round hot-rolled $d = 10$

mm in accordance with GOST 2590 with a cell of 90x80 mm which is welded to frames made of rolled corners L50x5 in accordance with GOST 8509 (Fig. 9).

Fig. 9. Finite-element model of a brake beam with a span of 6 m with holes bordered by corners L50x5 in accordance with GOST 8509 and a mesh.

It has been established that the edging of holes filled from meshes or expanded steel in brake structures makes it possible to increase their endurance due to a decrease in horizontal displacements.
