# Engineering geological mapping for empirical design evaluation of Tunnel 10 of Jakarta - Bandung high-speed railway, Indonesia

**Abstract.** An engineering geological mapping was carried out at the construction site of the Tunnel 10 of Jakarta - Bandung High-Speed Railway to obtain data and information of the engineering geological conditions, particularly the rock masses. This research aims to determine the rock mass classes at the tunnel construction site and recommend the tunnel support system based on the Rock Mass Rating (RMR) and the Japan Society of Civil Engineers (JSCE) systems. This research is expected to better understand the rock mass classes, which were previously determined based on the newly applied Basic Quality (BQ) system for the tunnel support empirical design. The results showed that the research area consisted of young volcanic products, namely moderate to highly weathered tuff breccia and andesitic breccia. The uniaxial Compressive Strength (UCS) of rock mass varies between 1-25 MPa. The RMR value ranges from 21 to 40, indicating disintegrated and poor rock mass quality. The proposed tunnel support system is the combination of shotcrete, steel support for

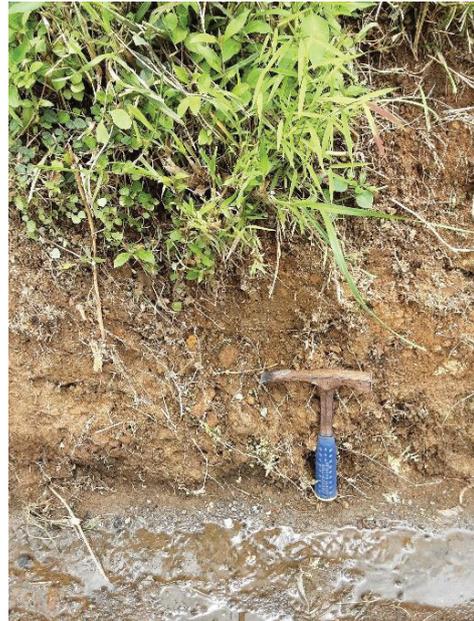
**Fig. 5.** Highly weathered tuff breccia in ST 4.

The spread of tuff breccia rock reached 58.48% of the total study area (shown in Figure 7 as a dark brown area). The tuff breccia rock observed on the surface has a moderate to a highly level of weathering so that the rock structure is not visible. The color of the rock is dark brown, composed of fragments measuring 0.06 - 2 mm with a fine-sized matrix - a very fine, poorly sorted with open packaging. Rock mass in Figure 5 indicates that ST 4 (Fig. 7) has a disintegrated structure with poorly interlocked, heavily broken rock mass with a mixture of angular and rounded rock pieces. The surface condition in ST 4 is poor with a slickensided, highly weathered surface with compact coatings or fillings or angular fragments. The surface condition of the rock mass is poor quality with a high degree of weathering.

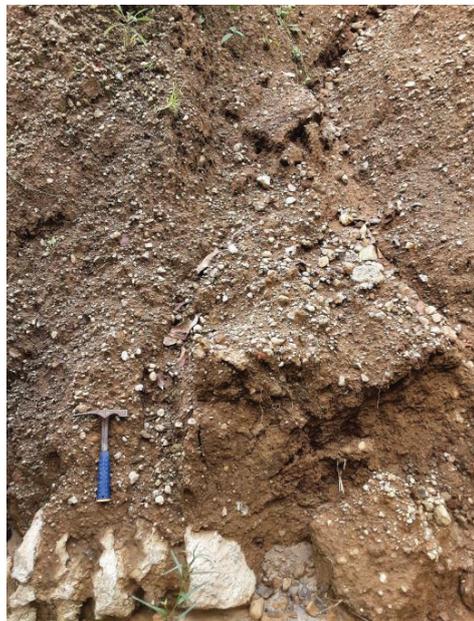
**Fig. 6.** Highly weathered andesitic breccia in ST 5.

area). Andesitic breccia has moderate to highly level of surface rock weathering so that the rock structure is not visible. The dominant rock color is light brown, composed of andesitic fragments from granule to boulder size with a matrix of granule size to very fine, poor sorting with open packaging. Figure 6 below shows that rock mass at ST 5 (Fig. 7) has a moderately weathered matrix with mainly andesite fragment size from coarse to boulder.
