Investigation and Research on Building Diseases in Yueliangdi Village, Yinggebao Township, Mulei Based on GIS and Infrared Thermal Imaging Technology

Abstract. In this paper, the representative buildings built in different periods of the village are observed and their types and conditions are recorded according to the phenomenon that the defects and diseases of the local historical settlements are increasingly serious due to blind transformation and excessive commerce in the protection work of moon village in Mulei County, Xinjiang. Then, the main building diseases of moon village are studied based on the theory of architectural pathology and GIS platform. The coupling relationship with local microclimate, and the degree of disease of the village houses are classified into three categories: light, medium and severe diseases. Based on the analysis of the change of macro climate and local microclimate conditions in the South and north of the East Tianshan Mountains, it is concluded that the main reason for the defect is the damp disease. The infrared thermal imaging technology is introduced to analyze the damp disease in the settlement, and the preliminary judgment method of the dam

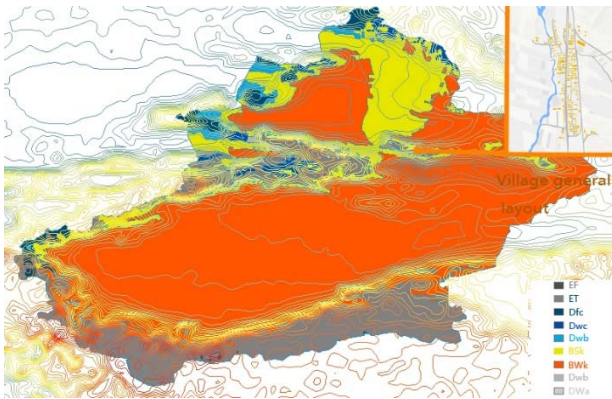
Fig3. Superimposed analysis of The GIS platform of Yuandi Village

In this study, the author used the Köppen climate zone theory and ArcGIS software to superimpose the Xinjiang Köppen climate zone with Xinjiang terrain contours and the geographic coordinates of Moon di Village and the author's general plane drawn by Google Maps. The analysis showed that Compared with other regions in northern and southern Xinjiang, the climate in Tianshan Mountains is more diverse and complex: the Tianshan Mountains have four types of semi-arid climate, monsoon climate, humid continental climate and tundra climate from low to high altitude. According to the geographic coordinates of Yueliangdi Village, the author judged from Fig. 2 and Fig. 3 that the climate type of Yueliangdi Village is a warm summer humid continental climate (Köppen classification Dfb climate). The main characteristics of this climate are: the coldest The average monthly temperature is below -3°C (27°F), the average temperature for all months is below 22°C (71.6°F), and the average temperature for at least four months is above 10°C (50°F). There is no significant difference in rainfall between seasons, and the data collected by the author verifies this

judgment: Yueliangdi Village ' s monthly average temperature is above 10°C in June, July, August, and September, and its precipitation varies in each season. There is no significant difference. From the collation of meteorological data, the author found that the annual precipitation in Yinggebao Township, where Moondi Village is located, can reach about 400mm, which can reach the standard of semi-humid climate. Because of the climatic conditions, Yinggebao Township and Mu Lei County became one of the main granaries in Xinjiang in the era of planned economy. Based on the above climatic materials, the author proposes that there is a crisis of damp disease at the northern foot of East Tianshan Mountain represented by Mu Lei.

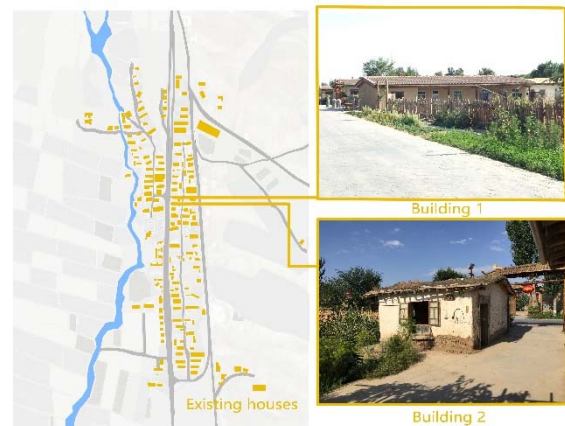
Fig4. General layout of yueyuendi village and selected residential buildings

This article selects two representative residential buildings, and introduced the infrared thermal imaging study, from the village general layout (Fig. 4), the two houses in the village of the moon to middle, because of the distance from rivers are ruled out the influence of river foundation, structural system, the same are adobe brick wall structure, Moreover, the two residences were built in the 1980s for local residents to live in for a long time, rather than built in recent five years for tourists to stay in the family hotel. The only difference is that the wall structure of Building 1 is larger than that of Building 2. In terms of wall structure, the outermost side of Building 2 is

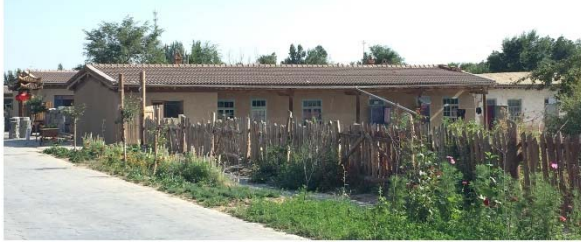
Fig5. Investigation and analysis of Building 1 disease

According to the pathological investigation results of Building 1 (Fig. 5), the east side of the main facade of Building 1 (the part on the right side of Fig. 5 that was not painted with imitation clay finish) was affected by rain and freeze-thaw. Most of the painted wall layer fell off, and the cracking and falling off of the overlying soil layer appeared in some parts. And on the west facade because its new finishes painting and no peeling phenomenon occurred, but under the eaves stylobate up part is a large painting layer infiltration, the phenomenon of empty drum, at the same time the entire building in the stylobate part, the porch pillar and window mouldings cracks occurred in the part of the crack and the material corrosion phenomenon, a few parts in the mould. To choose a building 1 eaves column and girder junction in judgment, temperature cracks found relative to other parts of the surface temperature is lower, while the eaves columns, girders and wooden fang also presents the low temperature condition, and from the hot like part of the larger area relatively visible moisture, shown in the figure shows that in the stylobate internal to the naked eye can't wet condition is still there.

3.1 Pathological analysis of hollow drum and peeling of wall painting layer

As local precipitation more focused on September 4 -, make settlement in the period of focus is washed by the rain, because of their special civil structure, combined with the roof overburden soil water storage ability is limited, the rain is through the roof into the wall, at this time the moon river surrounding the village just thaw, water reached the peak of my year, makes the soil moisture content is affected by river also showed a trend of rise, soil water down the stylobate to rise due to capillary action, make its damp is in serious condition at the point; Moreover, the temperature difference between day and night in the valley is huge, especially in April, when the daytime temperature is relatively high, the seepage vaporizes and expands, causing the deformation of the painted layer and the empty drum. Because the night temperature can fall below 0°C, the seepage can freeze and expand, causing the peeling layer to break off. As the facade wall of building 1 is shielded by the front eave gallery, the evaporation rate of infiltration rainwater on its

surface is slow, which makes the rainwater penetrate into the painted layer more than other parts, so the empty drum phenomenon is more obvious. The west facade is due to the perennial upward adsorption of soil water, which causes the large area of its painted layer to fall off, and the obvious infiltration marks of its base, and mildew spots also appear in some areas.

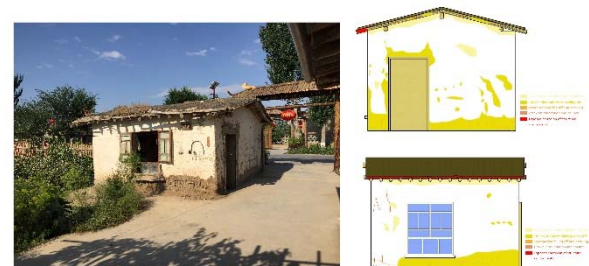
Fig7. Investigation and analysis of Building 2 disease

In Building 2, due to the failure to refresh the veneer outside the overlying soil layer, a large number of empty drums and peeling of the painted layer appeared. In addition, the cracking and shedding of the overlying soil layer in this building was significantly more than that in

Building 1, and there were also many cracks on the cornice. As shown in Fig. 3, from the direction of the gable, take the north facade as an example. The overlying earth cracks appear on the gable wall subjected to freeze-thaw action, and some cracks are long, up to 1.1-1.2m, with a width of 10-15mm and a depth of about 15mm. East facade direction its disease situation is relatively serious, appeared in the stylobate turns the soil loss, caused a large number of adobe bricks, exposed the relate to soil moisture stylobate is larger, and the influence of the freeze-thaw action on, at the same time, the border of stylobate and ground in a small amount of moss, the longitudinal wall part of the soil loss relative gable is more apparent, some parts of the fixed effect of oblique cross wood has also exposed long; In addition, the cornice part of Building 2 also suffered from deformation of cornice sealing plate and screw falling off due to rain water, freeze-thaw effect and old disrepair. Building 2, the author find out the typical stylobate and entrance door window frame based on infrared thermal image (Fig. 8), from the infrared thermal image shows: first, the temperature differences on the stylobate in conformity with the stylobate in vertical and horizontal cracks, and relatively intact surface temperature is higher, the more susceptible to cracks and rain, soil water infiltration and shade shadow; The shedding degree of the plastering layer at the base is also shown in the infrared thermal image because of the difference of heat transfer coefficient of different materials (exposed structural members).

The cracking of the overburden soil layer in Building 2 is obvious, and the reason of the cracking of the overburden soil layer is similar to that of the peeling of the overburden layer, both of which are caused by rain scouring, soil moisture and freeze-thaw action. However, the cracking and shedding of the overburden soil layer relative to the whitewash soil layer need to go through a slow and long process, which is often the result of years of accumulation.

Cracks are mostly found in the base and columns of the two dwellings, and the pathogenic mechanism is the same as the former two. Deformation of the components from the west side of building 2 verge board found that verge board bending deformation due to more people ignore the maintenance set screw, together with concentrated rainfall make wooden strip infiltration, and then affected by temperature changes and the effect of freezing and thawing, the bending deformation, the verge of building 2 board shall promptly repair, to avoid falling and injuring residents; The exposed corrosion phenomenon of the component is more than that found at the base and windowsill thread foot. The reason for this phenomenon is that the aforementioned cracks have not been treated in

time, which leads to their continuous development and finally causes the external plastering layer mortar to break off.

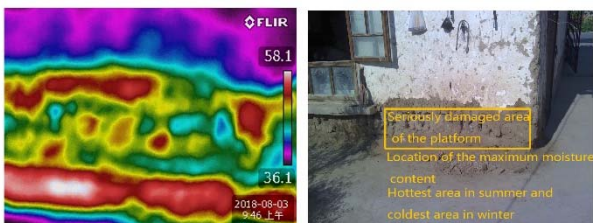
Fig9. Analysis of moist infrared technology of platform base

Come to a conclusion from the above analysis, the moon to village settlement main disease with local climate and environment more damp conditions, according to the author's research results before^[6], the introduction of infrared thermal imaging technology for wet disease diagnosis and analysis, as shown in Fig. 9, the author choose at building a stylobate is analyzed, through visual found its most serious stylobate damaged area (turns the soil loss, adobe bricks exposed), as shown in the right yellow area is further proof of the author studied before flooding bricks into a nonlinear relationship between moisture content and moisture distance, and then by the infrared thermal imager and determination of moisture meter, It is found that the seriously damaged area of the platform should be the hottest area in summer and the coldest area in winter, that is, the part of residential buildings with disguised thermal Bridges. At the same time, according to the determination of moisture meter and previous research results, the author can determine the minimum temperature area and the location of the maximum moisture content of the platform moisture disease^[4].
