Experience in inspection of operated rural school buildings

Abstract. Summarizing the experience of examining school buildings built in rural areas in 1950 - 1990, the article draws conclusions about their technical condition and compliance with the requirements of modern regulatory documents. All surveyed school buildings do not meet the requirements for resistance to heat transfer of enclosing structures, accessibility for all categories of low-mobile groups of the population. The article presents the results of a survey of a high school building in the Oblivsky district of the Rostov region and a high school building in the village of Karaichevskaya in the Rostov region, high school building in the Kuibyshev district of the Rostov region. A number of defects and damages were found in the buildings under investigation. The analysis of the experience of survey of school buildings located in rural areas of the Rostov region.

3.1. The result of the survey of the building of a secondary school in the Oblivsky district of the Rostov region

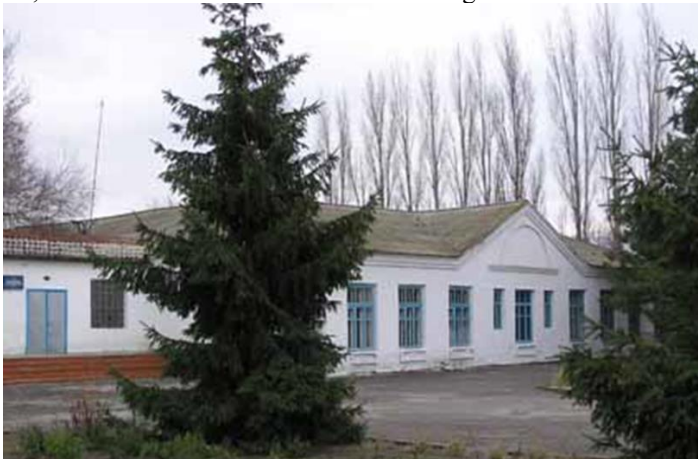
Fig. 1. The building of the "old" school.

The foundations of block 1 (the "old" school building) are made of rubble strips supporting aboveground structures-longitudinal and transverse walls of clay bricks with a thickness of 510 mm (external) and 380 mm (Internal). The internal surfaces of walls and brick partitions 120 mm thick are plastered with clay mortar.

The lintels above the window and door openings are made of wooden beams. Cover the attic with wooden beams. The ceilings are boarded and plastered with tiles and clay mortar. The roof is four-pitched from asbestos-cement wavy sheets on a wooden box.

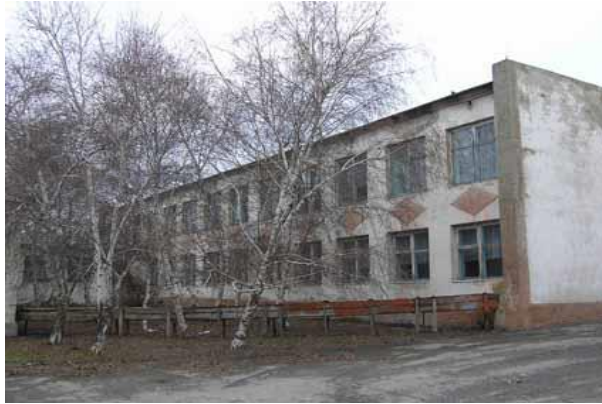
Fig. 2. Block 2 of the training complex.

Block 2 foundations - rubble concrete and supporting aboveground structures - longitudinal walls made of clay bricks with a thickness of 510 mm. The external and internal surfaces of the walls are plastered with cement-lime mortar. 120 mm thick brick walls. the lintels over the window and door openings are reinforced concrete, factory-made. The building's floor coverings are made of reinforced concrete multi-hollow slabs of the 1.141-1 series. Stairs made of reinforced concrete, supported on a reinforced concrete slab platform. The surface is flat on reinforced concrete slabs. The roof of the building is made of rolled roofing material on bituminous mastic with expanded clay insulation. Drainage from the roof is not organized in the direction of the external longitudinal walls of the Eastern and Western facades.

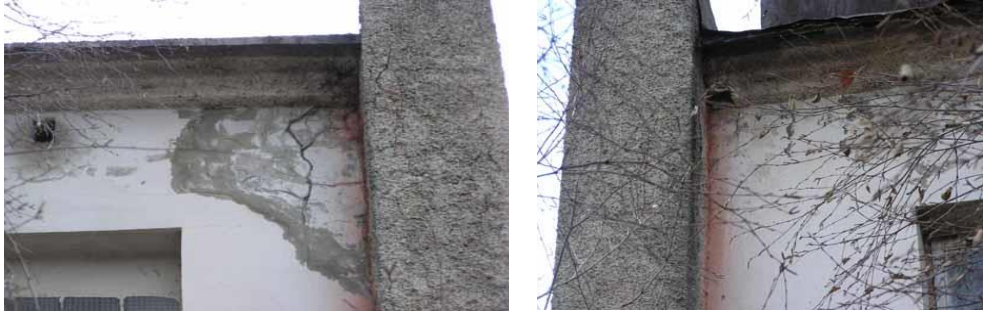
Examination of the school complex revealed a number of defects and damages[7, 8], the main of which are through cracks 2-3 mm wide opening in the gym wall (Fig. 3), defects in external masonry and plaster associated with atmospheric influences, which include thawed and destroyed local sections of plaster and masonry walls to a depth of 100 mm (Fig. 4) cracks of various lengths and widths of the opening above the openings of the external walls of block 1 (Fig. 5).

Fig. 3. Through cracks 2-3 mm wide in block 3 of the school complex.

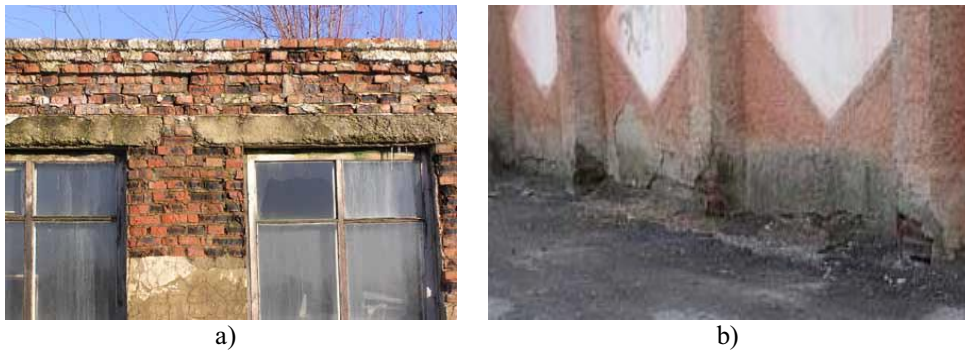
Fig. 4. a) thawed and destroyed to a considerable depth sections of external brick walls; b) destroyed pilasters in the wall of the gym in those places where the blind area is adjacent.

5. When the condition survey of the adjoining territory of school complexes in all cases showed local destruction of blind area around the perimeter of the buildings and the gaps of the blind area in close proximity to the walls of buildings in the input places of communication. It is necessary to ensure the supply of external communications, ensure the tightness of the inputs, restore the blind area, perform landscaping of the surrounding area, including the removal of vegetation located near buildings.

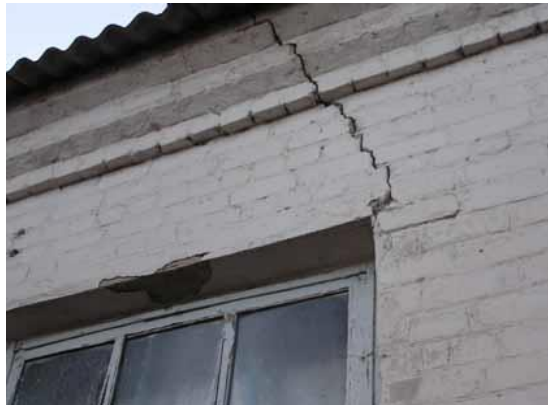
Fig. 5. Cracks above the aperture in block 1.

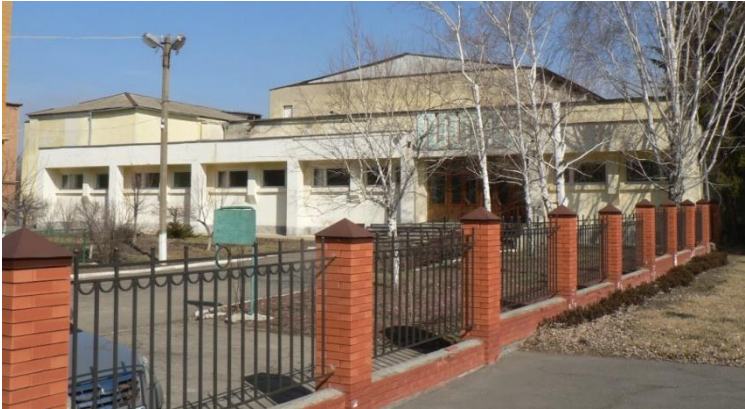
The high school building in the Kuibyshev district of the Rostov region, built in 1989, is a two-story building with a ground floor and has a T-shape with dimensions of 42.0×54.0 m in plan (Fig. 6). In addition to training halls, the building has a training and game rooms. The game room on the +4100 level has a built-in second level (balcony). The total area of the building is 2917.3 m². The construction volume is 9440 m³.

According to the design scheme, the building is made with load-bearing external and internal longitudinal and transverse brick walls made of ceramic bricks on cement – sand mortar, precast concrete floors and coatings external and internal walls and partitions are made of ceramic bricks on cement – sand mortar with a thickness of: external walls – 510 mm, Internal-380 mm, partitions-120 mm.

Fig. 6. General view of the school building in the Kuibyshev district of the Rostov region.

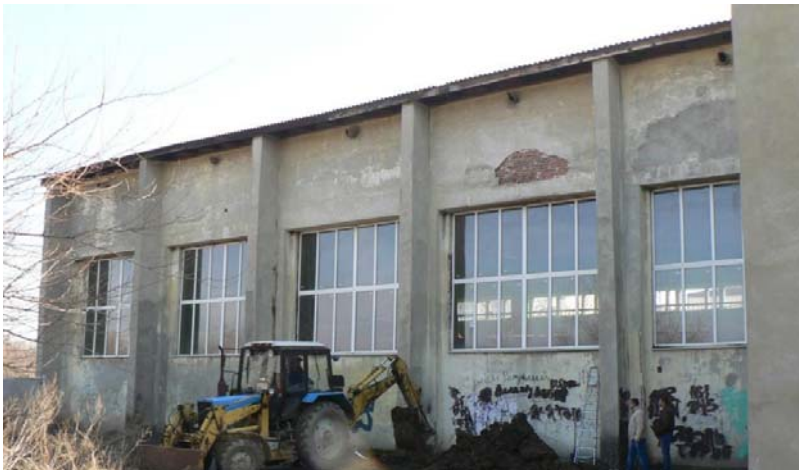
During the operation of the building, due to prolonged soaking of subsidence soils located at the base of the foundations, uneven deformations occurred, as evidenced by cracks in the load-bearing walls with varying degrees of disclosure. The reason for uneven deformations of Foundation soils is their soaking due to the partial destruction of the blind area around the perimeter of the building and leaks from engineering communications (Fig. 8).

Fig. 7. State of load-bearing structures of the game hall.

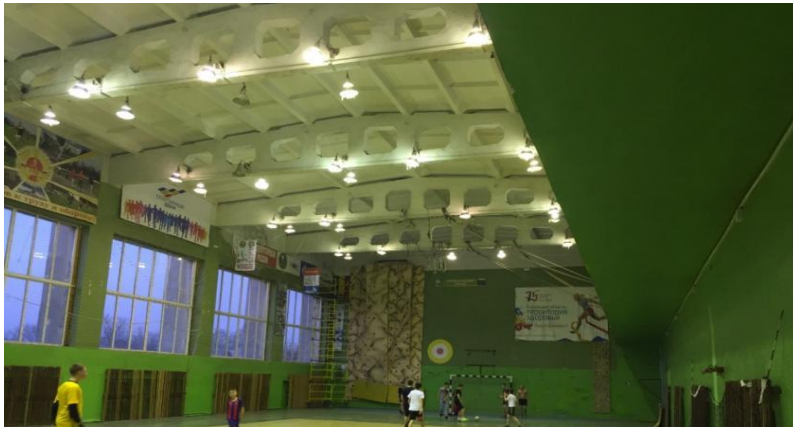
The floors and surface of the building are made of precast concrete slabs and monolithic profiles of various sizes on reinforced concrete and metal beams (Fig. 8).

Fig. 8. School game hall with load-bearing structures made of precast concrete structures.

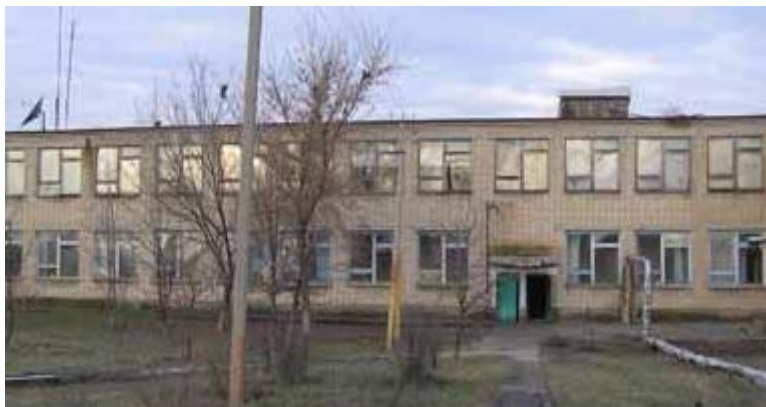
The secondary school building in the village of Karachevskaya in the Oblivsky district of the Rostov region has a complex configuration with overall dimensions of 51.86×21.15 m (Fig. 9). The building is two-storeyed with the built-in one-storeyed (in two lamps) gym, in a zone of a stairwell there is a technological underground 8.0 m long in which inputs of communications and a heat node are located. The total height of the building is 6.9 m with the height of the first and second floors 3.0 m.

Fig. 9. Facade of the school building in the village of Karachevsky

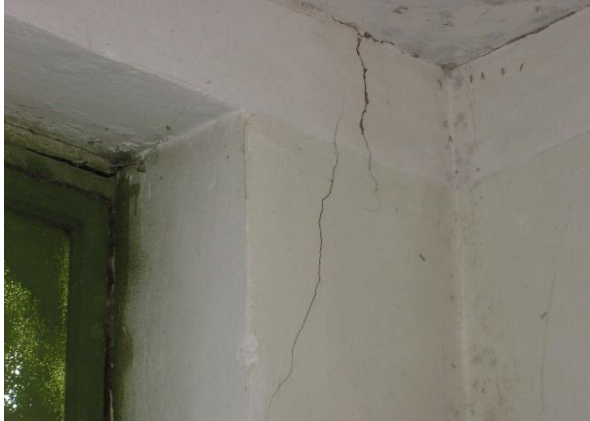
The main defects and damages identified during the survey are cracks of various lengths and widths of opening caused by uneven deformations of foundations in places of systematic soaking of Foundation soils (Fig. 10), thawed and destroyed local sections of walls, low strength of cement-sand mortar in masonry joints.

Fig. 10. crack above the 2nd floor window opening.
