Actual problems of the design documentation development for capital repairs or reconstruction of capital structural facilities

Abstract. The article discusses some urgent problems that designers face when developing design documentation for overhaul or reconstruction of capital structural facilities using the example of the object " The pool overhaul at the address: Rostov-on-Don".

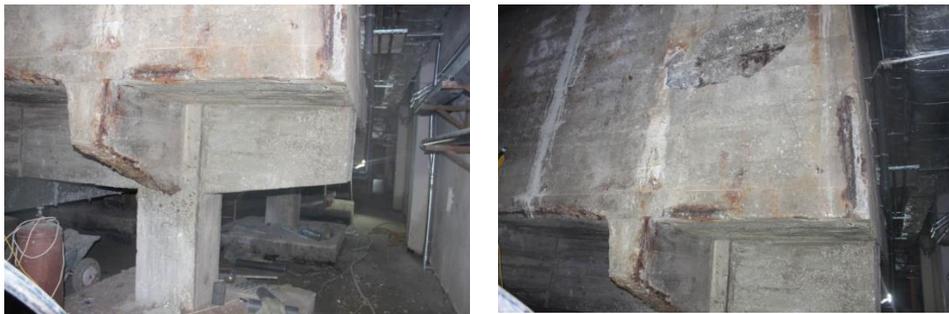
Significant defects and damage recorded during the survey - significant damage to the reinforcement by corrosion from 40 to 90% of the cross-sectional area. In addition, it should be noted that the protective layer of concrete in the walls is peeling off. In the cantilever beams of the deep-water part, cracks with an opening from 0.3 to 1.0 mm were recorded. This characterizes the destruction of these cantilever beams from the acting load. Reinforcement corrosion is on average up to 30%, which makes the periodic profile of the reinforcement indistinguishable. Destruction of the protective layer of concrete and corrosion of reinforcement of monolithic structures adjacent to the pool bowl.

Fig. 1 and 2. General view of the pool bowl structure.

The greatest corrosion destruction can be observed on the end wall, side walls of the deep-water part of the pool bowl.

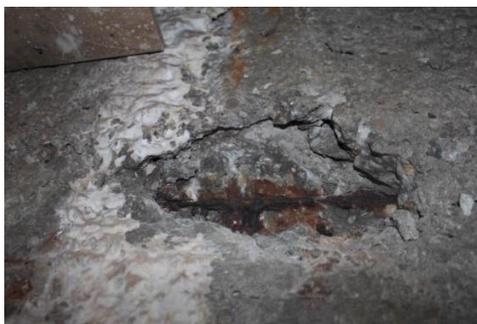
In the course of the survey, another reason for the violation of the concrete structure was discovered - physical corrosion of the reinforcement.

Thus, the corrosive destruction of reinforcing steel was the result of the combined action of neutralization of the concrete moisture-alkaline environment (carbonization as a continuous process) and de-passivation of reinforcing steel due to the effect of chlorine ions contained in the water of the pool bowl (continuous process).

Fig. 3. Opening the bowl structure from the side to determine the existing pool bowl reinforcement state.

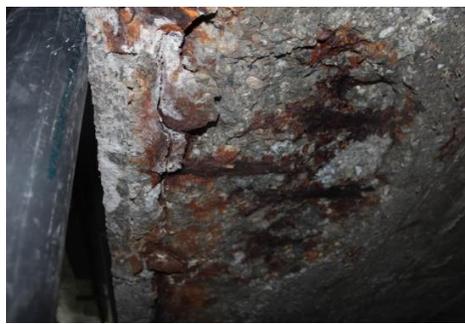
Fig. 4. Opening the structure of the pool bowl from the bottom side to determine the existing reinforcement state.

The main reason for the existing defects in the pool bowl structures is massive and regular leaks caused by a malfunction of the waterproofing.

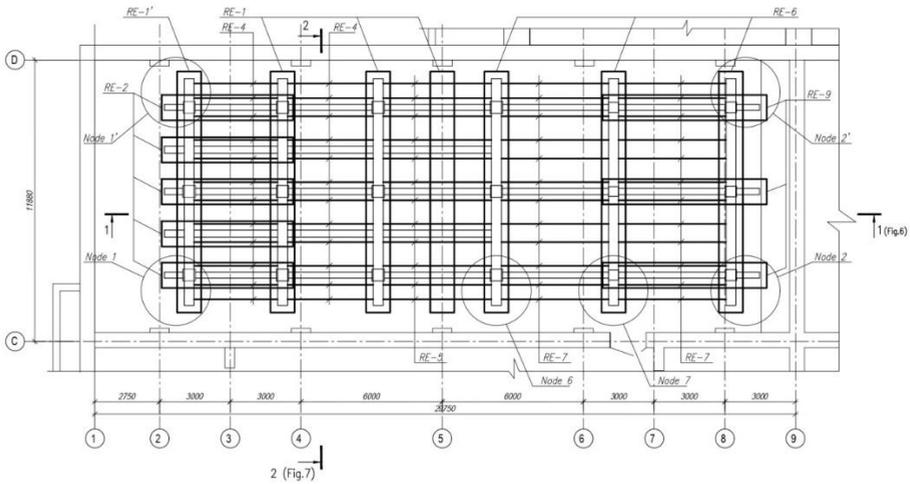
Fig. 5. Layout of amplification elements.

- installation of reinforcement elements RE-3; RE-3'; RE-3a; RE-8; RE-8' in the design position, installation of the support sheets of these elements on the freshly laid solution for a snug fit;

- installation of reinforcement elements in the design position RE-12 (support beams);
- installation of reinforcement elements RE-2 to the design position, welding along the perimeter of the contact zone with the support beams RE-112;

- installation of reinforcement elements RE-1; RE-1'; RE-6; RE-0 followed by welding along the perimeter of contact with downstream structures;
- installation of bottom reinforcement sheets and at the same time installation of bottom reinforcement beams RE-4, RE-5, RE-7;

- installation of sheets for strengthening the walls of the bowl and at the same time installing beams to strengthen the walls on the supports RE-1; RE-1'; RE-2; RE-6; RE-9 followed by welding along the contact zone perimeter;

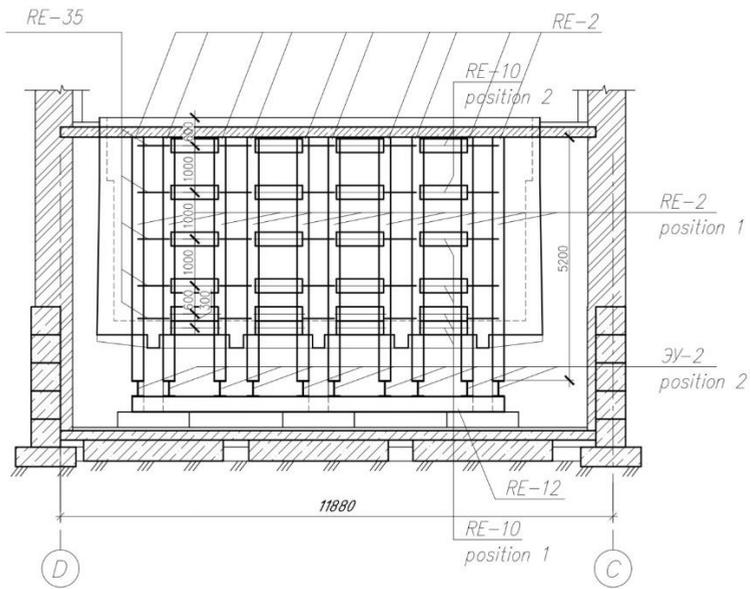
Fig. 9. View 2 (end, deep-water side).

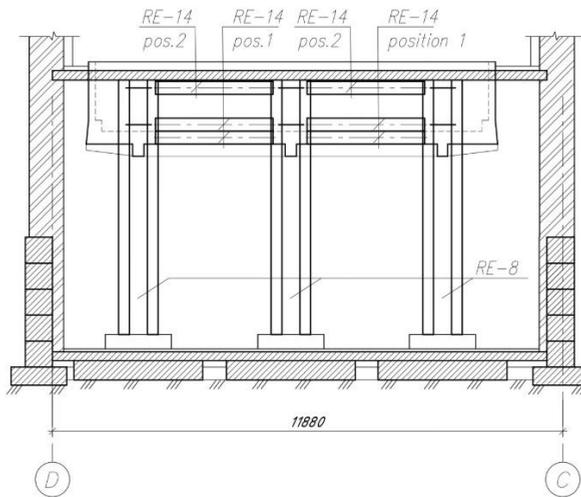
Fig. 10. View 3 (end, shallow water side).
