Innovative method for optimizing the microclimate of the winter hive for bees in the conditions of the cryolithozone

V.K. Evsyukova*, M.S. Savvinova, V.V. Sysolyatina, F.V. Nikolaeva, and A.Ya. Fedorov

Federal State Budgetary Educational Institution of Higher Education "Arctic State Agrotechnological University", 677007 Yakutsk, Republic of Sakha (Yakutia), Russia

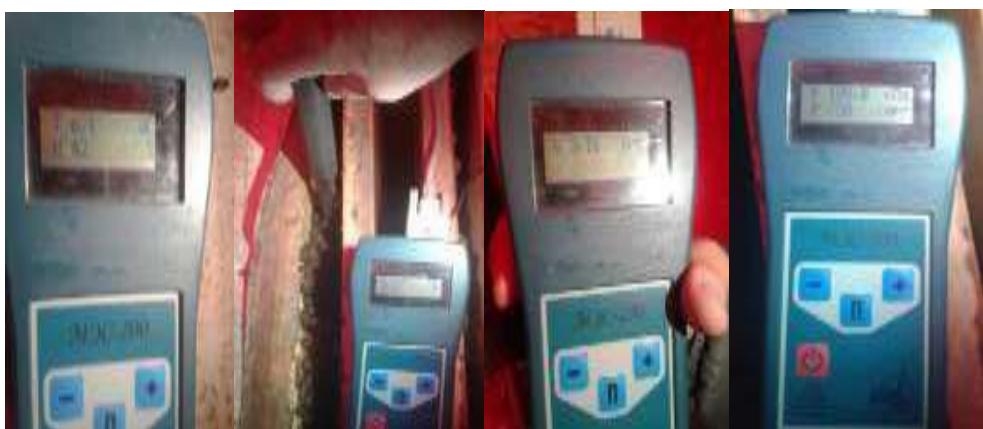
Fig. 1. Indicator of temperature and humidity

Fig. 2. Measurements in the hive inter-frame space

Fig. 3. Air velocity

Fig. 4. Pressure measurement

The average humidity in the winter hive is 42%, which does not correspond to the zoohygienic norm (Fig. 1). The optimal humidity should be 75-85%, but not lower than 65%. In the inter-frame space, the air humidity is 43%, which is also lower than the zoohygienic norm (Fig. 2). The humidity was optimized by placing water vessels in 3 places on the floor.

The average air temperature was +5°C, but in some places negative indicators of -18°C were observed. The range of temperature fields turned out to be wide. The speed of air movement in the winter hive premise is 0.18 m/s in some places (Fig. 3), which exceeds the zoohygienic standard by 0.08 m/s and 0.30 m/s (Fig.1,2,3,4 and Table 2).

1. When studying the microclimate parameters of the winter hive by generally accepted zoohygienic methods, the following results were obtained: there is a strong range of temperature fields, the average air temperature is $5\pm2.15^{\circ}\text{C}$, which is higher than the standard by $+1^{\circ}\text{C}$, in some places the temperature decreases to -18°C ; air humidity is only 42%, which is lower than the standard by 33-43%; air humidity in the inter-frame space is 43%, which is lower than the standard by 17-22%; air velocity is 0.18-0.40 m/s, which is higher than the standard by 0.08-0.3 m/s; illumination 0.0003 Lux meets the requirements of zoological hygiene; atmospheric air pressure is 750 ± 1 Hg. - within the normal range (Fig. 1,2,3,4).

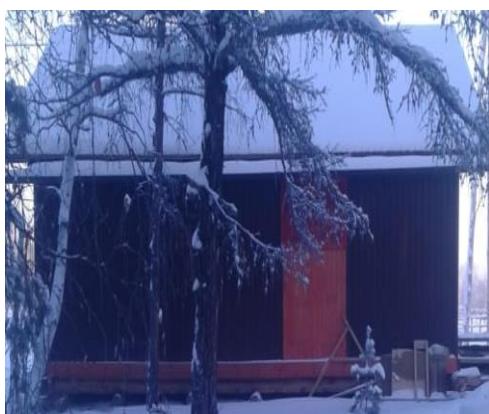
Fig. 5. View of the winter hive from the left side.

The entrance group (doors) have shutter defects, which leads to insignificant, but noticeable heat losses from above (Table 2 and Fig. 5,6). Heat loss can be minimized by

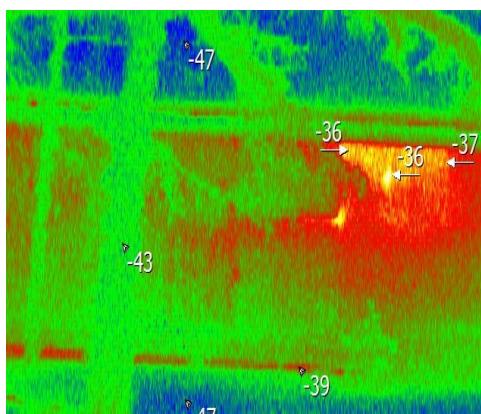
Fig. 6. Heat chart with defects of winter hive enclosing structures.

During the thermal imaging control of the external enclosing structures of the building, it was found that the temperature field is uneven. Defective areas with low thermal characteristics were identified on the enclosing structures. Such areas are: the seams of inter-panel insulation joints (glass wool) and the internal chipboard panels. In some places, the sealing of the joints of the enclosing structures (floor, walls, floorboards) was carried out poorly or damaged during operation (Table 2 and Figure 5,6,7,8,12).

The use of the infrared scanning method made it possible to instantly determine the reasons for deviations from the standards of the winter hive microclimate parameters for bees (Fig. 6,8,12), thereby promptly and purposefully eliminate them, and optimize the parameters of the winter hive microclimate (Table 2), and increase the successful wintering of bees (Table 2).

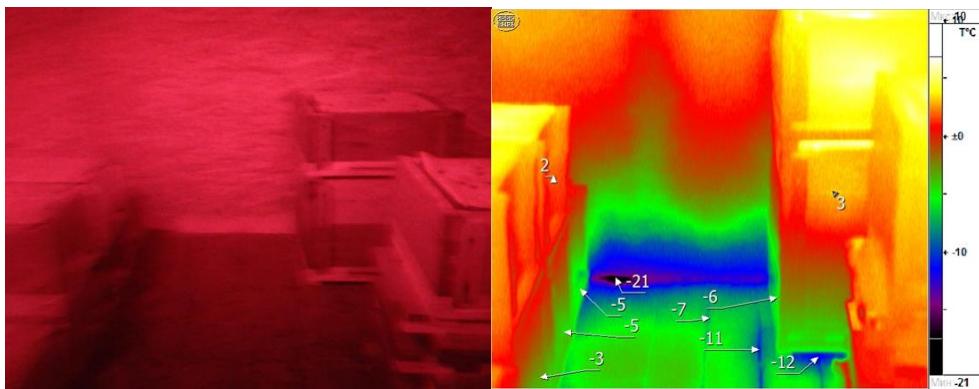
Fig. 7. Floor and walls of the winter hive back wall.

Fig. 8. Heat chart with defects of winter hive enclosing structures of walls, floors and floorboards with a temperature of -21°C .

better sealing. Heat losses were detected through the joints of external structures in contact with the floor (Fig. 7,8,12), as well as between the joints of the floorboards (Fig.8).

To eliminate heat losses, measures were taken to insulate the joints between the panels, the upper part of the door, the walls and floor, floorboards.

The club is located on the 2nd unit (Fig. 11, 12). The placement of the bee club on the second unit is explained by the low temperatures of defects in the joints of the walls and floor, as well as between the floor boards (Fig.3,4,7,8). By the nature of the bee colony, the club rushes to the warmest place, even if there are feeding frames on the first one. Cold and draughts irritate bees (Fig. 12).

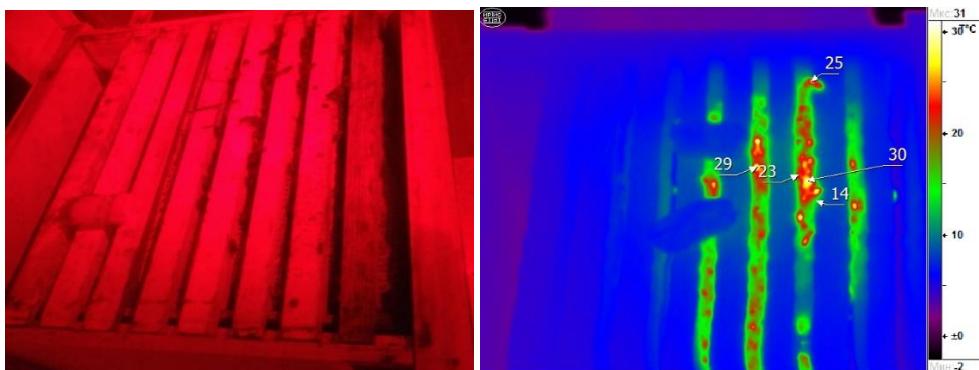
Fig. 9. Photo of the overframe space.

Fig. 10. Thermal diagram of the temperature distribution in overframe space with the analysis of thermal fields.

As can be seen from the thermal diagram (Fig.10), the main core (thermal center) of the club is located on 2-3 frames. The club density is not destroyed, the bees are calm. The club center temperature is 30°C, which proves the absence of brood (the presence of brood in the winter months is extremely undesirable - the food reserves and resources of the bee body are depleted, which would lead to colony death). In the presence of brood, the club temperature rises to 36.5°C).

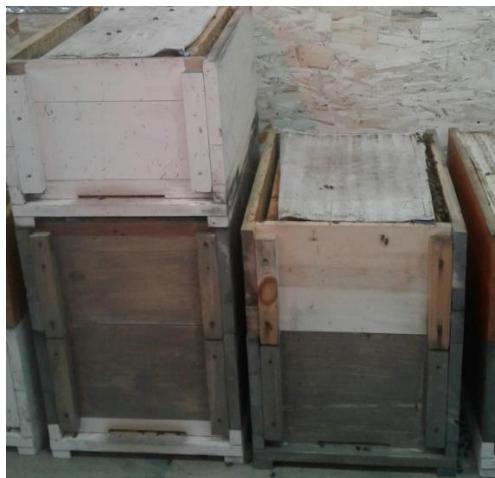
Fig. 11. Defects and club placement are not visible in the photo.

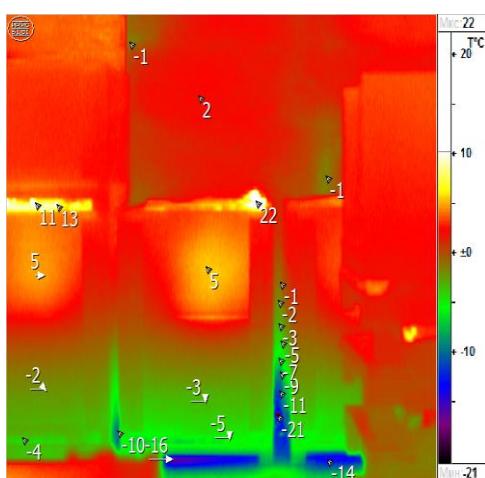
Fig. 12. Heat chart shows the club placement and the defects of the walls and ceiling with temperatures.

3. Infrared scanning can successfully monitor the state of bee colonies, without disturbing them at the time of winter dormancy: the heat charts clearly visualize where the club of bees sits, what frames it occupies, whether there is a brood at the club temperature (Fig. 11,12).
