# Research on Construction Crack Diagnosis and Treatment Technology of Double-Column Large Cantilever Pre-Stressed Bent Cap

**Abstract** This paper took a pre-stressed bent cap of a high pier of a bridge as the research object, expounded the crack type and construction process of the bent cap, combined with the numerical calculation and analysis of the construction process to study the crack generation mechanism and its influence during the construction period of the bent cap. Besides, it gave the repair and treatment technology of jacking and unloading combined with pressure glue, so as to provide reference for the disease diagnosis and treatment of similar bridge structures.

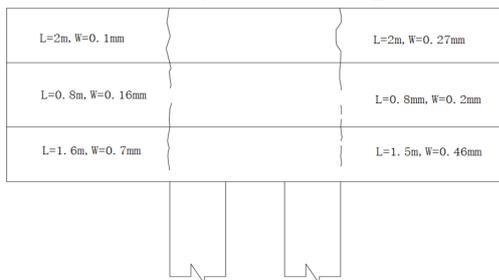
**Figure 1** Crack diagram of 9# bent cap (Unit: m)

The nine bent cap with the pier height greater than 40 m all had cracks from the installation and erection process of the T-beam to the second pre-stressed steel tendon tensioning. The cracks were distributed at the root of the bent cap cantilever and extend from both sides to the top surface, the length of cracks on the sides of high and low pile numbers is different. The serious cracks are in double "L" shape and extend downward to the position of 20 cm ~ 30 cm from the bottom surface of bent cap, but none of them reach the bottom surface. The cracks are wide in the middle of the side of the bent cap, and narrow in the top and end of the side cracks. The cracks are wide in the middle and thin at both ends. The maximum width of the side cracks is 1.42mm, and the maximum width of the top cracks is 0.53mm. The schematic diagram of cracks in the 9# bent cap is shown in Figure 1.

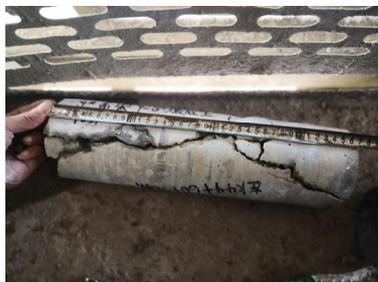
**Figure 2** Photo of cracks in 9# bent cap

From the photos of 9# bent cap cross seam drilling core sample (Figure 2) and the cross seam section after 11# bent cap removal (Figure 3), it can be seen that the side cracks of 11# bent cap high and low pile number almost run through the entire section; The coring length of 9# bent cap is 37 cm, and the crack is still extending inward. Due to the limitation of the detection method, the specific information of the crack depth cannot be given, but the crack depth of the bent cap can be judged to be deeper.

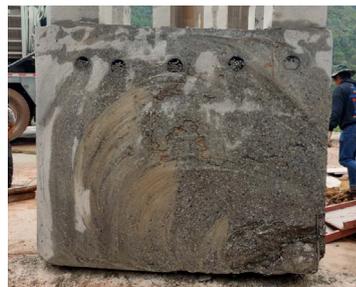
**Figure 3** Cross-section photo of 11# bent cap cut across seam

The lateral vertical cracks at the root of the cantilever of the bent cap and the "L"-shaped cracks connecting the side and the top are the negative moment bending cracks under the most unfavorable construction load. The anatomy of 11# bent cap reveals that the cracked area along the width direction of the bent cap has accounted for more than 2/3, and the cracked area along the height direction of the bent cap has accounted for more than 1/2. Compared with the theoretical calculation, the width and height of the compression area of the structure are greatly reduced, which will have the following effects on the structure: After the bent cap is cracked, the internal force of the cross section is redistributed, the area of the concrete in the compression zone of the cracked section is reduced, the shear resistance section is reduced, stress concentration is formed, resulting in stress concentration and greater loss of bearing capacity. After the bridge being put into operation, the live load may lead to further increase of crack development, aggravation of crack degree and even damage.

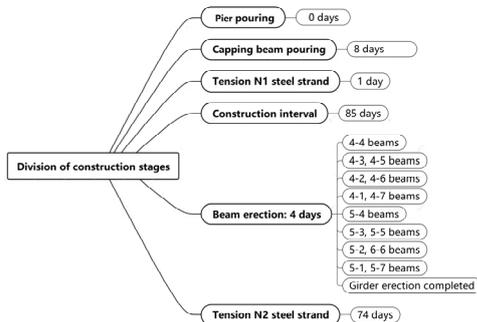
Figure 4 Division of construction stages

(3) Construction stage: The construction stage is divided into 14 construction stages as shown in Figure 4 during calculation, in which the girder body is erected in the order of 4, 3, 5, 2, 6, 1 and 7, as shown in Figure 5. In the process of erecting T-beam by the bridge erector, T-beam can move along the longitudinal and transverse bridge directions as shown in Figure 6.

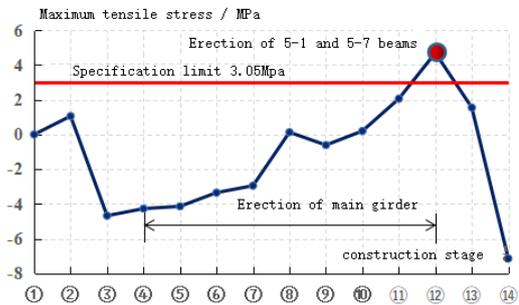
Figure 7 Maximum tensile stress of top edge of bent cap pier top section

shown in Figure 7 and Figure 8. It can be seen from the figure that the maximum tensile stress of normal section on the top edge of bent cap pier top section is 4.70MP when 5-1 # and 5-7 # beams are erected in construction stage 12.

Based on the above analysis, it is considered that after considering the temporary load during the construction period, under the most unfavorable condition of T-beam installation and erection, the maximum normal cross-sectional tensile stress on the top edge of the top section of the bent cap pier reaches 4.70MP, which has exceeded the specification limit of 3.05MPa, cracks appear in the cross section of the bent cap pier top and the root of the cantilever. The calculation results are consistent with the actual bridge test results, indicating that the construction temporary load has a greater influence on the mechanical performance of bent cap.

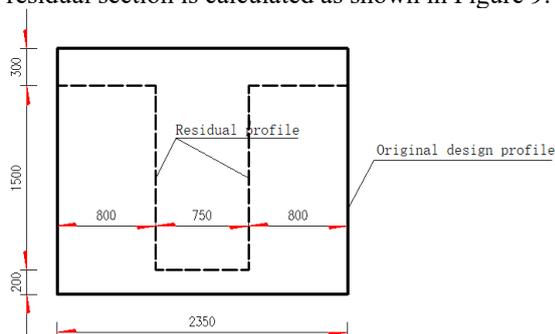
**Figure 9** Calculation of residual section of bent cap

Based on the investigation results of the cracking status of the bent cap, the shear bearing capacity and shear section of the cracked bent cap are checked, and the residual section is calculated as shown in Figure 9.

The load effect of the shear bearing capacity of the control section of the bent cap (the root section of the outer cantilever of the bent cap) is 12556.6 kN, and the bearing capacity is 3433.4 kN; The load effect of the shear section of the control section (the root section of the outer cantilever of the bent cap) is 12556.6 kN, and the bearing capacity of the shear section is 4192.3 kN. The bearing capacity of the residual section and the shear section of the bent cap do not meet the requirements of the code. If the glue injection method is considered to repair the original concrete section, the effective bonding depth should reach 63cm. It means that the width of the section involved in the force should be at least 2000 mm.
