Problems and countermeasures in the restoration project of cultural relics of Macao Chong Sai Pharmacy

Abstract. The Macao Chong Sai Pharmacy has a long history and rich historical materials. It is not only a cultural relic of Sun Yat-sen's old democratic revolution in Macau, but also the former residence of the new democratic general He Chang in Macau. It is also the site of the Sino-Western maritime trade transit terminal. Triple cultural relic value.

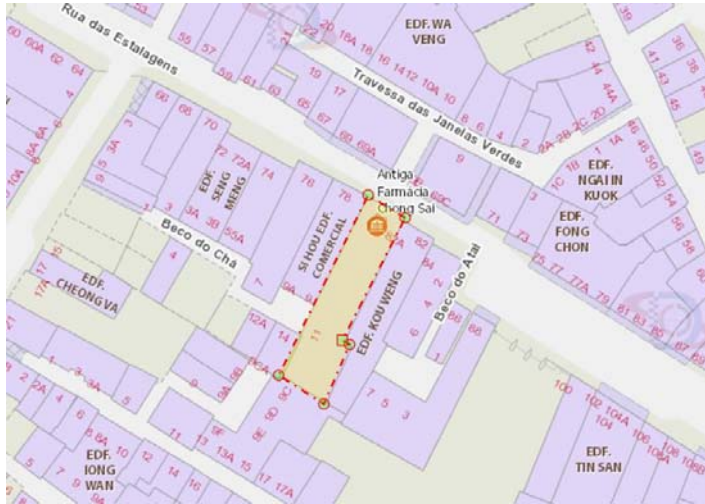
Fig. 1. The floor plan of the Chong Sai Pharmacy (webmap.gis.gov.mo).

The Chong Sai Pharmacy is located at No. 80 Caodui Street, Macau (Picture 1), with a width of about 5 meters, a depth of about 28 meters, and a height of about 17.5 meters. It is divided into three floors. It is a typical Lingnan bamboo tube house building with the layout of the lower story and upper story (pictured 2). The building is a brick-wood structure, with hard mountain purlins, double-slope tile roofs, and bright light tiles on the roof to enhance the natural lighting in the interior. The wall is made of blue brick walls, with 5 straight and 1 dicing methods, and thin brick joints. The front elevation has a concave door design, with front cornices and gable heads. The door consists of a sliding door and a panel door. The panel door is changed to a glass door after restoration. There are two types of windows: shutters and oyster shell windows. Oyster shell windows are traditionally crafted windows in which the shell is polished into a semi-permeable shell and embed ded in the wooden window frame. It has the function of heat insulation and wind shelter.

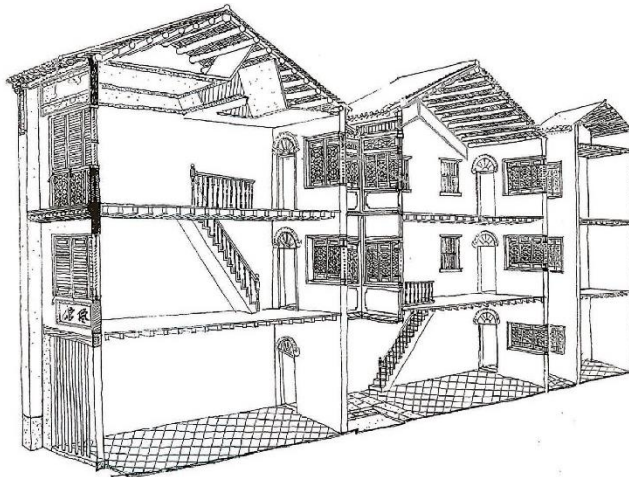
Fig. 2. Sectional view of Chong Sai Pharmacy (Ta Kung Pao [8]).

The facade is three-in-depth, the floor is covered with orange clay stairs, and there are 2 patios in the middle for ventilation and lighting. The middle of the first floor is the relic of the dock stone structure during the Ming and Qing Dynasties. The interior door is an arch, and the lintel is covered with petals. The semi-circular gray clay sculpture, with bat-rat brackets at both ends of the door lintel. The suspended ceiling is square and concave, surrounded by money patterns and flower patterns, which has the effect of breathable and anti-termite. There is an ancient well on the left side of the second entrance on the first floor, and the second entrance on the second floor is on the right. There are two sets of casement windows on the second floor, one enters the wooden ladder, and one enters the third floor. The windows along the street on the third floor are two sets of casement windows. The upper set is shutters with horizontal wooden lattices, and the lower set is oyster shell windows with vertical wooden lattices. On the wall at the second entrance of the building, there is a peach blossom ash clay sculpture from stone.

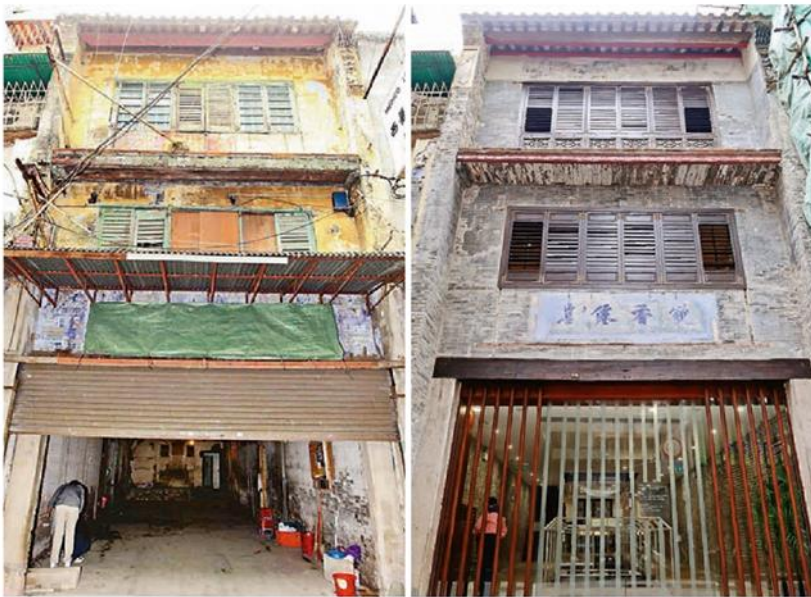
Fig. 3. Comparison of Chong Sai Pharmacy before and after restoration (left old and right new).

The Chong Sai Pharmacy preserve the original structural characteristics as a whole. After restoration, the entrance lobby on the first floor retains the archaeological relics for display, and the excavated cultural relics are placed at the end, including the Clark porcelain and pad porcelain cakes exclusively for export during the Ming and Qing Dynasties. The name of the Clark porcelain is taken from the sailing ship used for trade in Portugal. Carrac", transliterated as "Clark". In addition to porcelain, there are coins, Anping pots, jade cigarette holders and other commodities at the time. The signboard on the facade of the Chinese Medicine Bureau reads "Yinxiang Tiongguan". Combined with the jade cigarette holders found in archaeology, it is speculated that the Chong Sai Pharmacy once sold opium. Cigarette shop. On the second floor is the Sun Yat-sen Exhibition Hall and Library, where there is an installation of "The Voice of Father and Son", where you can listen to the recordings of Sun Yat-sen's past speeches. The third floor mainly displays the design style and materials of the building, including shutters, oyster shell windows, gray plastic and other objects and historical photos. The restored Chong Sai Pharmacy not only allows people to trace Sun Yat-sen's footprints in Macau, but also to feel his patriotism and sentiments of his family and the world. Although the restoration work of the Bureau of Traditional Chinese Medicine has been completed,

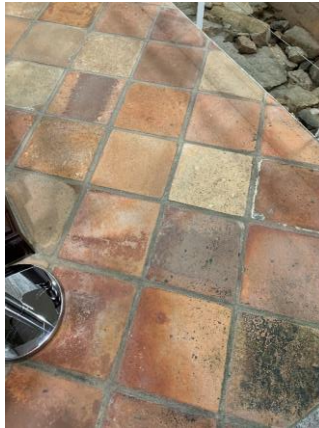
Fig. 4. Ground paving of Chong Sai Pharmacy.

The indoor floor of the Chong Sai Pharmacy is made of orange clay step bricks. The joints of the bricks are about 1 cm. This not only destroys the beauty of the floor, but also causes cracks if the joints are too thick. Especially as the floor tiles, it is easy to cause cracks after the joints are cracked. The tiles are worn or fall off, as shown in Figure 4, the edges of the step tiles on the right side have been worn and turned white. In addition, some floor tiles have been blackened and faded. The brick surface has uneven color, rough texture and lack of daily maintenance. It should be cleaned and maintained in time, otherwise it will easily cause broken windows and reduce the overall environmental quality. The edge of the paving is too hard, the brick body is cut and placed on the edge, and the material is not transitioned. The edge of the brick body after the cut will have uneven gaps, which are easy to seep water, resulting in mildew on the ground and deterioration of the quality of the paving, causing a chain reaction.

The caulking materials of the step bricks should be consistent with the original materials, such as lime mortar, etc., avoid using modern materials such as cement, etc., which will lead to the "inconsistent" of the new and old building materials, and the construction techniques and materials are also historical information Part of this should be fully respected, preserved intact, repaired as before, and never "superfluous". Avoid brick joints that are too large, usually about 2 mm. If there is overflow of joint filling materials during the bricklaying process, it should be dealt with in time. After the bricklaying is completed, the excess caulking materials should be manually cleaned up with sanding paper to avoid damage to the beauty of the paving. Finally, the jointing process is used to enhance the cleanliness. Avoid using machines to polish the brick body. There are water barrier and breathable layer on the surface of the old brick. Polishing the brick body will make the brick lose the water barrier, causing liquid to penetrate into the brick and corrode the internal structure. It is easy to reduce its physical properties. Use in the future Cracked or broken in the middle.

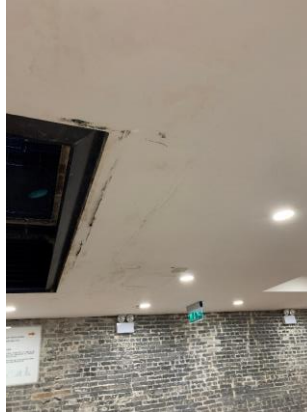
Fig. 5. Ceiling of Chong Sai Pharmacy.

Water leakage and mildew occurred on the ceiling of the Chong Sai Pharmacy (Figure 5). The reason for this phenomenon is speculated. First, the air-conditioning drainage pipe in the ceiling is leaking, and the ceiling lacks drainage structure, which causes water to accumulate in the potholes, causing mold and water leakage. The phenomenon. Second, because the air conditioner is turned on for a long time and lacks dehumidification equipment, the outdoor air temperature is not balanced with the indoor air temperature, and the air humidity is high, causing condensation water to accumulate on the ceiling, resulting in moldy dripping. Regardless of the reason, it should be treated and prevented in time. Mold can cause air quality degradation and affect human health. Secondly, the ceiling is not easy to clean. In the long term, it will expand the moldy area. The mold will spread in closed rooms and cause other cultural relics in the room. Mildew, resulting in loss of value of cultural relics.

It is necessary to fully understand the intention of the ancients on the structure and function of the building, and avoid excessive interference of modern equipment on the cultural relics. If it is necessary to use modern equipment, a complete and timely evaluation standard and system should be established after the building is used, and the problems such as water accumulation and mold should be dealt with and corrected in time to avoid the problem from becoming out of control.

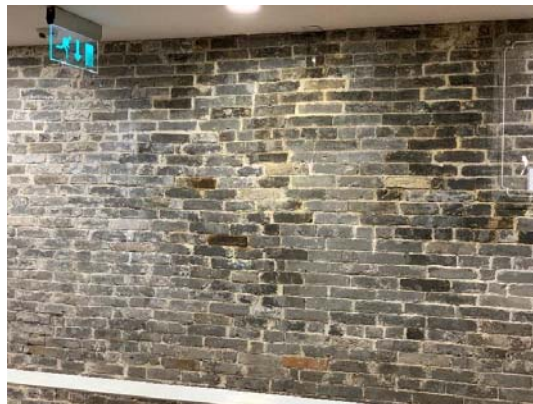
Fig. 6. Brick wall of Chong Sai Pharmacy.

The blue brick wall in the Chong Sai Pharmacy was damaged due to weathering (Figure 6). After the damage, dark yellow salty bricks were used to fill. Not only the appearance is damaged, but the salty bricks are acidic. The hardness and life of the bricks will be greatly reduced, which is easy to cause a breakage of a brick wall. The combination of salty bricks and weakly alkaline blue bricks will affect the surrounding blue bricks, acidify the surrounding bricks, and reduce the overall quality of the wall. From the perspective of cultural customs, salty bricks are often used in places such as cooking fume kitchens, toilets, huts, pig pens and cattle pens, and are not suitable for use in residential interiors, which violates the residents' habits. In addition, the early blue bricks were mostly made by hand-moulding, and there would be a difference between concave and convex surfaces. They should be arranged according to the convex surface on the top and the concave surface on the bottom. It was found on the site that some blue bricks were backfilled without paying attention to the unevenness of the blue bricks. Reverse backfilling not only decreased the aesthetics, but also made the stability of the brick wall down. Seriously, it would also cause the brick wall to collapse.

Salty bricks should not be used in the restoration of cultural relics, which not only violates folk customs, but also is not conducive to the protection of cultural relics. Targeted repairs should be made to the damage of the blue brick in different situations: ① When the damage of the blue brick is less than 2 cm, the damaged part should be cleaned in time and the brick body should be kept. ② When the damage of the blue brick is equal to 2 cm, use old bricks to fill it, avoid using cement and other materials for filling. ③ When the damage of the blue brick is greater than 2 cm, new blue bricks should be replaced. Avoid using acidified salty bricks. Try to use bricks with the same color, material and craftsmanship, and good quality. ④ The brick body should not be filled too much, just stop at the point. After the lime slurry is used to fill it and dry, it is washed with clean water as a whole, and then the brick joints are used to fill the joints. Finally, the wall is coated with clear limestone to make the brick body form a new protective film.

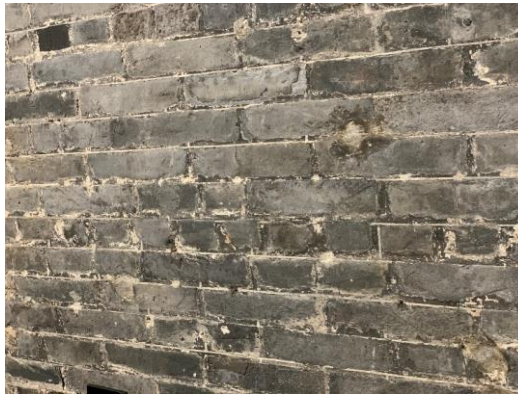
Fig. 7. Detail of brick wall of Chong Sai Pharmacy.

The brick walls of the Chong Sai Pharmacy use cement to fill the gaps and cracks (Figure 7). The physical properties of cement and blue bricks are different. The cement is too hard and impermeable, which will easily cause the brick walls to crack and break again. In addition, the overall color of the brick wall is different from that of the cement. The use of cement to fill the pit affects the beauty of the brick wall, which makes the brick wall less clean and poor in quality. Brick walls have a relatively large proportion of the indoor visual area. Large areas of untidy brick walls will reduce the public's experience of viewing the exhibition and affect the positive effects of cultural communication in the exhibition hall. On the contrary, the public will form negative emotions. In addition, the filling of brick joints overflowing between the blue bricks should be treated in time to keep the brick walls tidy and beautiful to avoid messy caulking.

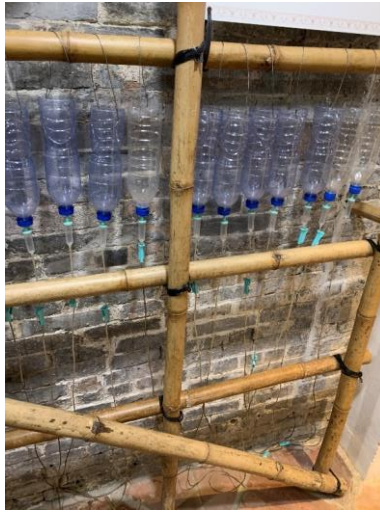
Fig. 8. Desalting by injection.

The brick walls of the Chong Sai Pharmacy use the injection method for water interception and desalination projects (Figure 8). This method is not suitable for the double corner walls of Lingnan buildings. The double corner walls of Lingnan buildings are hollow walls, which have the effect of thermal insulation. Injection needs to make holes in the wall to destroy the stable structure of the wall. The principle of injection is to inject water-cutting liquid under the wall, but the effectiveness of the interception cannot be guaranteed. The brick surface of the bottom layer is obliquely cut and the hole is injected to remove salt. It is to be demonstrated, and the picture style used in the schematic diagram displayed on the spot also has errata, and it is not the structural diagram of the double corner wall. In addition, there is an experimental nature of injection desalination. The usual practice is not to use precious cultural relics as experimental objects, but to choose similar old houses for experiments and

directly experiment on cultural relics, which will cause the risk of destroying cultural relics. After the cultural relics are destroyed, the original stable physical structure is difficult to restore, and the value and beauty of the cultural relics will be further lost.

The use of injections to remove salt by the Chong Sai Pharmacy not only requires drilling holes in the brick wall and destroying the brick wall structure, but the effectiveness of the salt removal effect on the unique double-corner wall structure of Lingnan Architecture also needs to be verified. At present, there are many non-destructive desalination technologies that will not damage the structure of the brick wall, and the process is simple, and the effect has been confirmed, such as the paste desalination method, the humidity difference desalination method, and the mortar desalination method. The following is an analysis of the steps of the method.
