# HIC and SSC of Carbon Steel in High Partial Pressure CO<sub>2</sub> Environments with Elevated H<sub>2</sub>S

**Abstract:** The Hydrogen Induced Cracking (HIC) and Sulfide Stress Cracking (SSC) behaviours of sour service and non-sour service carbon steel API 5L X65 were investigated under high pressure carbon dioxide environments, containing elevated amount of hydrogen sulphide (H<sub>2</sub>S); the test environments simulated offshore pipelines transporting full-well streams in high carbon dioxide (CO<sub>2</sub>) environments with elevated H<sub>2</sub>S concentrations. It was systematically studied under standard NACE condition and high pressure carbon dioxide field condition with variation in other key parameters (temperature, pressure and hydrogen sulfide concentration). The HIC and SSC were tested using a High Pressure and High Temperature (HPHT) Autoclave. The surface cracking morphology was analysed using Scanning Electron Microscopy (SEM), Ultrasonic Technique (UT) and Magnetic Particle (MP). The results showed that no cracks were detected in NACE standard and field-condition SSC tests for both sour service and non-sour services carbon steel. In HIC test, crack was dete

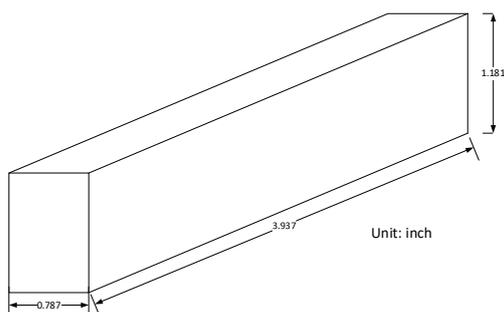
As shown in Figure 1, the specimens for HIC test were machined from both X65 (I) and X65 (II) plates (thickness ≈ 3 cm) with a size of 10 cm × 2 cm × 3 cm as recommended by NACE Standard TM0284-2003[7]:

**Fig. 1.** Samples used for HIC test

Specimens with the same thickness were used to eliminate thickness effect. The specimens were ground up to 320-grit silicon carbide (SiC) paper, rinsed with deionized water, cleaned with isopropyl alcohol in an ultrasonic bath, and dried using a heat gun.

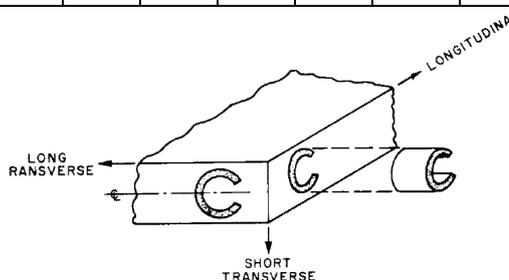
The specimens for C-ring SSC test were machined from both X65 (I) and X65 (II) plates as shown in Figure 2 as per ASTM Standard G38-01[8]:

**Fig. 2.** Sampling procedure for C-ring SSC test specimen.

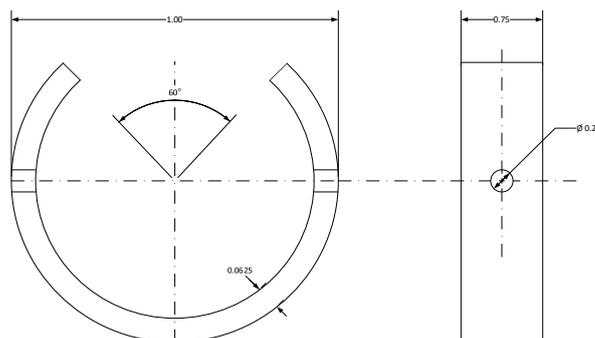
Figure 3 shows a dimension of C-ring sample used in the present study:

**Fig. 3.** Dimensional drawing of the C-ring SSC test specimen

The deflection necessary to obtain desired stress on the C-ring SSC specimen was calculated using the following equation:

$$D = \frac{\pi d(d - t)S}{4tE}$$

- D= deflection of C-ring test specimen across bolt holes;
- d= C-ring test specimen outer diameter (1");
- t= C-ring test specimen thickness (0.0625");
- S= desired outer fiber stress (90% and 80% of yield stress);
- E= elastic modulus (207 GPa).

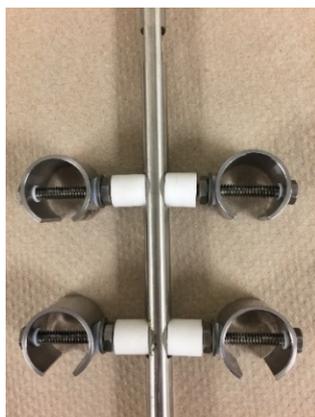
C-ring SSC test specimens were stressed by tightening bolting fixtures to the calculated deflections as measured by Vernier caliper. Four C-ring SSC samples with two stress levels, namely 80% yield strength (YS) and 90% YS were placed on the sample holder, specially designed for the test as shown in Figure 4 below:

**Fig. 4.** C-ring SSC samples with sample holder: 2 samples from X65 (I) and 2 samples from X65 (II).

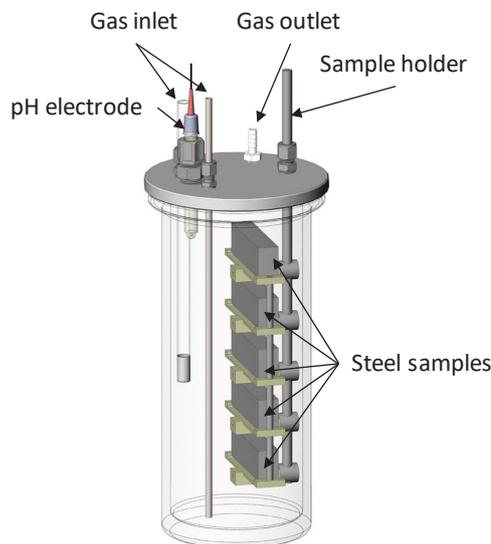
The experiments made use of a 5-L high pressure and high temperature (HPHT) Hastelloy autoclave as shown in Figure 5 below:

**Fig. 5.** The 5-L Hastelloy autoclave assembly used in the experimental setup for HIC test.

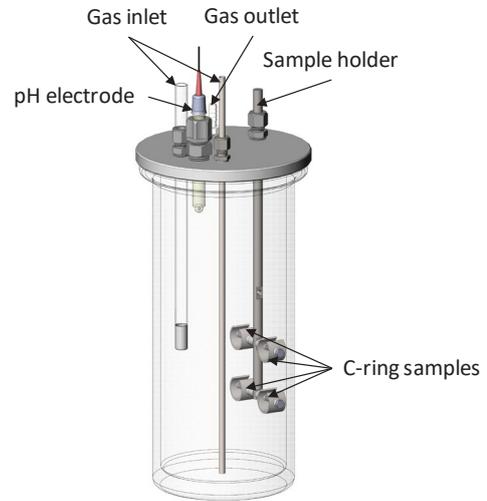
**Fig. 6.** The 5-L Hastelloy autoclave assembly used in the experiments setup for SSC test.

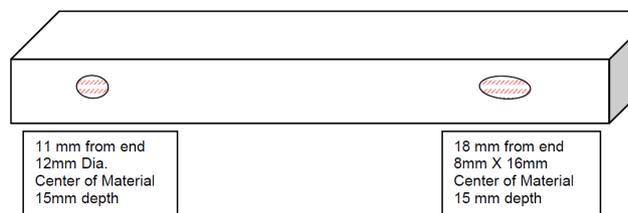
Figure 7 shows the results of ultrasonic A-scan inspection of HIC on X65(II) samples exposed to standard NACE condition:

**Fig. 7.** Results of ultrasonic inspection after HIC test for sample X65(II).

The depth of the indications showed that the cracks were mainly located in the centerline. In order to further investigate the extent of HIC, further analysis was conducted by cutting the crack sample identified by ultrasonic technique. Figure 8 shows SEM pictures of cracks observed

Internal HIC crack was only detected from non-sour service X65(II) in standard NACE condition due to the pipeline being non-resistant to HIC attack as compared to sour service X65(I). For field condition simulations, no cracks were observed in all conditions even though the partial pressure of H<sub>2</sub>S was more than 0.05psi. It is noted that the CO<sub>2</sub> environment was dominant in field condition even though the partial pressure H<sub>2</sub>S was in sour service region based on NACE MR0175-ISO15156 standard (2015). Therefore, no cracks were observed in all the field condition experiments.

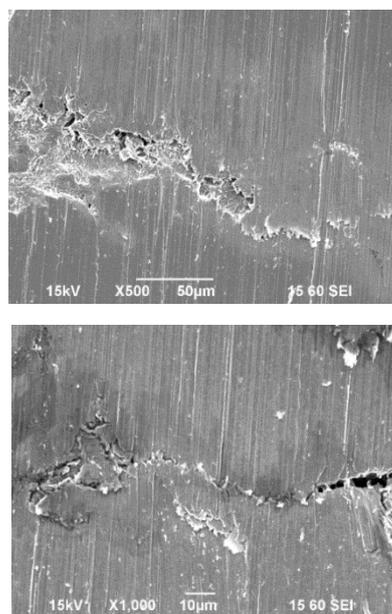
on the sample X65(II). It shows multiple cracks as well as some blistering.

**Fig. 8.** SEM image of cracks on the sample X65 (II)

1. Multiple cracks and blistering were observed on X65 (II) carbon steel (non-sour service) from the HIC test following NACE Standard TM0284-2003.
2. No macro/micro cracks were found on X65(I) carbon steel (sour services from the HIC test field condition).
3. No macro/micro cracks were found on both X65 (I) and X65 (II) from C-ring SSC test following NACE Standard TM0177-2016 and field condition.

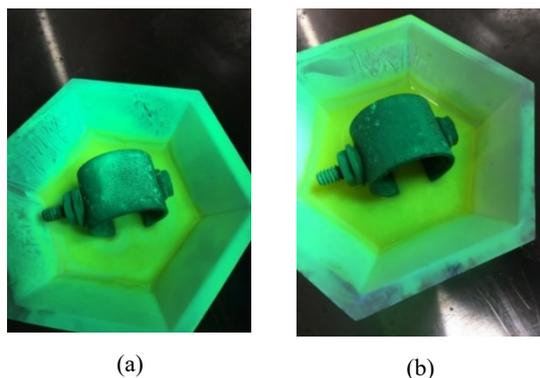
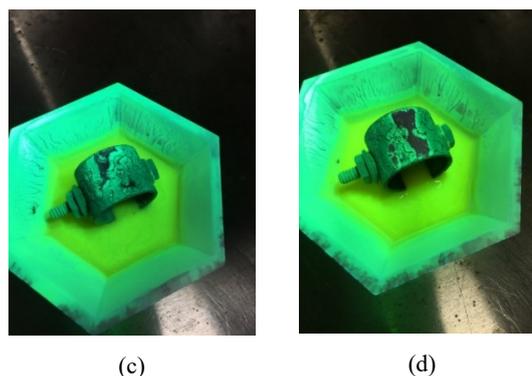
At the end of experiment, the samples were chemically cleaned by Clarke solution in order to remove the corrosion products. After cleaning, the samples were checked by MAGNAFLUX in order to detect macro surface cracks. Figure 9 shows standard condition SSC test pictures of the samples with black light after applying magnetic particles. No surface macro cracks were observed from all samples. The samples were also observed by SEM in order to investigate the presence of micro cracks. No micro cracks were detected from all samples either.

**Fig. 9.** Pictures of samples under magnetic particle analysis: (a) X65 (I), 90% YS, (b) X65 (I), 80% YS, (c) X65 (II), 90% YS, (d) X65 (II), 80% YS.

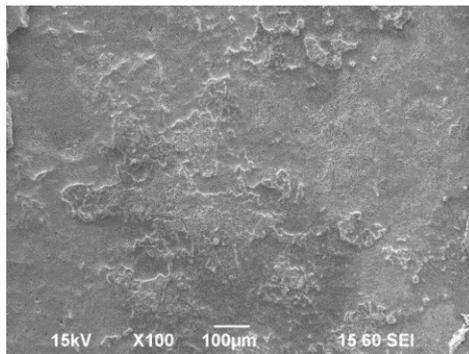
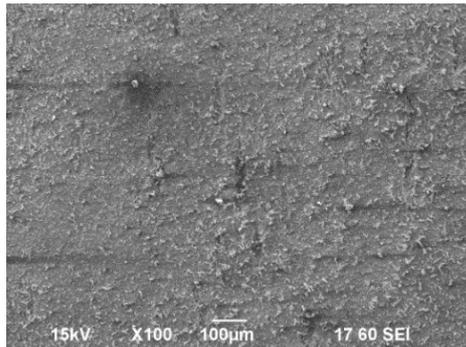
For the C-ring samples exposed to the field condition, the samples were also observed by MAGNAFLUX and SEM. Figure 10 shows SEM pictures of the samples after cleaning. Both pictures show general corrosion, but no micro cracks were detected from all samples.

**Fig. 10.** SEM images of cleaned C-ring SSC samples after exposing to 120 bar CO<sub>2</sub>, 80°C and 2000 ppm H<sub>2</sub>S condition for 30 days: (a) X65(I), 90% YS, (b) X65(II), 90% YS
