Research on Safety Evaluation and Sustainable Conservation Strategy of Tunbao Buildings--An example of residential buildings in Benzhai, Anshun, Guizhou

Abstract. Tunbao architecture is a combination of defensive and residential architecture of Ming Dynasty, and is an important material substrate of Tunbao culture. With the accelerated pace of urbanization, the population of Anshun Tunbao has moved out, aging has increased and natural catalysis has led to the dilapidation and decay of the dwelling architecture, which lacks certain conservation measures. This paper takes Anshun Tunbao residential buildings in Guizhou as an example, and summarizes the development of residential buildings in this village through literature and field research, and summarizes the current problems of preservation. The results of this study are presented in the form of a graded "point-to-point" conservation strategy, which is intended to provide a theoretical reference for the conservation and restoration of historical buildings in the Han ethnic area of Guizhou.

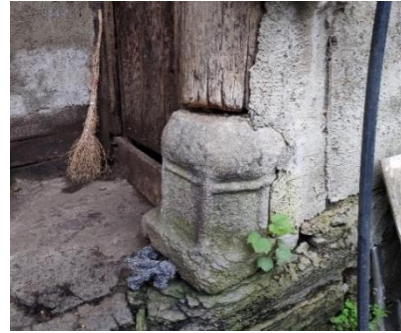
Figure 2-1-1 Column foundation appears
Source: Author's own photos

Second, the local occurrence of column base dislocation, column directly resting on the column base, because of uneven settlement and other reasons to produce column base dislocation, coupled with the humid climate and precipitation weather led to water penetration between the column base, accelerating the column tilt, stone softening, reducing its weighing compressive resistance

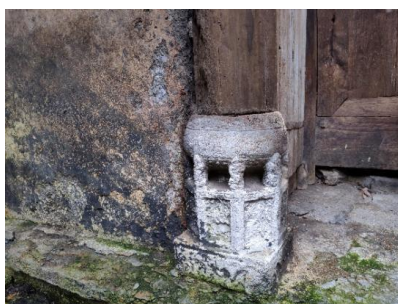
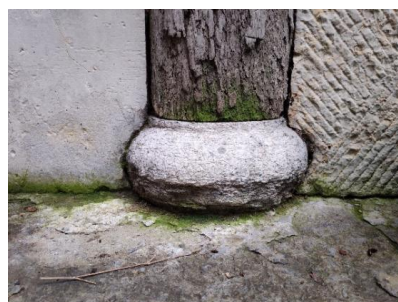
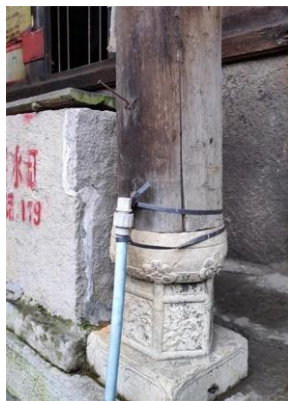
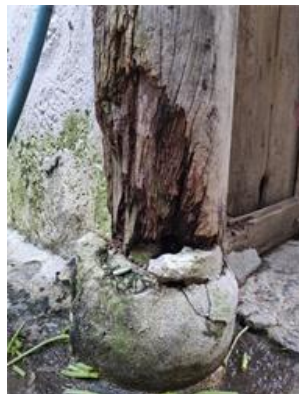
Figure 2-1-2 Damage to wood column
Source: Author's own photos

The research found that the traditional buildings in this cottage generally have wooden pillars with cracked bodies, and the next problem is the rotten bottom of the pillars (Figure 2-1-2). Most of the wooden pillars in this cottage are still in "diseased" working condition, and some of them have reached the level of damage at the point of dilapidation and still have not been properly repaired. The gua pillars and square in the rows of frames have not seen any obvious damage

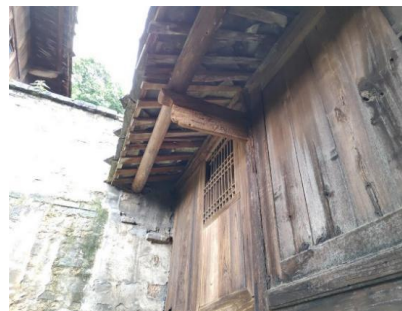
Figure2-1-3 The stigma purlin bearing method of traditional buildings in Benzhai
Source: Author's own photos

The roof cover of the traditional building of this cottage includes arch ow (see beam), purlins, rafters, and the way of bearing purlins on the pillar head is picking square bearing purlins (Figure 2-1-3), the specification of purlins is about 150mm in diameter, and the section form of purlins is mostly round, but there are also square and other forms. The roof cover is transferred by the purlins on the respective pillars, the purlins rest on the pillars, the golden purlins on the golden pillars are also arranged under the arch ow (see beam) as its middle bearing load members, using a combination of ridge rubbing and arch ow (see beam) way of connection, other pillars and purlins using the chisel excavation sandalwood bowl connection method. The damage of the roof cover of this traditional building is mainly caused by the damage of the roof slate (tiles) and the damage of the sliding purlins (Figure 2-1-3). Damage to the roof slate (tile) often forms a hole in the roof, and sliding purlins cause damage to the rafters and slate (tile) as well.

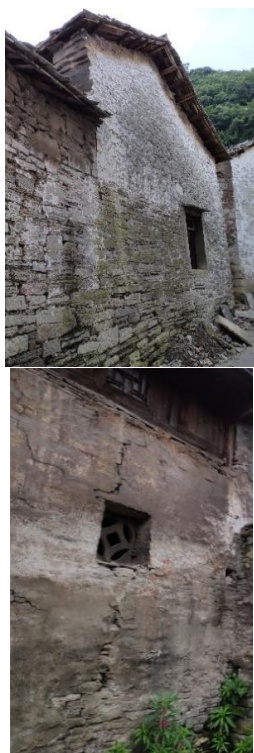
Figure2-2-1 Breakage of wall
 Source: Author's own photos

The load-bearing walls of traditional buildings in this cottage contain both masonry structures and brick masonry structures. The stone masonry structure is generally built along both sides of the street or the external wall of the village, with a height of 1.8~2.5 m. It is made of small block-shaped stones or large stones piled up (Figure 2-2-1), or a thin ash masonry is laid between the stones, and the masonry method is either ordinary piling or masonry with aesthetic effect, and the choice of stones and the masonry method reflect the economic strength and social status of the Tumbao family. The choice of stone and masonry method reflects the economic strength and social status of the Tumbao family [5]. The masonry also plays a role in overcoming the poor bearing capacity of the weak foundation by virtue of the thickness of the wall. The main problems of cracking and tilting of the masonry walls in this cottage are that the structural damage of the masonry will produce a chain of damage, which is attributed to the way the stone structure is arranged, once the wall has through cracking or tilting beyond the limit will bring safety hazards, the towering hill wall tilts inward, while the street side of the street wall tilts, the direction of tilting is not regular.

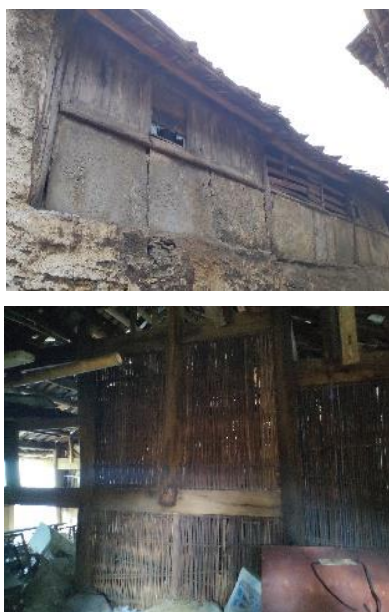
Figure 2-2-2 Types of non-load bearing walls
 Source: Author's own photos

Non-load-bearing walls of traditional buildings in this cottage include wood-paneled walls, combined walls composed of stone and wood panels, and bamboo-woven walls and bamboo-clad mud walls (Figure 2-2-2), which are important components of the enclosure structure between the two columns of traditional buildings. Plank walls and combination walls are common wall types in traditional buildings in this stronghold and are also widely used in traditional buildings in Guizhou region.

Wooden panel wall is a common enclosure structure in this cottage. The plank wall of this cottage is in the form of vertical arrangement, and the wall structure made of about 20mm thick plank and border splicing has good stability. The combination wall located on the second floor of the building is less damaged, and only two pieces of the wall are found to have cracked slabs; however, the combination wall located on the second floor of the building is more seriously damaged, and part of the wall is located on the street side, and two to three adjacent walls have been tilted at the same time, and such walls have become a safety hazard.

The number of bamboo woven walls and bamboo woven sandwich mud walls in this cottage is relatively small compared to the wooden panel walls, but his damage is more serious. Bamboo woven walls are often arranged as partition walls in the second floor interior. The bamboo woven walls as interior partition walls are relatively well preserved, with only some of them showing deformation and decay. However, the large area of bamboo woven sandwich mud wall as an exterior protective wall produces deformation in the middle and lower part of the wall protruding to the outside, the indoor bamboo woven sandwich mud wall has decayed due to humidity and other reasons, the mud and sand filled in the wall appears to fall off locally or in a large area, there is a bending deformation of the wall due to environmental factors.
