# Shoreline deformation of the Konda river: trends and threats

*Boris Seredovskikh*

Nizhnevartovsk State University, 11, st. Dzerzhinsky, Nizhnevartovsk, 628609, Russia

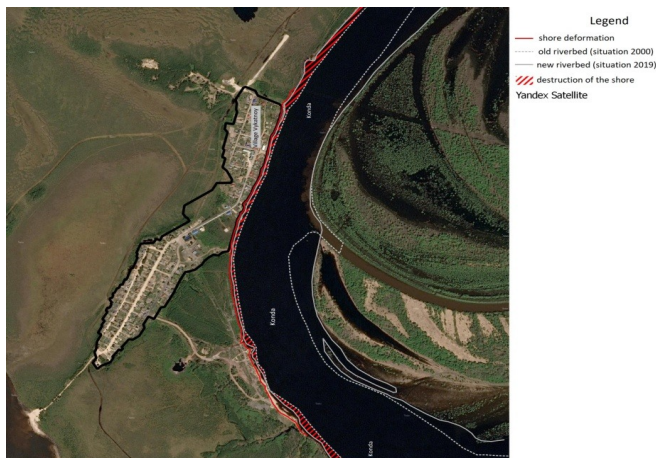
The progressive destruction of the bank line is also confirmed by the results of cartographic studies by overlaying different-age maps of the key area - the topographic map of 2000 (Topomap marshruty.ru) and the Yandex Satellite satellite image (figure 4).

**Figure 4.** Bank line Change Map, Vykatnoy settlement (2000-2020).

The bank line deformation is particularly intense in the lower reaches of the Konda River near the Vykatnoy settlement. The bank height is from 2 to 4 m, the length of the collapse section is 800 m. According to the results of field surveys in 2018-2019, the trend of bedrock bank collapse continues. Repeated observations recorded that the distance from the rafter to the bedrock bank edge decreased - 8.00 m (02.08.2018), 7.48 m (27.07.2019).

There are 15 residential buildings in the bank collapse zone. The number of people living in the collapse zone is 32 people. At present, there is a threat of residential houses collapsing. The existing bank protection dam was built by economic method, it is necessary to replace it with capital bank protection structures with a length of 800 linear meters.
