Technical condition of brickwork of the Grado-Yakutsk Trinity Cathedral of the 18th-19th centuries

Abstract. In the permafrost conditions of Yakutsk, the preserved old stone buildings made of locally produced ceramic bricks are of historical and scientific value. One of the first brick buildings in permafrost conditions is the Grado-Yakutsk Trinity Cathedral, which is now 315 years old since the start of construction. The article presents the results of the brickwork survey, the main being the strength characteristics determined under laboratory and field conditions. To ensure objectivity in determining the strength of bricks and brickwork, in addition to crushing the selected samples with a hydraulic press, the impact pulse method and the ultrasonic method were used. Significant heterogeneity of the brick structure and density was confirmed by ultrasonic examination of the selected samples and impact pulse examination of the wall structures directly at the site. The percussion-impulse determination of the strength of the masonry and the mechanical determination of the strength of the selected samples confirmed the grades of the compressive strength: XVIII century bricks - M50, XI

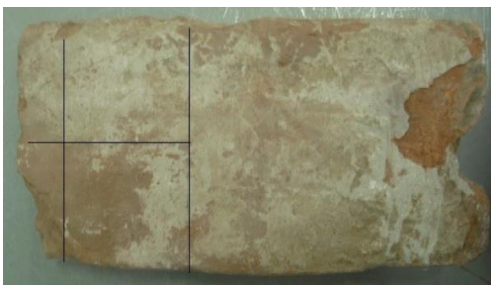
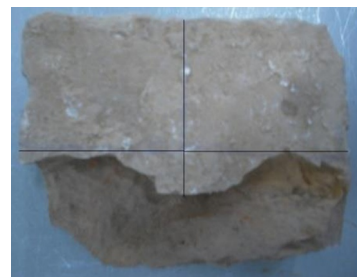
Fig. 1. Brick fragments for prototype production.

a) XVIII c.

b) XIX c.

The marking of brick sawing for the production of prototypes is shown in Fig. 1. Sawing was carried out with diamond discs on a cutting machine. The bricks were covered with a layer of lime-sand mortar approximately 2-4 mm thick, so their surface was carefully cleaned with a metal spatula.

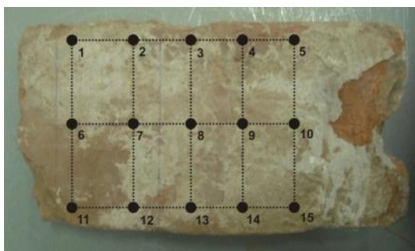
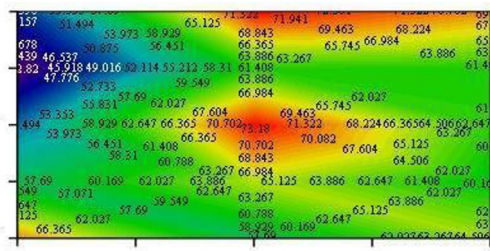
Fig. 2. Results of ultrasonic measurements for 18th century bricks.

Prior to sawing, the seized samples were subjected to ultrasound examination. Figures 2a and 3a show the location marks of the piezometric transducers of the device. The ultrasonic pulse was passed through the given marks and the time of its passage was recorded in μ s. The obtained data were linearly interpolated and plotted as a surface (Fig. 2b and 3b).

The blue colour shows the minimum values of the ultrasound transit time, and the red colour shows the high values, respectively. Transitions from blue to red colour illustrate transitions of ultrasound transit time variation.

a) Piezo transducer location marks on the brick.

b) Interpolated surface of ultrasound propagation time variation by marks (μ s)

The patterns obtained show the relative heterogeneity of material density throughout the entire volume of both 18th century and 19th century samples. Therefore, the strength characteristics of ceramic bricks were determined by two methods: non-destructive and destructive.

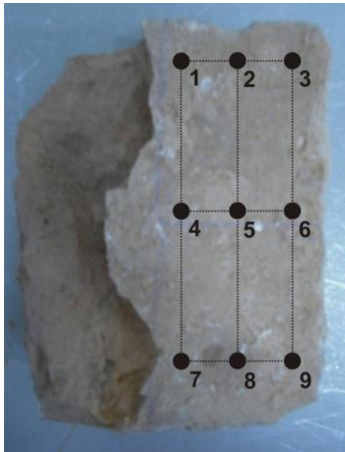
Fig. 3. Results of ultrasonic measurements for 19th century brick.

a) Piezo transducer location marks on the brick

b) Interpolated surface of ultrasound propagation time variation by marks (μs)

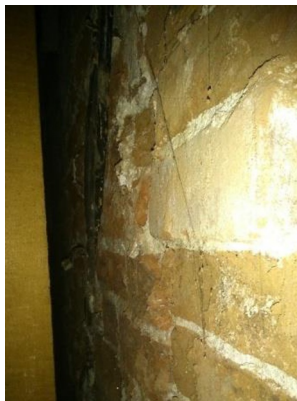
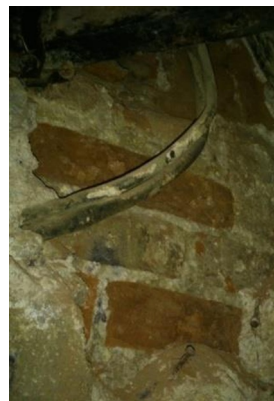
Fig. 4. Brick masonry fragments for non-destructive strength testing.

There are quite a large number of non-destructive methods of controlling the strength of building materials, but in this study used the method of impact pulse device IPS-MG4-03. The strength measurements were made directly on the surface of the wall structure in places where there was no plaster coating (Fig. 4). The brick surface was cleaned with a dry cloth before measurement.

a) XVIII c.

b) XIX c.

The greatest influence on the variability of measurement results is the condition of the wall surface. The visual assessment of the wall condition is generally unsatisfactory (Figure 4), with a rough surface, lime efflorescence and irregularities, which is likely to have led to the high variability of the test results. Nevertheless, in some areas of the wall surface, there are bricks that crumbled when rubbed with a metal trowel. Therefore, in order to objectively assess the brick strength, all measurement results are taken into account. This wide range of values is the result of the complex influence of the following factors:

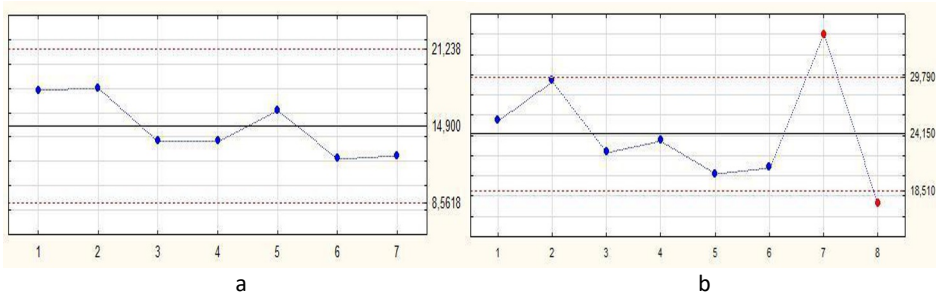
Based on the test results, X-bar and R maps of compressive strength of ceramic bricks of XVIII and XIX centuries were constructed (Fig. 5 and 6).

Fig. 5. X-bar map of variability of compressive strength of ceramic bricks XVIII c (a) and XIX c (b).

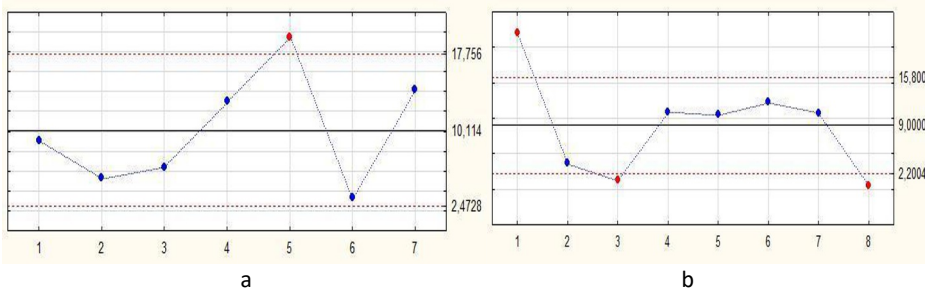
Fig. 6. R map of variability in the spread of ceramic bricks of the 18th century (a) and 19th century (b).

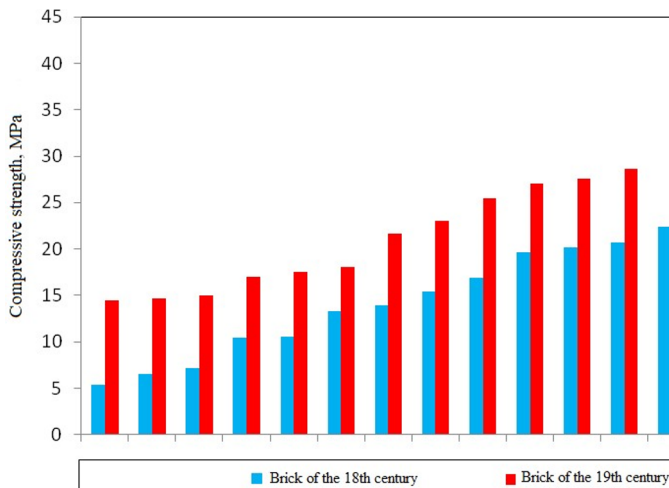
For clarity of comparison of brick strength, a ranked series of each individual measurement in ascending order is constructed (Fig. 7).

Fig. 7. Comparison of compressive strength of bricks by impact pulse method.

As expected, despite the considerable variation in the measurement results, the arithmetic mean compressive strength of 19th century bricks is 1.5 times greater than that of 18th century bricks. Most likely, this can be explained by the service life of the bricks.

The analysis of the test results showed that the strength of ceramic bricks varies within a very wide range. For example, for the XVIII c brick the strength varies from 5.4 to 22.4 MPa, which determines the difference between the maximum and minimum strength value

by a factor of 4, and for the XIX brick by a factor of 2.7. On this basis, the XIX brick has a lower variability than the XIX c brick.

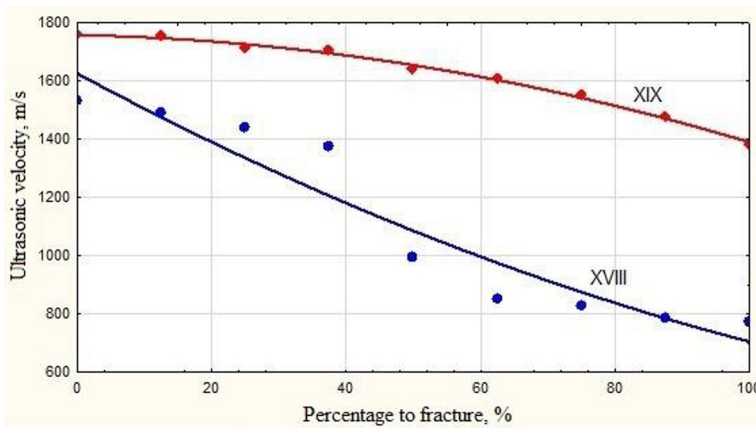
In the destructive method of determining the compressive strength of ceramic brick samples of the XVIII and XIX centuries we used a hydraulic press in parallel with an ultrasonic device. In this case, the samples obtained by sawing were tested in compression until complete destruction with a parallel determination of the ultrasound velocity through the sample.

Fig. 8. Variation of ultrasound propagation velocity in the process of brick fracture.

By mechanical destructive method it was determined that ceramic bricks of the XVIII century have a compressive strength of 6.5 MPa, and XIX - 7.1 MPa. The ultrasound velocity depending on the degree of destruction of the samples is shown in Fig. 8, where clear regression lines can be seen, which confirm the fact that the ultrasound velocity decreases in the structure with defects.
