# Heritage Building of *Residensi Tunku Abdul Rahman*: Preserve and Conserve for The Future

**Abstract.** Residensi Tunku Abdul Rahman is over 100 years and registered as National Heritage. Heritage building sets certain standard in preserving their value where weather and climate change have become biggest challenge in maintaining the status. Humidity, hot and rainy weather, also sunlight in tropical region made some damages to the building. Therefore, preserving and conserving the building is important to give knowledge and create awareness to the public. This research made to inspect the damage and defects of the building, then, propose the scope of conservation work and building conservation. Analysis of damage/defects thorough the building using the Building Condition Assessment Rating System (BCARS) by identifying the level of building condition and its' rating. The basis of the assessment is in the aspects of safety, functionality, and maintainability of the building that was assisted by several equipment used for the purpose of damage assessment and measuring work. Based on the analysis, there are 71 types of damage that were identified including rotten and broken wood lou

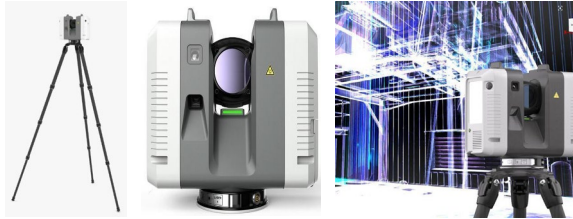
**Fig. 2.** 3D Terrestrial Laser Scanner Leica RTC360 3D equipment used to record the building in the form of 3D drawings.

There are several equipments used for the purpose of damage assessment and measuring work for measured drawings of buildings. They are 3D Terrestrial Laser Scanner Model Leica RTC360 3D to document and record the environment in the form of 3D drawings. FLIR ix IR Camera - 60101-0301- uses an infrared camera that can help identify problems, and diagnose them more efficiently. It can be used to perform energy audits, detect moisture, detect mechanical wear, check electrical overloads, justify repairs and minimize downtime. Lastly, Surveymaster BLD- 2000 Protimeter & Protimeter BLD5702 Digital Mini & ClimaPilot ThermoHygrometer - a 'non-destructive' tool used to obtain moisture readings on wall and floor surfaces. For this study, only the wall was used as a subject for moisture study.

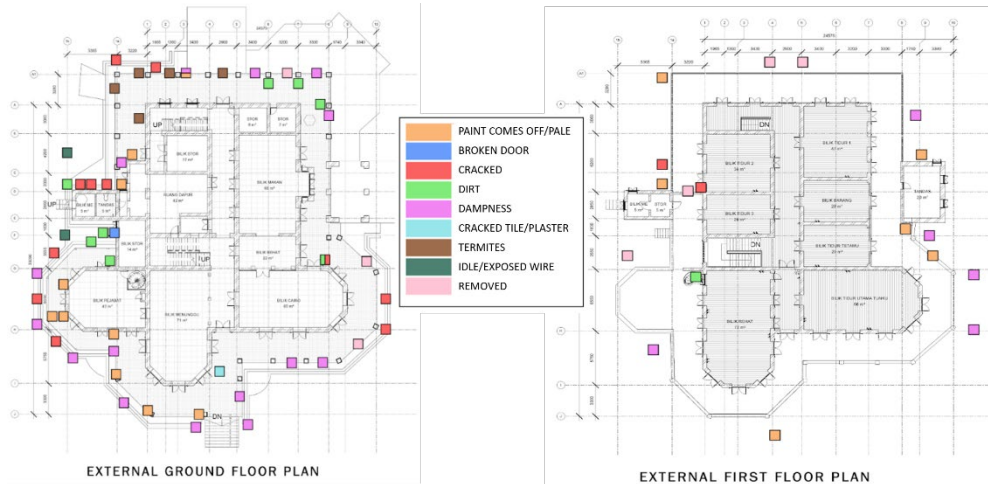
**Fig. 6.** Location of building’s external problem condition.

Drawings below show the location of building’s problem/condition from ground to first floor, external and internal part of the building with its indication of damage. Damages mostly happened on the exterior part of the buildings. This caused by exposure to weather of rain, sun, and wind. This needs some prevention measure to maintain the building heritage.

From the drawings, lots of defects/decays happened around the façade condition of the building, also indoor area. Dampness was found in many areas outdoor and indoor. This caused by weather and climate change at the exterior, and roof leaking for the interior throughout more than 100 years old of the building. Exterior façade also faced paint that comes off or pale colour due to exposure to direct sunlight and rain. As temperature rises, exposed building's materials got dried and wet continuously in extreme conditions and created lots of cracks. All of these happened due to hot humid and rainy weather of tropical climate. Hence, conservation works need to conduct to preserve this building for the future.

The factors that contribute to the damage and defects are dampness caused by rising damp from the soil and exposure to weather such as rain and sun, shrinkage of building materials and finishes on its' surface which cause cracking, blistering, and peeling, also water leakage in the air conditioning system which results in damage to the ceiling, moisture, moss and dirt.

- Dispose of the damages, broken, rotten, missing and decayed part and replace with the same building material as the original, preferably from the same type of wood as the original.

- Finishing the soffit wood in its original condition
- repair damage by using appropriate methods, especially on rotted, leaking and broken parts. (location: the roof of the upper floor, and the roof of the lower floor in the 'porch' section and the wind insert.

- Remove the cracked layer of plaster using hand tools carefully to provide a flat surface.
- Making repair works that is a new patch based on a mixture of filler materials that complies with the original composition of the material.

- Injecting or installing waterproofing material at the base of the wall to prevent water seepage to the top of the wall.
- Any repainting work must follow a preliminary paint study to ensure that the new paint used matches the original.
