# Evaluation of oil palm shells and mask fiber on the flexural strength of pre- and post-corrosion concrete

**Abstract.** One of the innovations in concrete technology that is also in line with reducing industrial and community waste is making mask fiber concrete mixed with oil palm shells as an aggregate substitute. In this research, 10% oil palm shells were used with mask fiber added at 0.2% of the specimen volume to increase the flexural strength value of corroded concrete. Tests include corrosion acceleration tests and concrete mechanical properties such as flexural strength, density, and ductility. There are two specimens, namely pre- and post-corrosion concrete. With the acceleration process, pre-corrosion specimens are carried out on the reinforcement before the concrete molding process, while post-corrosion specimens are accelerated by corrosion after the concrete is 28 days old. Tests on pre- and post-corrosion specimens show differences in the properties and characteristics of the concrete mechanical properties test results. The flexural strength value of post-corrosion concrete tends to increase with increasing corrosion. Meanwhile, the flexural strength value of pre-co

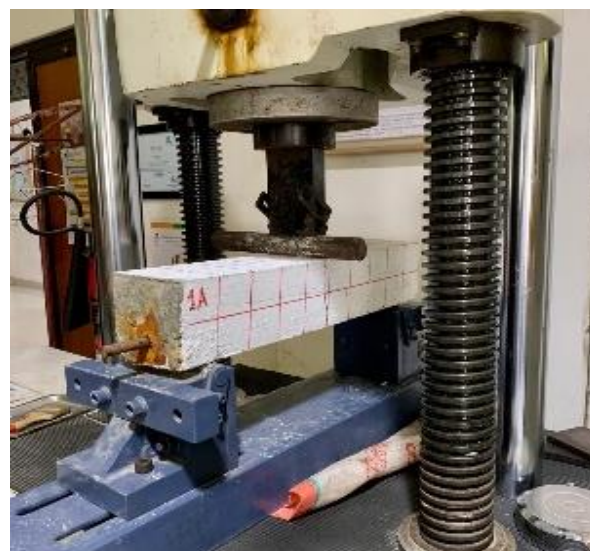
**Fig. 4.** Flexure test scheme

The bending test equipment uses a Universal Testing Machine (UTM). Flexural strength testing uses one loading point located in the middle of the beam span with 5 cm between the edge of the beam and the support. The test is carried out until the beam cracks due to the applied load. Using the flexural strength test method with a centralized load [27]. The flexural strength testing process can be seen in Figure 4.

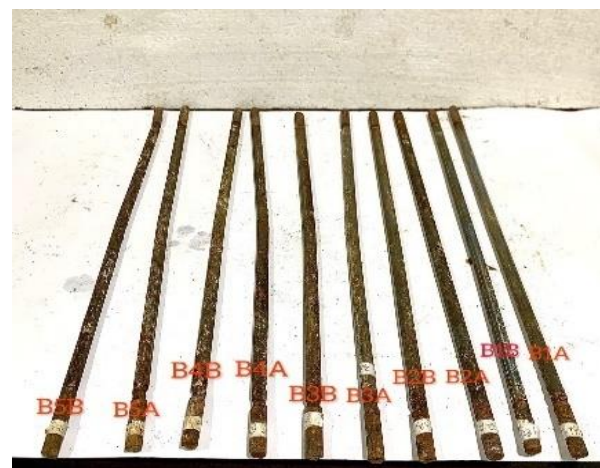
**Fig. 5.** Post-corrosion reinforcement

Meanwhile, as shown in Figure 5, pitting corrosion occurs in the reinforcement because of the corrosion process. Pitting occurs only at the ends of the reinforcement that are not covered with concrete. The occurrence of pitting at the ends of the reinforcement is thought to be caused by the installation of cables in the concrete to be connected to the DC power supply only
