Environmental safety of main gas pipelines

Abstract. Analysis of the causes of accidents indicates the prevailing influence of corrosion factors on the structural reliability of main gas pipelines. During operation, main pipelines are exposed to the in-pipe pressure of the pumped product and ground electrolytes, which leads to corrosion-mechanical damage. Moreover, these factors can act in the most unfavorable combinations. This combined action reduces the durability of the material. This leads to much faster destruction of the pipe metal. Therefore, it is necessary to monitor not only general corrosion damage, but also local damage, which, when subjected to mechanical stress, can become a source of corrosion crack. The article discusses the main factors influencing the environmental safety of main gas pipelines, as determining the required level of quality at the time of operation.

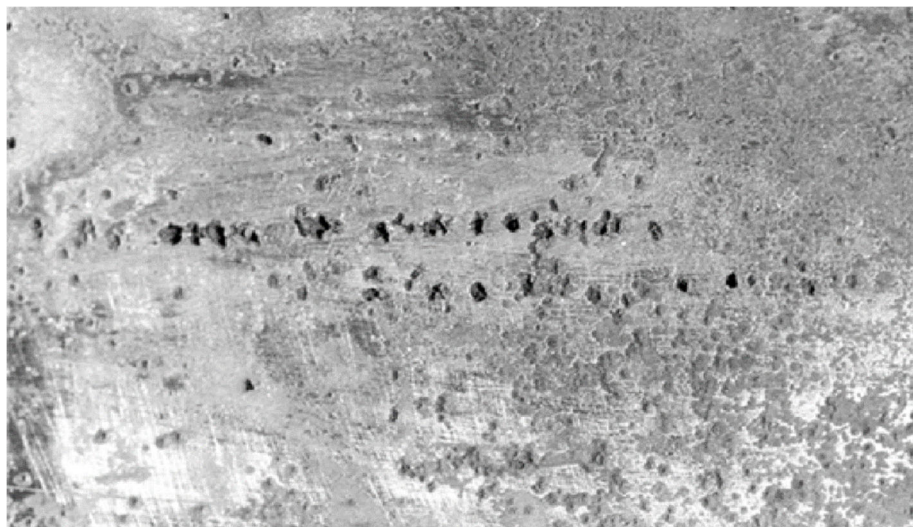
When testing a semi-circular sample in a carbon-containing medium, point defects form on the surface at the sites of manganese inclusions. In the resulting ulcerative lesions, acidification of the initial medium occurs and the mechanism of active anodic dissolution develops (Figure 3). However, after 4200 hours of testing, no defects were observed in the joint of the main crack. Apparently, the composition of the corrosive medium used in these laboratory tests is not capable of combining stitch ulcerative defects into one crack.

As can be seen from Figure 3, the corrosion resistance of the metal deteriorates in places of non-metallic inclusions, due to the dissolution of which line defects are formed.

Fig. 3. A colony of ulcerative lesions in the form of a point defect.
