# Technology for reducing the risk of landslides by unloading the landslide mass

**Abstract.** The work has developed measures to reduce the risk of a landslide in the area near the village of Toktogul, Uzgen district of the Kyrgyz Republic. This landslide area was studied on the basis of field research on the ground and the results of desk work. The sliding of soil masses in the area can cause destruction and debris of residential and administrative buildings, roads and power lines, as well as injury and death. Considering the equilibrium of the system of forces acting on the mass of filler soil of the slope section and analyzing them, measures for unloading the landslide body in this section are proposed. The proposed longitudinal profiles of drainage channels to reduce the moisture content of subsidence soil and transverse profiles of developed soil to reduce the weight of subsidence soil are presented. Based on the results of processing research data and analysis, it is recommended to reduce the weight of unstable (subsidence) soil by stepwise development along the slope of the site and transporting it up to 5 km for subsequent brick production. It is also recommended to prote

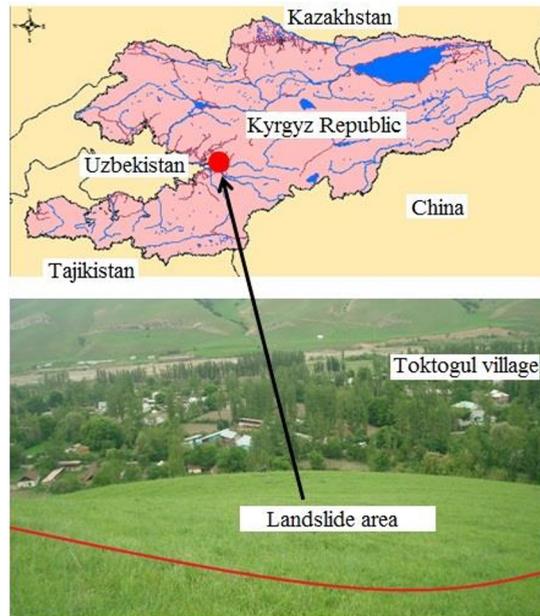
**Fig. 1.** Location of the landslide area: a) study area on the map (red dot); b) top view of the landslide area (the landslide separation line is shown in red).

Geomorphologically, the landslide area is located within the southwestern foothills of the Fergana Range, in the valley of the Zerger River (Figure 1). Landslides occur periodically in this area. At 6:40 am on April 29, 2017, a landslide with a volume of more than 1 million cubic meters occurred in the village of Ayu, Zerger rural district, Uzgen district. According to the Ministry of Emergency Situations of the Kyrgyz Republic, the earthen mass covered 7 houses, in which there were 24 people.

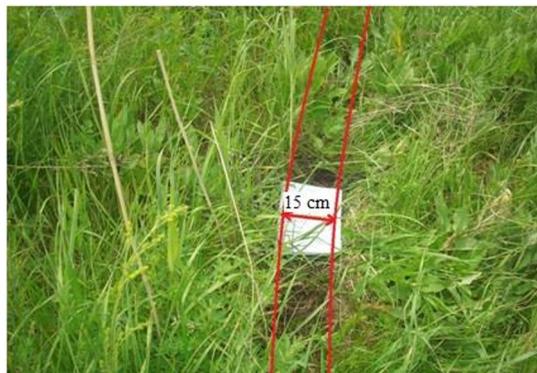
**Fig. 2.** Cracks on the landslide surface.

Physico-geological phenomena and processes manifest themselves in the form of type II subsidence, with the formation of cracks oriented subparallel to the watershed line (Figure 2). By the time of the survey, the cracks had closed almost completely and remained on the surface of the relief in the form of a barely noticeable ledge. They have an intermittent step-by-step character and disappear in places. The time of their occurrence and maximum disclosure, according to the Ministry of Emergency Situations of the Kyrgyz Republic, falls on 1992-1993.

Judging by the absence of a ledge in the relief, indicating a clear manifestation of subsidence, it can be said that the manifestation of the initial, hidden phase of the formation of a landslide-subsidence may have taken place. And, apparently, after the cessation of water supply to the irrigation canal at the foot of the slope over the past few years, the subsidence process has slowed down or stopped. Even in the high-water year of 2017, when landslide processes intensified in the region, no new cracks appeared in this area.

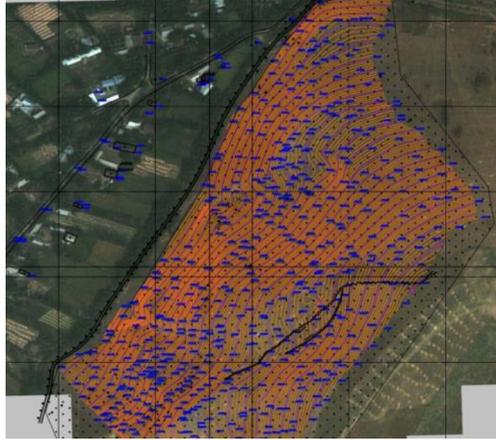
**Fig. 3.** Digital topographic plan of a landslide area against the background of a satellite image of the area.

The Ministry of Emergency Situations of the Kyrgyz Republic provided relevant cartographic materials for the study. Figure 3 shows a georeferenced and digitized topographic plan of the area against the background of a satellite image from the Google Earth mapping service.

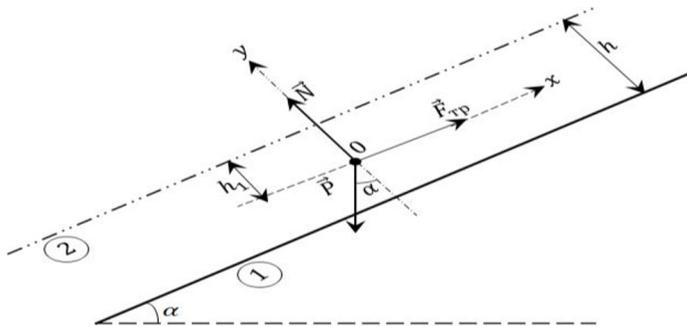
**Fig. 4.** Design diagram of a landslide slope of an area with a soil mass of thickness  $h$ : 1 – strong bedrock; 2 – subsidence soils with thickness  $h=(10\div 20)$  m;  $\alpha$ -angle of inclination of the slope of the site to the horizontal plane.

Figure 4 shows a diagram of the landslide slope section and the forces acting on the soil.

Here we consider a simplified diagram of the equilibrium of a system of forces that is easily understood by readers. Of course, it was possible to consider other schemes, for example, the shift of the soil thickness along a straight surface or along a cylindrical surface, considering the soil as a dispersed body [14-16].

The figure shows that the following forces act on the thickness of subsidence soil:  $P \vec{}$ -self-weight of subsidence soil with thickness  $h$ ;  $N \vec{}$ -normal pressure force;  $F_{fr} \vec{}$  friction force between sliding surfaces of subsidence soils or subsidence soil and siltstone (bedrock).

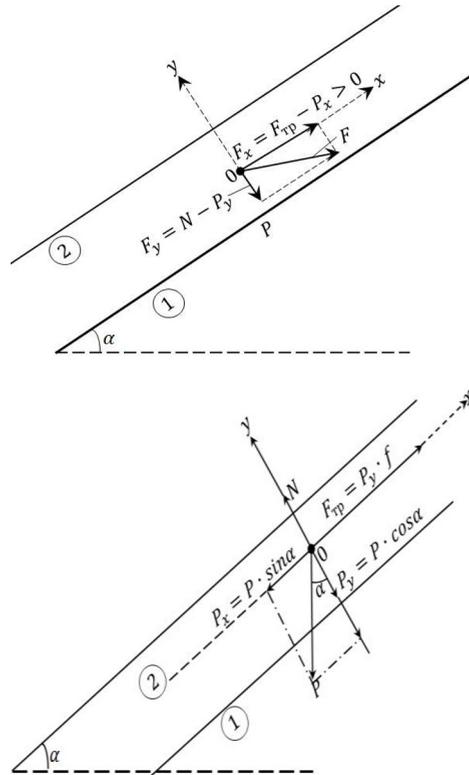
**Fig. 5.** Scheme of a stable slope: a) forces acting on the thickness of subsidence soil; b) projection of all forces onto the coordinate axes  $x, y$ , that is, forces  $F_x$  and  $F_y$ .

Figure 5 shows a diagram of a stable slope. Here, the friction coefficient takes into account both the friction between particles of loess soil and the adhesion between particles. As humidity increases, the friction coefficient decreases.

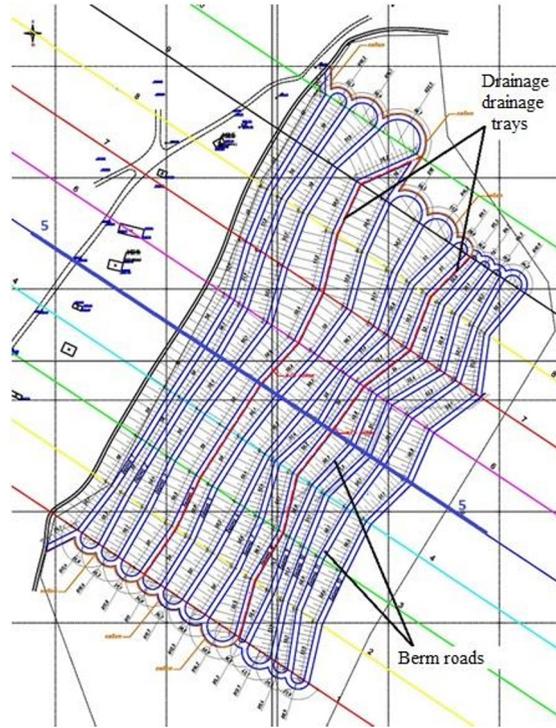
**Fig. 6.** Plan of a berm-road and drainage ditches in a landslide area.

The volume of excavation work was calculated based on data obtained from the topographic plan and measured longitudinal profiles of the area. Figure 6 shows the plan of the berm-road after the development and transportation of soil for the project.

Drainage ditches and road berms have a double-slope profile with a slope from the middle of the road to the edges; their longitudinal slope is about 2.5%. Along the edges of this area, transverse monolithic reinforced concrete trays are provided, along which water will flow into low-lying areas outside the landslide area.

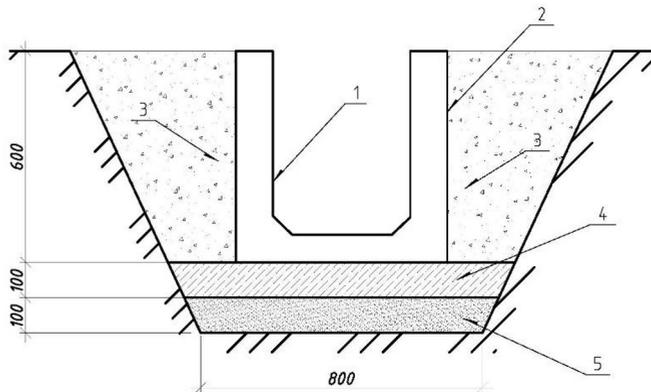
**Fig. 7.** Road drainage tray: 1 – tray according to GOST 32955-2014; 2-bitumen mastic; 3 - backfill; 4 - concrete base; 5 - underlying layer.

All of the above ditches are constructed from hydraulic concrete of class B25 on a gravel-sand cushion 20 cm thick. For reinforcement, reinforcing mesh 6 m long is used and installed (increased) with an overlap. Reinforcing mesh is made from reinforcement grade AIII  $\phi 12$  [16].

Figure 7 shows a reinforced concrete drainage tray.

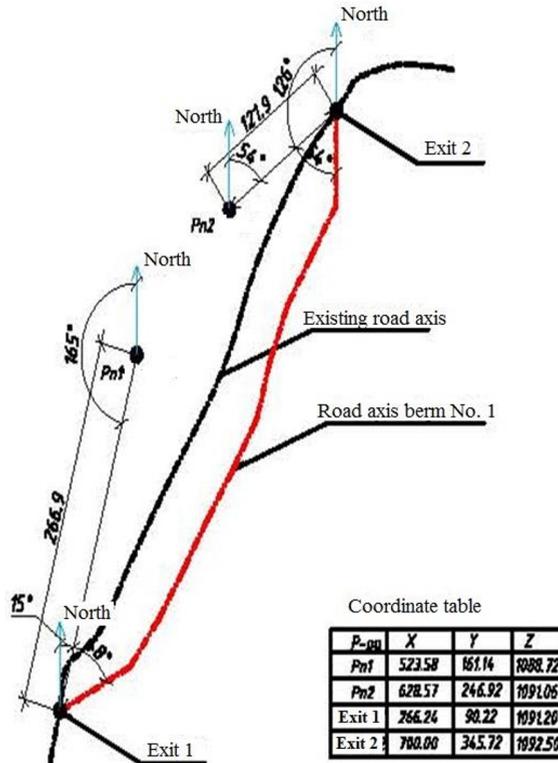
**Fig. 8.** Scheme of linking the landslide area to the local support network.

Figure 8 shows a diagram of the landslide area. The reference marks of the local backbone network are marks on the plinth (Pn1) and on the stairs (Pn2) of private residential buildings. Coordinates of reference points: Pn1 - X=523.58 m, Y=161.14 m, Z=1088.72 m; exit 1 coordinates - X=266.24 m, Y=90.22 m, Z=1091.20 m; coordinates Pn2 - X=628.57 m, Y=246.92 m, Z=1091.06 m; coordinates of exit 2 - X=700.00 m, Y=345.72 m, Z=1092.50 m. Direction angles: between Pn1 and exit 1 -  $\alpha_1=195^\circ$ ; between Pn2 and exit 2 -  $\alpha_2=54^\circ$ . Distances: from Pn1 to exit 1 - L1=266.9 m; from Pn2 to exit 2 - L2=121.9 m.
