# Analysis of agrotechnical indicators of the new the working body of the steam cultivator

**Abstract.** The paper presents a comparative analysis of the work of a serial lancet paw with the proposed new working body of a steam cultivator through field research on the fields of the Donskoy Agricultural Scientific Center. Optimal modes and parameters of operation of proposed new working member are determined in comparison with serial working member of steam cultivator. The advantage of the new working element of the steam cultivator has been established in comparison with the standard lancet paw in terms of agrotechnical indicators.

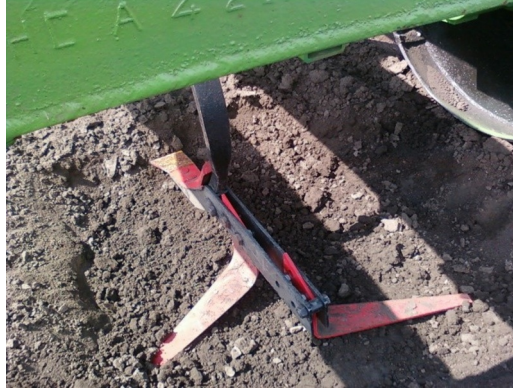
The design of a new working organ of a steam cultivator has been developed in the Department of mechanization of crop production at the Federal State Budgetary Scientific Institution of the "Donskoy" Agricultural Research Center. The new working body consists of a rack with a chisel and sequentially mounted left- and right-sided plane cutters (Figure 1).

**Fig. 1.** The new working body of the steam cultivator.

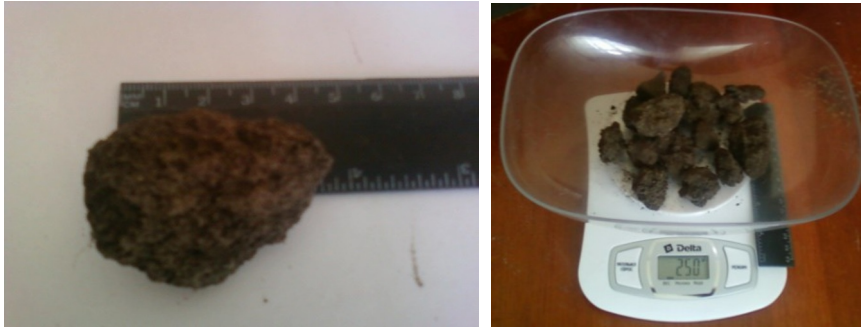
Since the gripping width of a standard pointed paw is less than the size of a pallet (0.5x0.5 m) divided into squares of 25x25 mm, superimposed on the treated layer to quantify lumps exceeding the size of 25 mm, the quality of crumbling of both working bodies was determined by weighing, by taking a sample of the treated soil and weighing individual fractions (Figure 2).

**Fig. 2.** Selection and weighing of lumps larger than 25 cm.

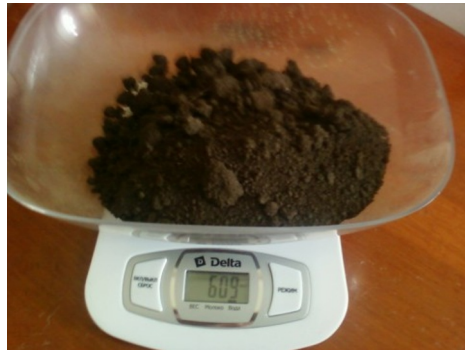
The quality of soil crumbling was determined from samples taken at 4 points in 3 repetitions in the forward and reverse directions of movement with manual analysis of fractions in laboratory conditions to isolate lumps larger than 25 mm and then weigh them (Figure 3).

**Fig. 3.** Weighing of the total soil sample.

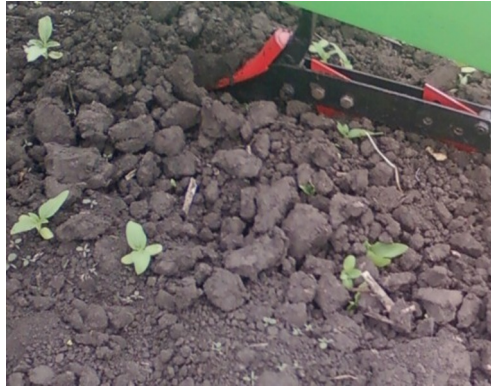
The improvement in the quality of crumbling by the new working body of the steam cultivator is explained by the occurrence, with an increase in the speed of movement, of the impact interaction of the formation with the chisel, which forms a leading crack in the longitudinal direction (Figure 5), and plane-cutting rippers cut in the transverse direction of the separated soil mass (Figure 6).

**Fig. 5.** Formation of a leading crack with a chisel.

At the same time, the higher the speed of movement, the further the crack front spreads, which is accompanied by a greater intensity of soil crumbling by the new working organ of the steam cultivator.

This is due to the close relationship between the amount of energy required to crumble the soil and the energy of the formed crack, which is directly proportional to the surface tension of the lump.

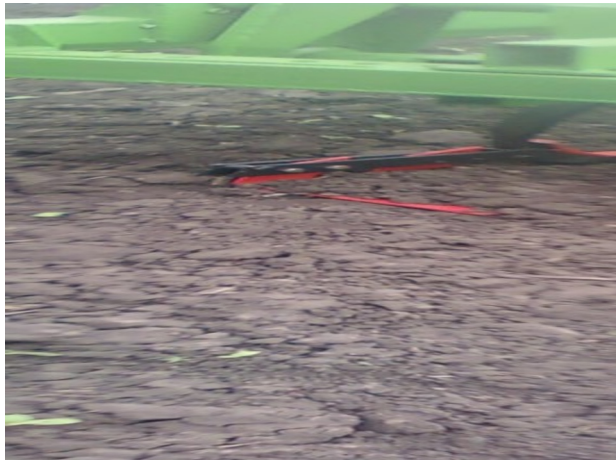
**Fig. 6.** Crumbling of the soil with flat-cut rippers.
