Study of heat protection of external envelopes of a residential building in the cold period

Abstract. In the study a full-scale thermovisional survey was carried out in the cold period of time of a multi-apartment residential building located in the Northern part of the Republic of Kazakhstan. The result of the survey showed the presence of significant problems on heat protection, where according to the analysis of thermograms of external wall envelopes it was revealed that almost all living rooms have envelopes with a negative value of heat protection, which does not meet existing standards. The analysis of thermograms of all rooms showed the existing problems on thermal stability of external wall envelopes, as the temperature difference between the inner surface of the external envelope and the internal air temperature ranged from 5.5 °C to 19.7 °C, where the difference reached 49 times in some places, depending on the living room. Analysis of thermograms of window openings also showed a lot of deviations. Thus, thermograms of window apertures showed deviations from sanitary-hygienic norms on dew point value from 12°C to 26.2°C depending on the living room. The revealed deviatio

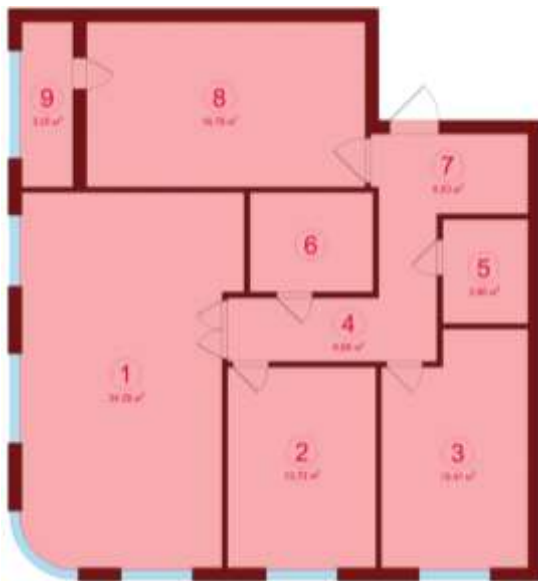
Fig. 1. Plan of a 3-room apartment: 1 - hall; 2 - children's room; 3 - kitchen; 4 - hallway; 5 - pantry; 6 - shower room; 7 - anteroom; 8 - bedroom; 9 - bathroom.

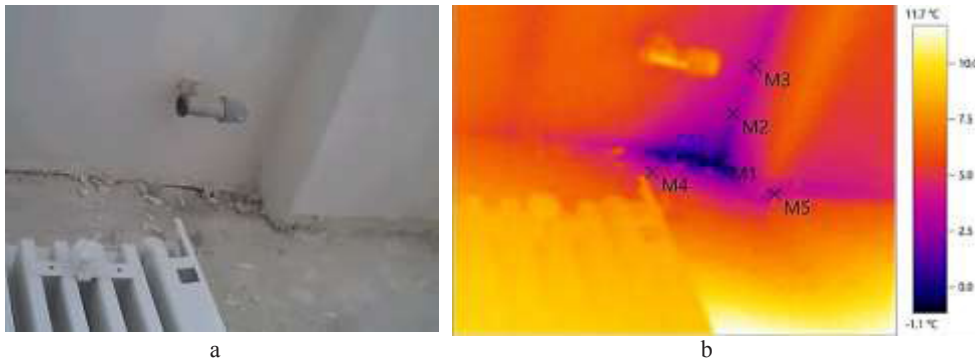
Fig. 4. Thermogram of wall exterior envelope of room No.2: a - full-scale photo of the wall; b - thermogram of the wall (M1=0.8°C, M2=3.0°C, M3=3.5°C, M4=4.0°C, M5=3.6°C, CS1= -1.1°C).

Based on the method of nondestructive testing with the help of thermovision camera was carried out inspection of continuous sections of the exterior wall envelope of rooms (1,2,3,8), Figures 3-6, where according to Figure 1 (room number 1) it was revealed that despite the correctness of the design solutions quality of the envelope does not meet the norm [50], as the temperature difference between the inner surface of the envelope and the internal temperature of the room should not exceed 4°C , which should be equal to 15.3°C . The actual difference is, in the case of the minimum value of the point (CS1) to 18.9°C , which is almost 47.2 times lower, and in the case of the point (M5) with a maximum temperature of 5.5°C the difference is 13.8°C , which is almost 1.5 times lower than the norm (Fig. 3b) [50]. Figure 4 shows the thermograms of the solid external envelope of room No. 2, where a similar situation on thermal protection is observed. Thus, according to the point (CS1) the minimum surface temperature is -1.1°C , and the maximum point (M4) is 4.0°C , which are lower than the internal air temperature by 20.4°C (17.5 times) and 15.3°C (4.8 times) respectively (Fig. 4b). According to the thermograms of room No. 8 of the fragment of Figure 5, it was also found that the temperature difference between the minimum and maximum points amounted to 19.7°C and 16.6°C , which is also 49 and 7.3 times below the norm, Figure 5b [50]. The thermogram of room No. 3 (Fig. 6) showed that the minimum temperature of the point (CS1) on the fragment is equal to 0.9°C , and the maximum temperature of the point M5 is equal to 9.6°C , which also revealed a non-compliance with the norm for thermal protection, which is lower by 21.4 and 2.1 times, respectively, Figure 6b.

to 15.3 °C, where the deviation is 47.2 times lower than the norm, the thermogram of room No. 2, showed a deviation of 20.4 ° C, which is almost 17.5 times lower than the norm. According to the thermogram of room No. 8, the temperature difference was up to 19.7°C, the deviation from the norm is up to 49. The thermogram of room No. 3 also showed the difference up to 9.6°C, which is 21.4 times lower than the norm.
