Study of heat protection of translucent external envelope in winter period

Abstract. This article presents the results of thermophysical studies conducted in the cold period by non-destructive testing of translucent exterior building envelopes for heat protection and illumination of the room with natural light. As an object of study was chosen 3-room apartment on the fifth floor of the 17-storey residential complex "Sport Towers", located in Astana, where the survey was conducted in the daytime. The window openings of the respective rooms were selected as translucent exterior envelope. As a result of the survey it was found that the internal temperature of the living rooms has a deviation of 3.5% from the optimal norm on the parameters of microclimate of the premises, which leads to a violation of the norm and overconsumption of heat energy for heating due to inadequate thermal protection of translucent exterior envelopes. At humidity 48.1% and internal temperature of the room 19.3 °C that the dew point was 8.1 °C. The value of the surface temperature including in the zone of adjoining to opaque elements of the considered structures showed deviation from -16.3°C to 8.0°C, which ex

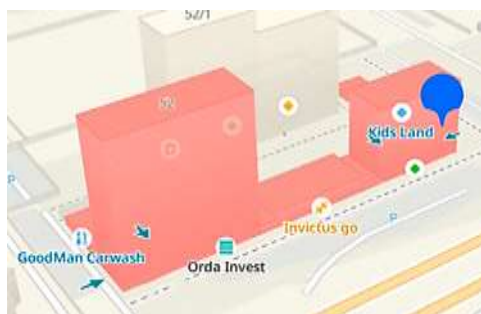
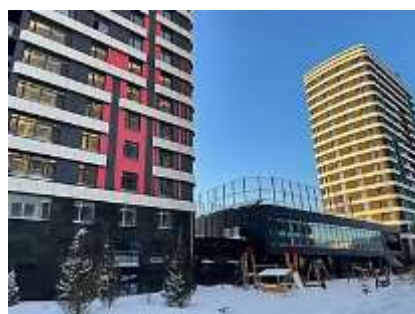
In the work as an object of study was chosen a characteristic 17-storey residential complex “Sport Towers”, located at the address, Republic of Kazakhstan, Astana, Turan Avenue 52/1, block D, apartment 297, 5th floor (Figure 1a). The general view of the exterior envelope with ventilated façade is presented in Figure 1b, and the design of the ventilated façade with geometric characteristics is presented in Figure 1c.

Fig. 1. Object of study: a - situation diagram; b - general view of the façade; c - exterior envelope structure.

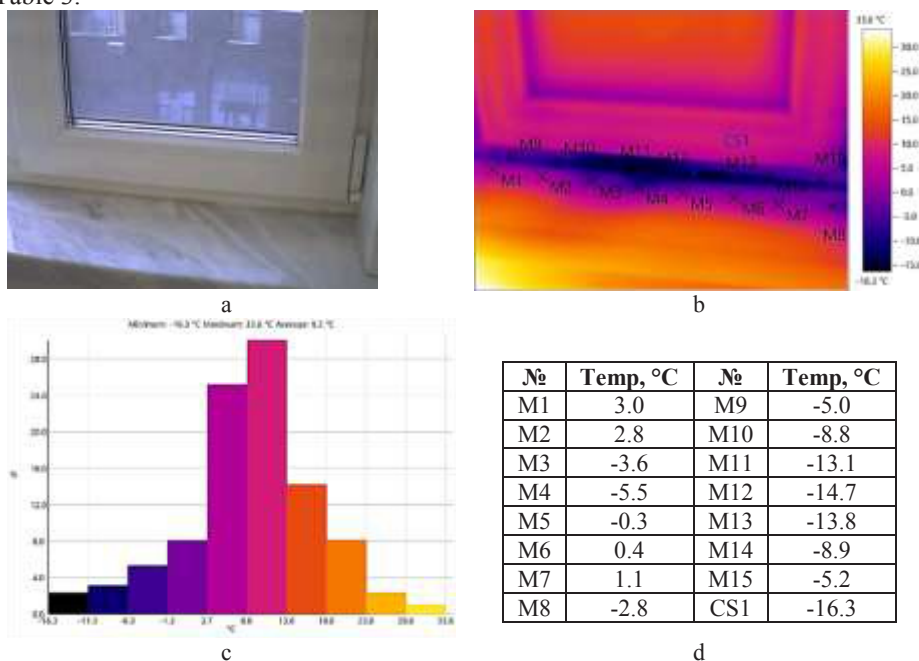
Fig. 4. Fragment of the right part of the external translucent envelope of the bedroom with vulnerable points: a - full-scale photo of the fragment; b - thermogram with vulnerable characteristic points; c - diagram of temperature values with percentage ratio; d - table of points with temperature values.

Thus, the analysis of thermograms of the fragment of the right part of the external translucent envelope of the bedroom room showed (Figure 4a) that the surface temperature of the sill part of the structure significantly exceeds the dew point (Table 3). At humidity 48.1% and internal temperature of the room 19.3 °C dew point was 8.1 °C, and the thermogram of Figure 4 (b) indicates that the minimum surface temperature including in the zone of adjoining to opaque elements of the considered structure was from -16.3 °C to 3.0 °C (Figure 4d), which does not correspond to the dew point temperature up to 3.01 times [42], and the total area not corresponding to the norm of the specified fragment was 44.1% (Figure 4c). Inspection of the left part of the exterior translucent envelope of the bedroom room showed (Figure 5a) that the surface temperature of the sill portion of the structure also significantly failed to meet the dew point (Figure 4b), where the minimum surface temperature ranged from -12.4°C to 6.8°C (Figure 5d), which does not meet the dew point temperature up to 2.53 times [38], and the total area not meeting the norm of the specified fragment was 16.5% (Figure 5c). Inspection of the sill part of the exterior translucent envelope of the bedroom showed (Figure 6a) that the surface temperature of the sill part does not correspond to the dew point (Figure 6b), where the minimum temperature on the surface was from -13.5°C to 6.9°C (Figure 6d), which does not correspond to the dew point temperature up to 2.66 times [40], and the total area that does not correspond to the norm of the specified fragment amounted to 29.4% (Figure 6c).

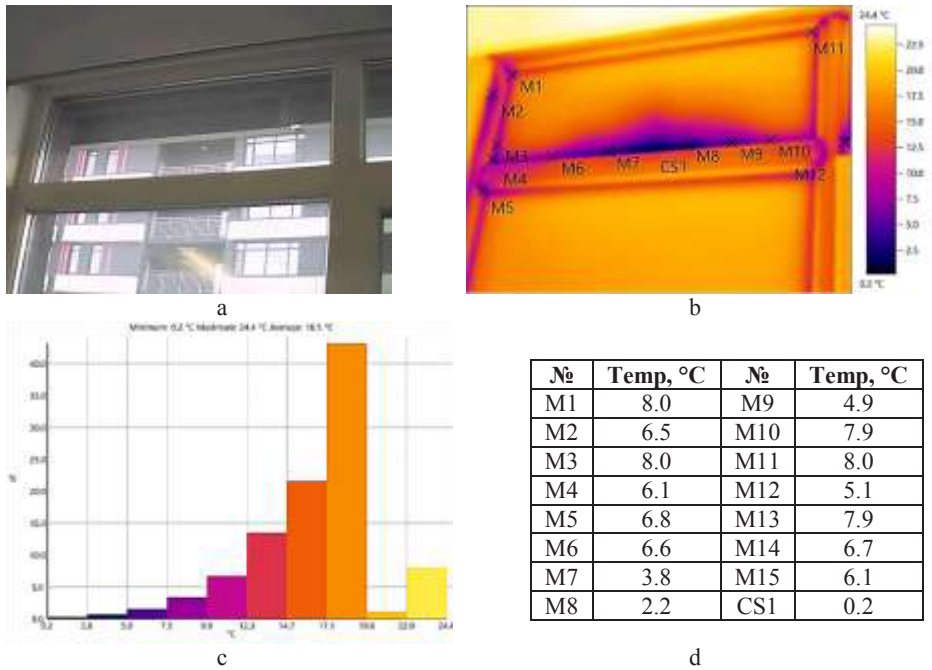
Fig. 7. Fragment of the front part of the external translucent envelope of the hall room with vulnerable points: a - full-scale photo of the fragment; b - thermogram with vulnerable characteristic points; c - diagram of temperature values with percentage ratio; d - table of points with temperature values.

Examination of the front part of the exterior translucent envelope of the common room showed (Figure 7a) that the surface temperature in the area adjacent to the opaque part

does not correspond to the dew point (Figure 7b). The minimum surface temperature ranged from 0.2°C to 8.0°C (Figure 7d), which also does not meet the norm [38], and the total area not meeting the norm of the specified fragment was 5.9% (Figure 7c). Inspection of the fragment of the left upper part of the exterior translucent envelope of the kitchen room showed (Figure 8a) that the surface temperature in the area adjacent to the opaque part did not correspond to the dew point (Figure 8b). The minimum temperature on the surface was from - 5.6°C to 1.4°C (Figure 8d), which does not correspond to the dew point temperature up to 1.7 times [40]. At the same time, the whole surface of the specified fragment does not correspond to the norm, as it is below the dew point temperature (Figure 8c). Examination of the fragment of the right upper part of the external translucent envelope of the kitchen room showed similar results (Figure 9a,b), where the surface temperature in the adjacency zone was from -4.7°C to 2.5°C (Figure 9d), and the temperature of the entire surface of the fragment (Figure 9c) relative to the dew point does not correspond to 1.58 times [40].

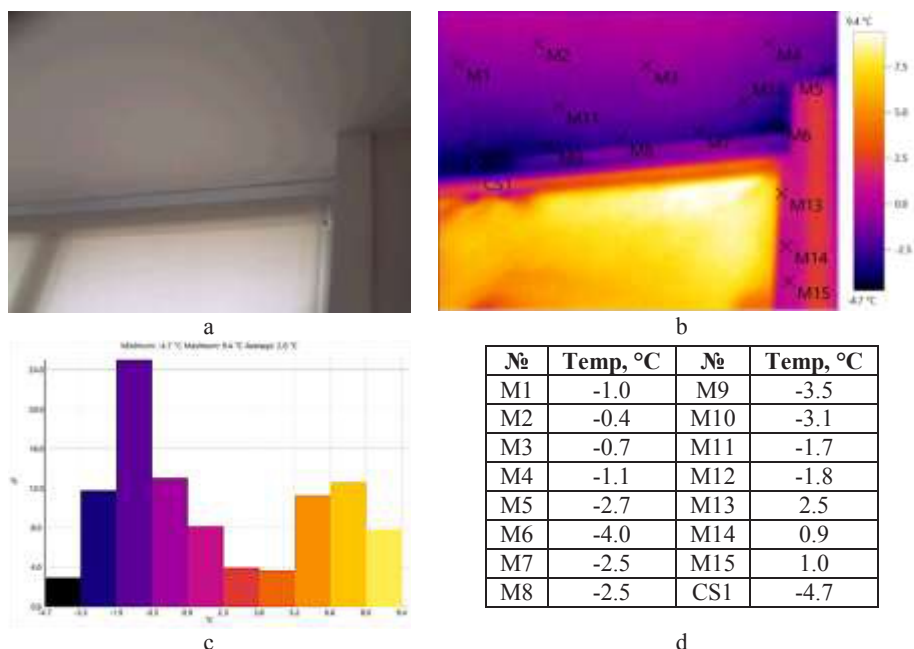
Fig. 9. Fragment of the upper right part of the external translucent envelope of the kitchen room with vulnerable points: a - full-scale photo of the fragment; b - thermogram with vulnerable characteristic points; c - diagram of temperature values with percentage ratio; d - table of points with temperature values
