# Need and Awareness of Leakages and waterproofing in High rise Building

**Abstract.** Identification of leakage sources is itself a perplexing process and needs expert views from experienced work and trade specific professionals. Comprehensive strategies relevant to work methodologies are to be implemented that prioritises durability and efficacy of waterproofing system. Leakages when identified at final stages of building handovers induces a high cost in repair and maintenance of defects pertaining to waterproofing failures or due to non-consideration of leakage prevention measures at the design and specification establishment stages. Despite of a thorough technical knowledge even seasoned civil engineering professionals and even waterproofing specialists are not aware of the probable root causes of observed leakages. Various factors contributing to leakages through different areas of buildings are mentioned along with preventive measures in relation to process enhancement, workmanship, materials, etc. in relation to prevention of leakages. Photographic examples of different types of leakages are provided for an easy understanding of non-technical users regarding the kind of def

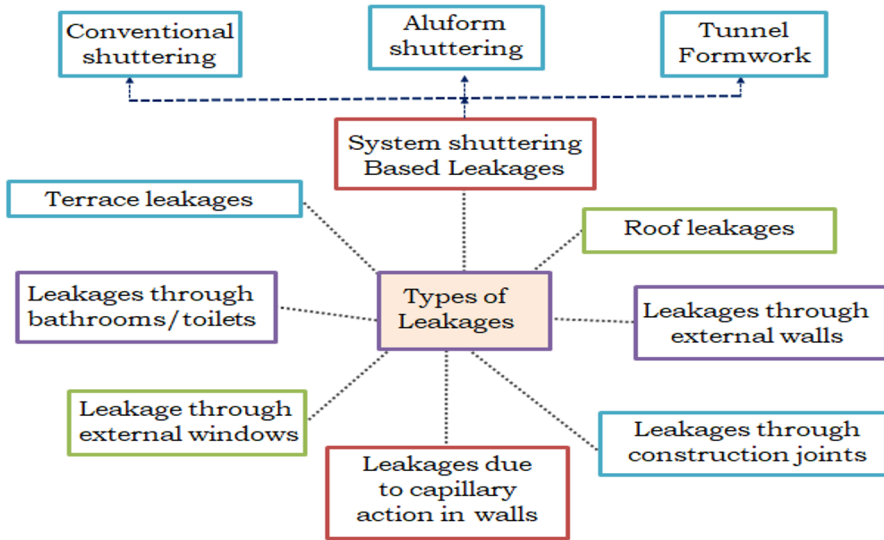
Fig.1 Types of Leakages

Different types of leakages are as shown in fig. 1

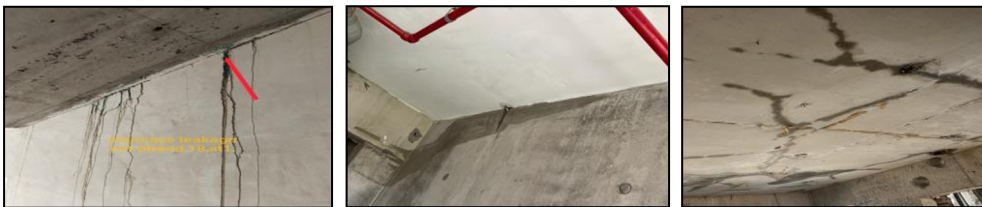
Fig. 2 Terrace and Roof Leakages

**Terrace and roof Leakages:** Terrace leakages results from shrinkage cracks, construction joints, and hollow pockets left in sunks, etc. left unattended at the time of slab casting. Rainwater or water from other sources when stagnated at area then results in leakages through terraces. Such type of leakages is very critical because they directly affect the top floor customers and leakages may even be as greater as continuous dripping water.

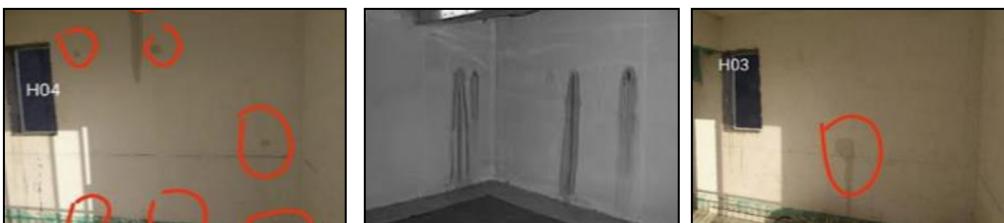
Fig. 3 External Wall Leakages

**External Wall Leakages:** If the exterior walls of a flat have cracks or gaps, water can infiltrate during rainfall. This can lead to dampness, mold growth, or water seepage on the internal walls. These leakages majorly arise in case of Aluform/ Mivan or Tunnel formwork system where excess wall tie/conic tie openings are available. Such openings if not packed properly at RCC repairing stage results in rainwater seeping and percolating inside common areas and flat of building.

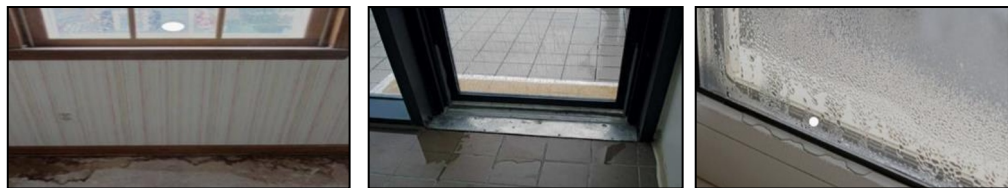
**Fig. 5** External Window Leakages

**External Window Leakages:** These leakages occur at times of heavy or moderate rains from external windows by water leaking from window sides or even tracks. They may result in damage of internal paints, debonding of floor tiles or even flooding in area which could lead to roof leakage in flat below. Photographic representation and examples of leakages through external windows for easy identification of observed problem,

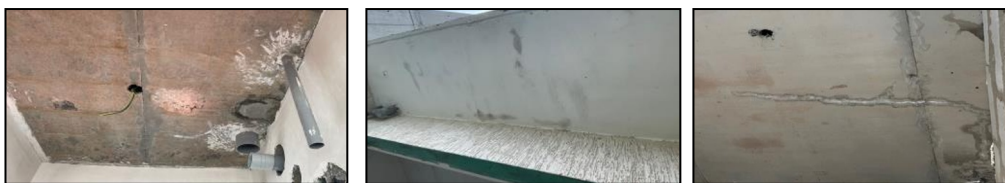
**Fig. 6** Leakages through Toilets and Bathrooms

**Leakages through Toilets and Bathrooms:** Toilet and bathrooms are highly susceptible to leakage problems. They are considered to be wet areas because of continuous use and contact with water. This water if leaked may percolate to other areas including adjoining wall or floor below and cause major problems such as customer conflicts, peeling of and contamination of wall paints, false ceilings, etc. Consequently, identifying the segments of the network and exact leaking pipelines connected to these segments are challenging (13). Multi-label classification methods can be used for leak detection in pipelines (14). Photographic representation and examples of leakages through toilets and bathrooms for easy identification of observed problem,

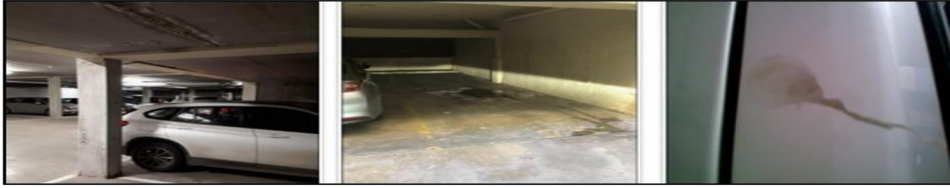
**Fig. 7** Water leakage through car parking roof

**Water leakage through car parking roof:** These are the leakages from roofs of MLCP's (multi-level car parking) arising due to problems such as stagnant water, car washing at above floors, etc. Such leakages result in problems such as stains on cars due to continuous dripping water and often results in parking space related conflicts.
